MASTER PLAN FINAL REPORT APRIL 19, 2010

Lambertson Lakes Open Space Master Plan

HISTORICAL **STRUCTURE ASSESSMENT**

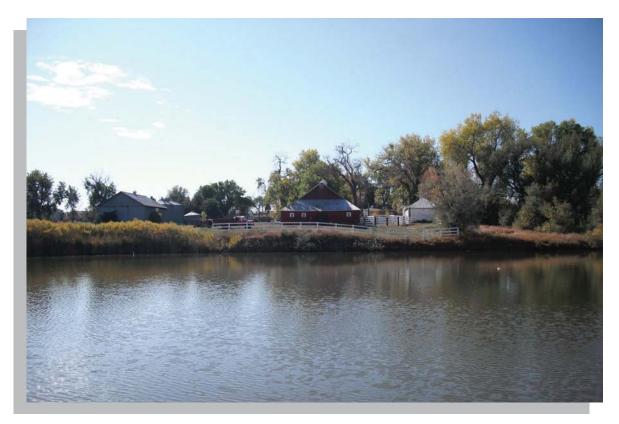
Photo 1 - View of homestead site. Looking south across Lambertson Lake #1.

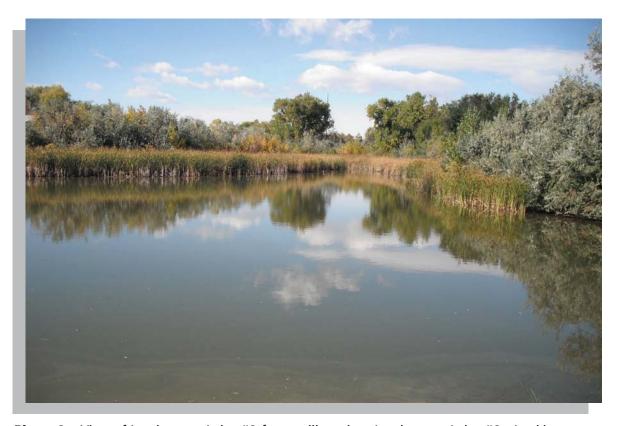
Photo 2 - View of Lambertson Lake #2 from spillway into Lambertson Lake #3. Looking west.

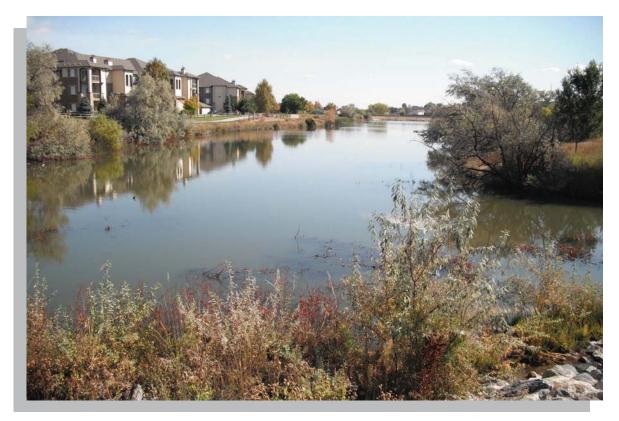
Photo 3 - View of Lambertson Lake #3 from Lambertson Lake #2. Looking east.

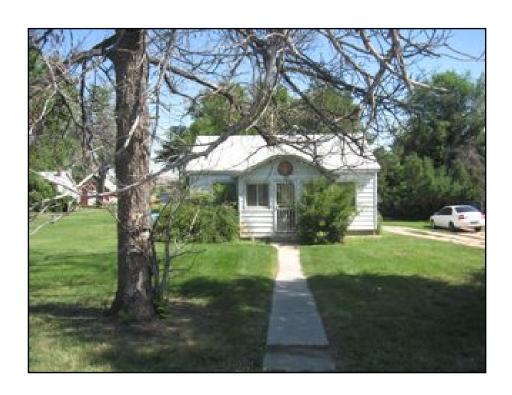
STRUCTURE CONDITION ASSESSMENT Building 1 – Farm House

The foundation consists of a cast-in-place concrete perimeter walls with a partial basement. There is crawl space under the remainder of the building. The foundation appears to be in fair condition. The concrete is showing signs of weather. Some vertical cracking (approximately 1/4" in width) was observed. The location of the cracks (middle of the building) and type of crack (vertical) indicates that the crack is most likely due to shrinkage and lack of adequate reinforcement. The perimeter drainage appears to be adequate with positive drainage around the entire perimeter.

The buildings HVAC system consists of a Carrier gas fired furnace approximately 25 to 30 years old. This unit is located in the basement and distributes sheet metal ductwork through a crawl space to the main level floor air registers. The furnace flue appears to be in OK condition and rises and terminates at the roof level. Overall the ductwork is in good condition and could be reused. The furnace is in poor condition and should be replaced. No cooling is present in the house. The basement has no combustion air present and both the furnace and water heater are atmospheric type appliances. This building would be classified as having a loose construction so some natural infiltration is occurring, but this is no substitute for the code minimum combustion air. This item should be addressed in a timely matter as this has potential health risks to the tenants.

The building's hot water is served by a 30 gallon atmospheric heater located in the basement. This heater is approximately 25 to 30 years old and should be replaced. The domestic water piping material is galvanized iron. This is typical for buildings of this age, but it should be replaced as this material degrades and deposits build up within the pipe restricting flow and adding pressure. New copper or plastic piping should be installed. The gas service is sub fed from building 2 (Ranch House). No meter is present for Building 1. The water service is fed from the well located on the site. A new well was dug recently and is in good operation. It is suspected that the new well is tied into the existing galvanized domestic water piping which should be removed.

The buildings sanitary system could not be assessed as below grade investigation work is required. Due to the age of the building it is conceivable that clay piping is present. This should be removed and replaced with PVC or cast iron.

The vertical cracks should be epoxy injected to prevent further deterioration.
