**Supplemental Source Area Characterization Plan  
Implementation Report  
Thornton Shopping Center  
East 88<sup>th</sup> Avenue and Washington Street  
Thornton, Colorado**

EPA ID COR000212639

Compliance Order on Consent Number: 24-02-01-01

February 14, 2025

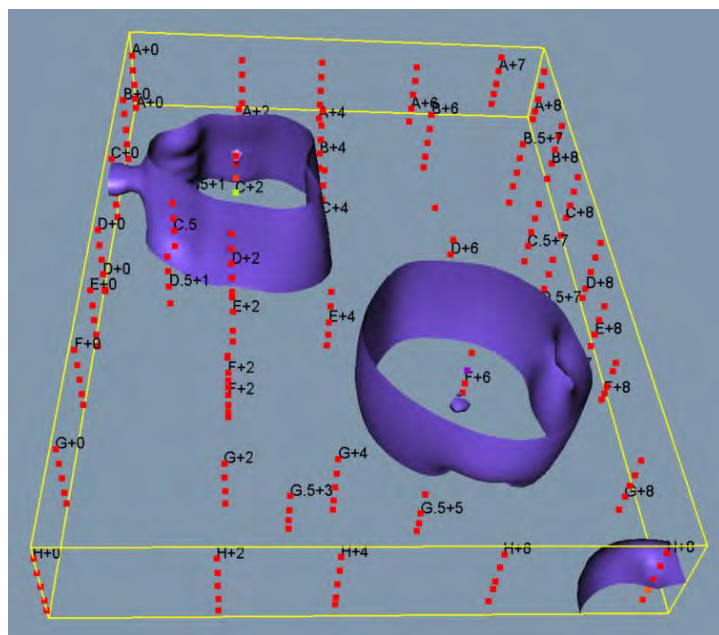
**Illustration 1.** VOXLER interpretation of shallow PCE soil results (0-24 feet bgs). Isosurface contour of 10 mg/kg. View is elevated at the south, looking north.

Based on the results of the source area shallow borings, limited evidence of the historical BOS treatment solution injections was observed and significant PCE mass remains within the source area. Using the survey coordinates of the soil borings, ERO modeled the results using Golden Software Voxler 3-D graphic program to visualize the distribution of PCE in the subsurface at the source area. In general, as shown in Illustration 1 below, PCE concentrations in soils appear to be centralized in two locations – the original source area within 8866 North Washington and in the general area of the sewer southeast of the source area. The high PCE concentrations with depth to the southeast is presumed to be indicative of potential DNAPL migration along the top of the competent bedrock that causes mechanical refusal to DPT drilling. In addition, as shown in Illustration 2 of the same data, but with a lower isocontour concentration (6 mg/kg), a strong northwest-southeast trend to elevated soil PCE concentrations is present – generally consistent with groundwater flow.

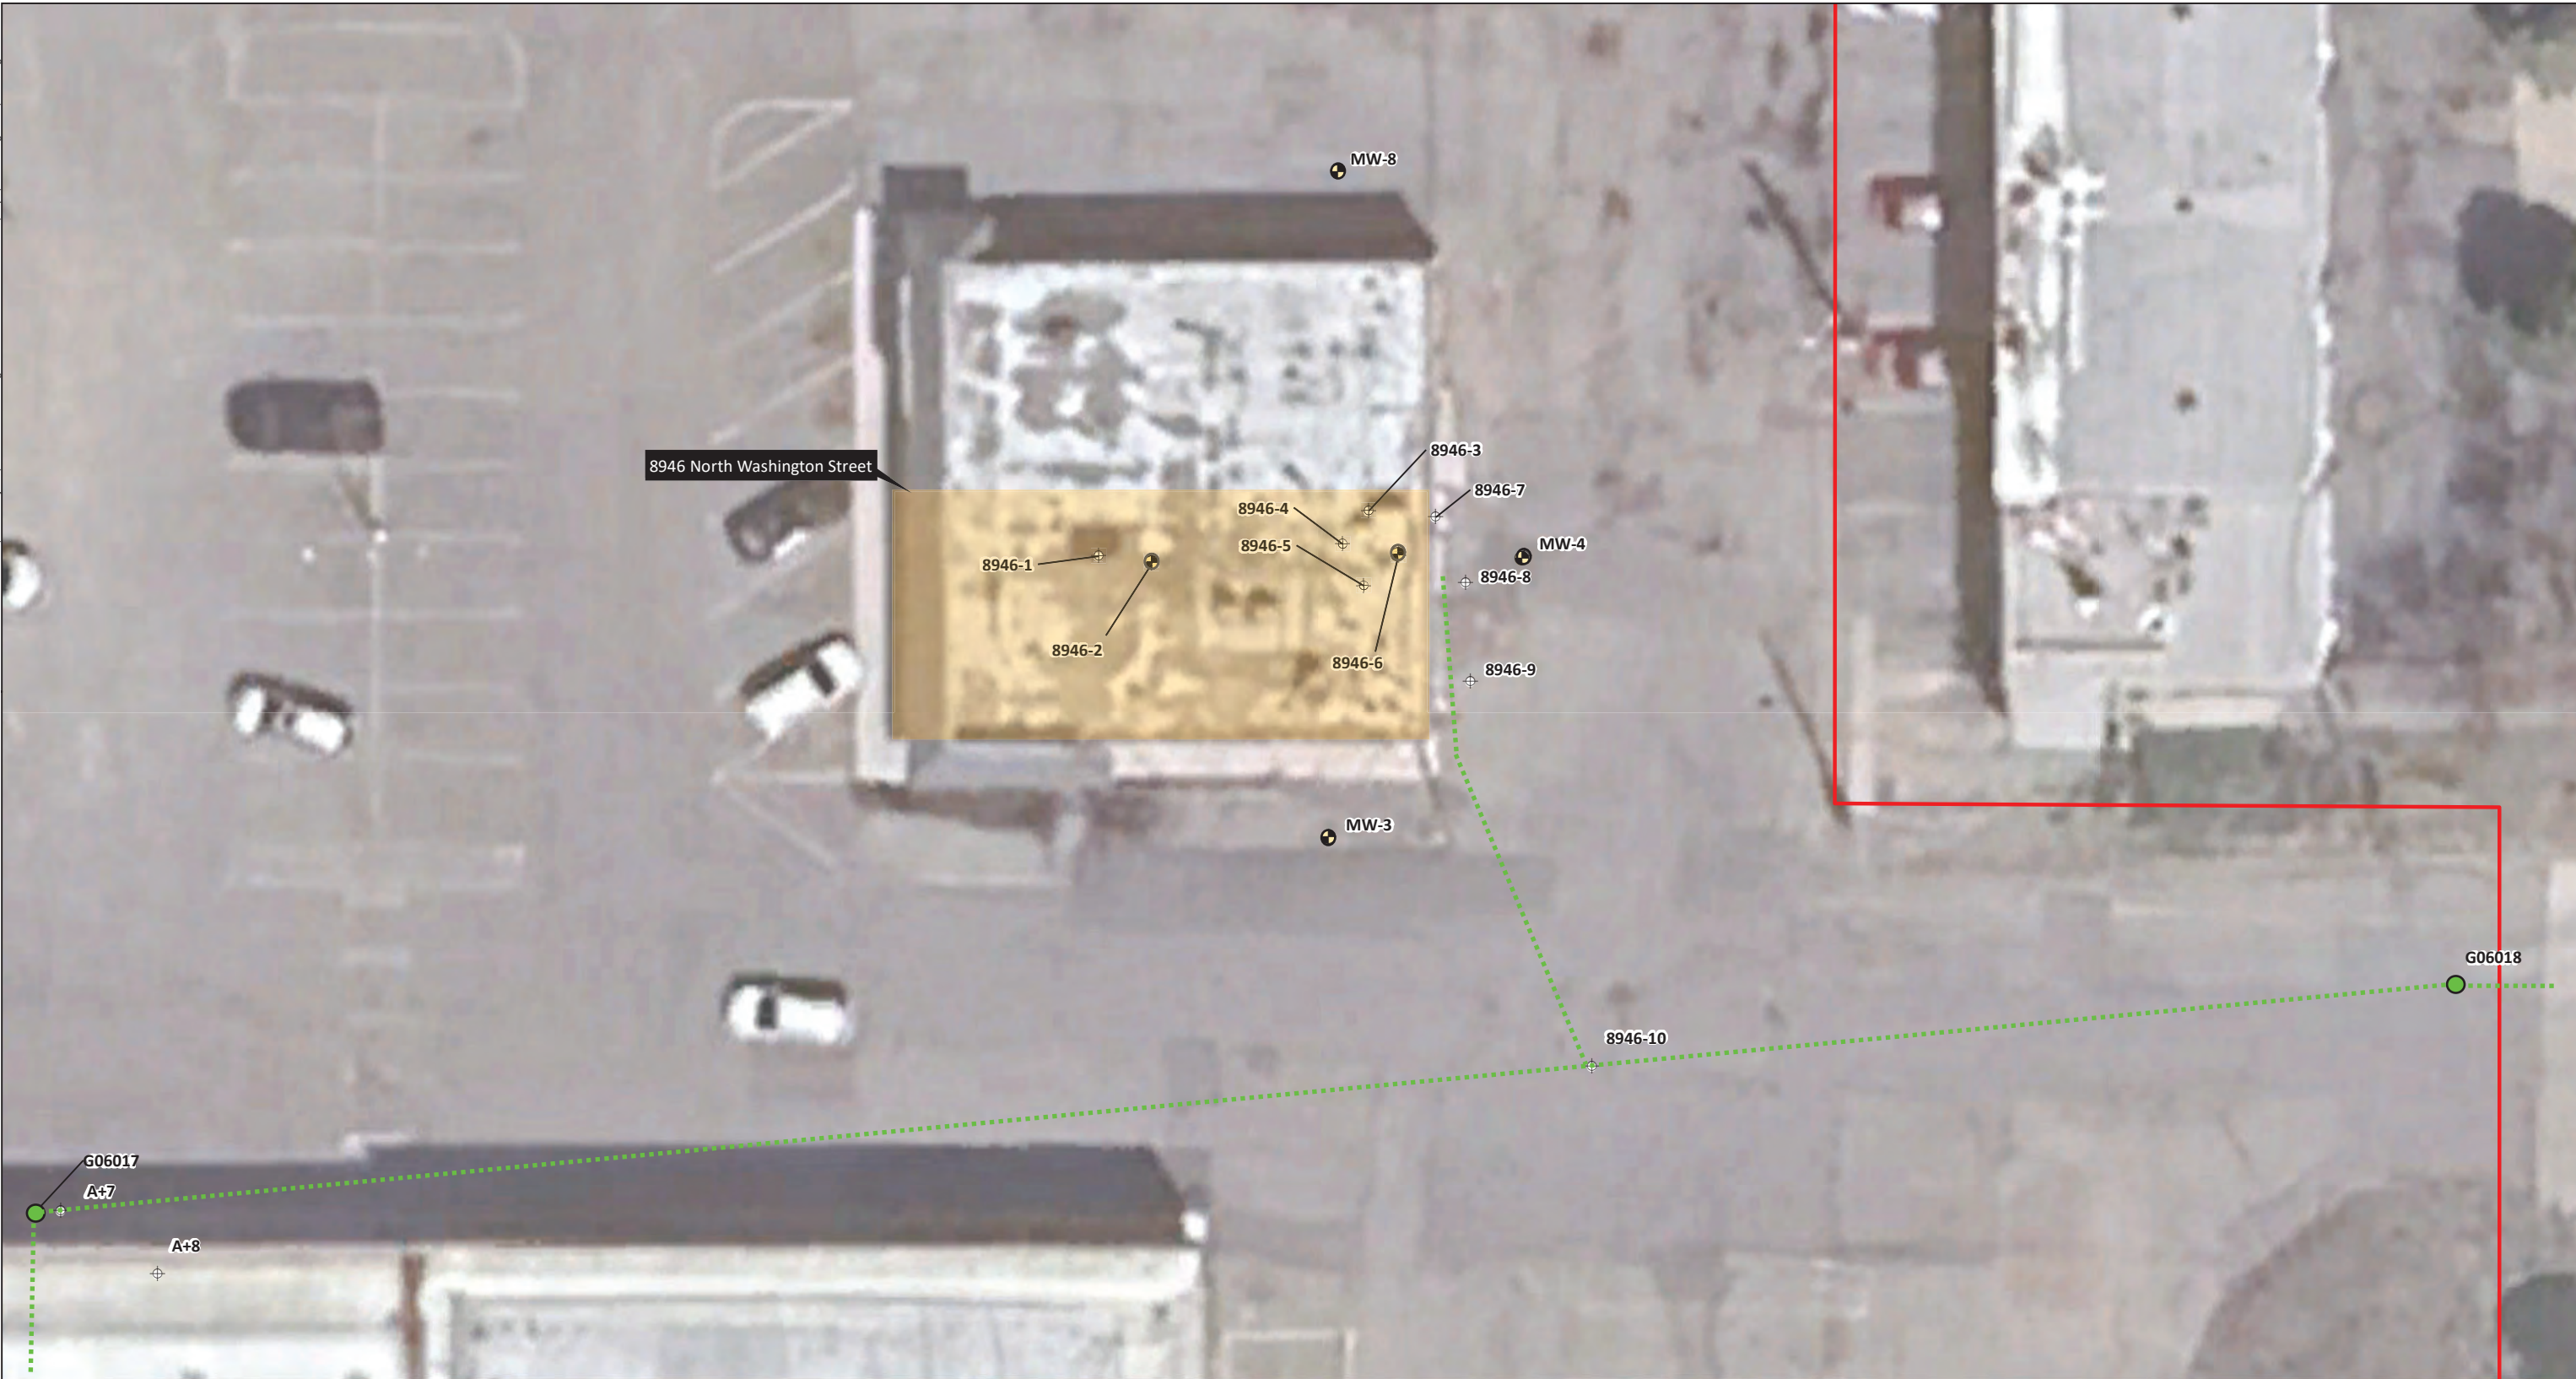
#### Thornton Shopping Center - 8946 Washington Street Investigation

Soil borings were drilled using DPT to drill to bedrock/mechanical refusal in the same manner as described above for source area borings. During drilling, soil samples were collected from the interval with the highest PID reading and/or location of any observed staining or olfactory indication of suspected contamination. In addition, soil samples were collected from the approximate water table and at the base of each boring. Only one soil boring identified suspected contamination (8946-1) at a depth of 7 feet bgs. The discrete soil samples were collected directly from the core within the sample sleeve, packed into laboratory-provided, certified clean glass sample jars, labeled, and placed on ice for transport to the laboratory for analysis of VOCs associated with dry cleaners by EPA Method 8260B under chain-of-custody procedures.

**8946 Washington Street** – The sanitary line for this facility exited out the rear/east door of the facility and connected to the main line southeasterly of the unit building. As noted above, the main line continued easterly down the alley between Oak Place and East 89<sup>th</sup> Avenue (Figure 3).

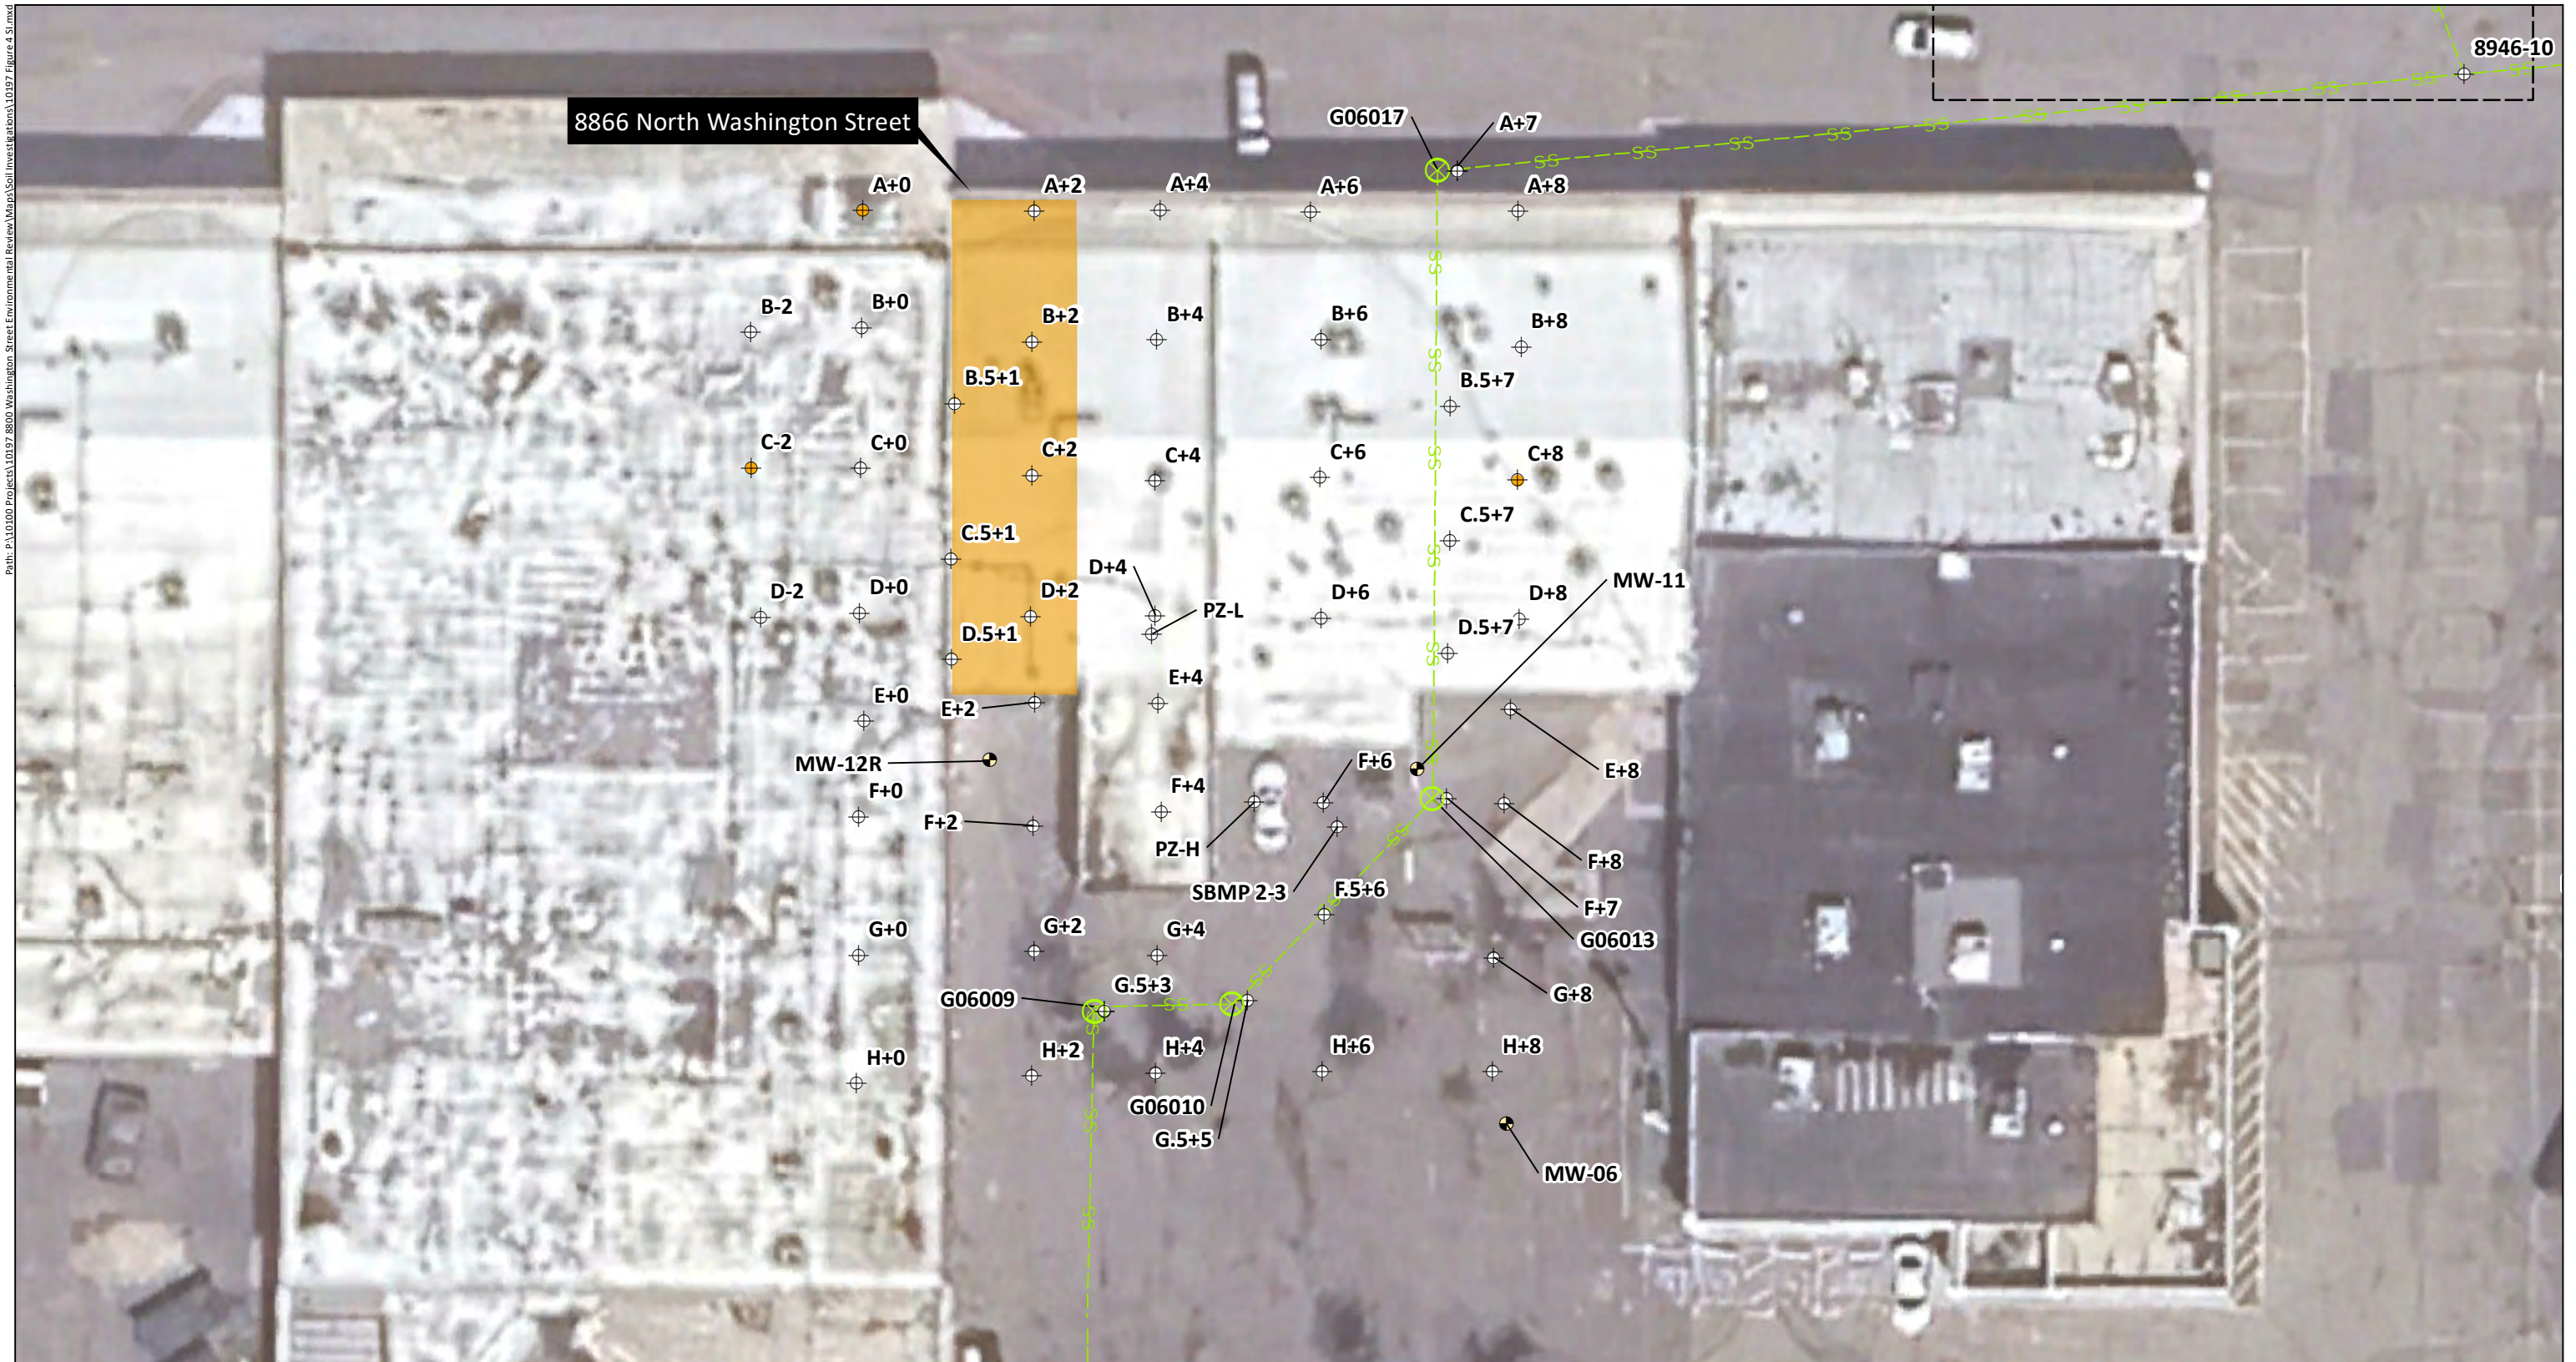
Figure 4. Source Area Soil Boring Detail

Soil results from deep soil borings are shown on Table 5. Boring logs are presented in Appendix C, sample field sheets in Appendix E, and laboratory sheets in Appendix F. Deep boring locations A+0 in the northwest corner of the source area and D-2 in the west boundary of the source area did not contain detectable PCE in soils between the surface and 60 feet bgs. As noted above, shallow soil samples from each of these two borings did not contain detectable PCE concentrations.

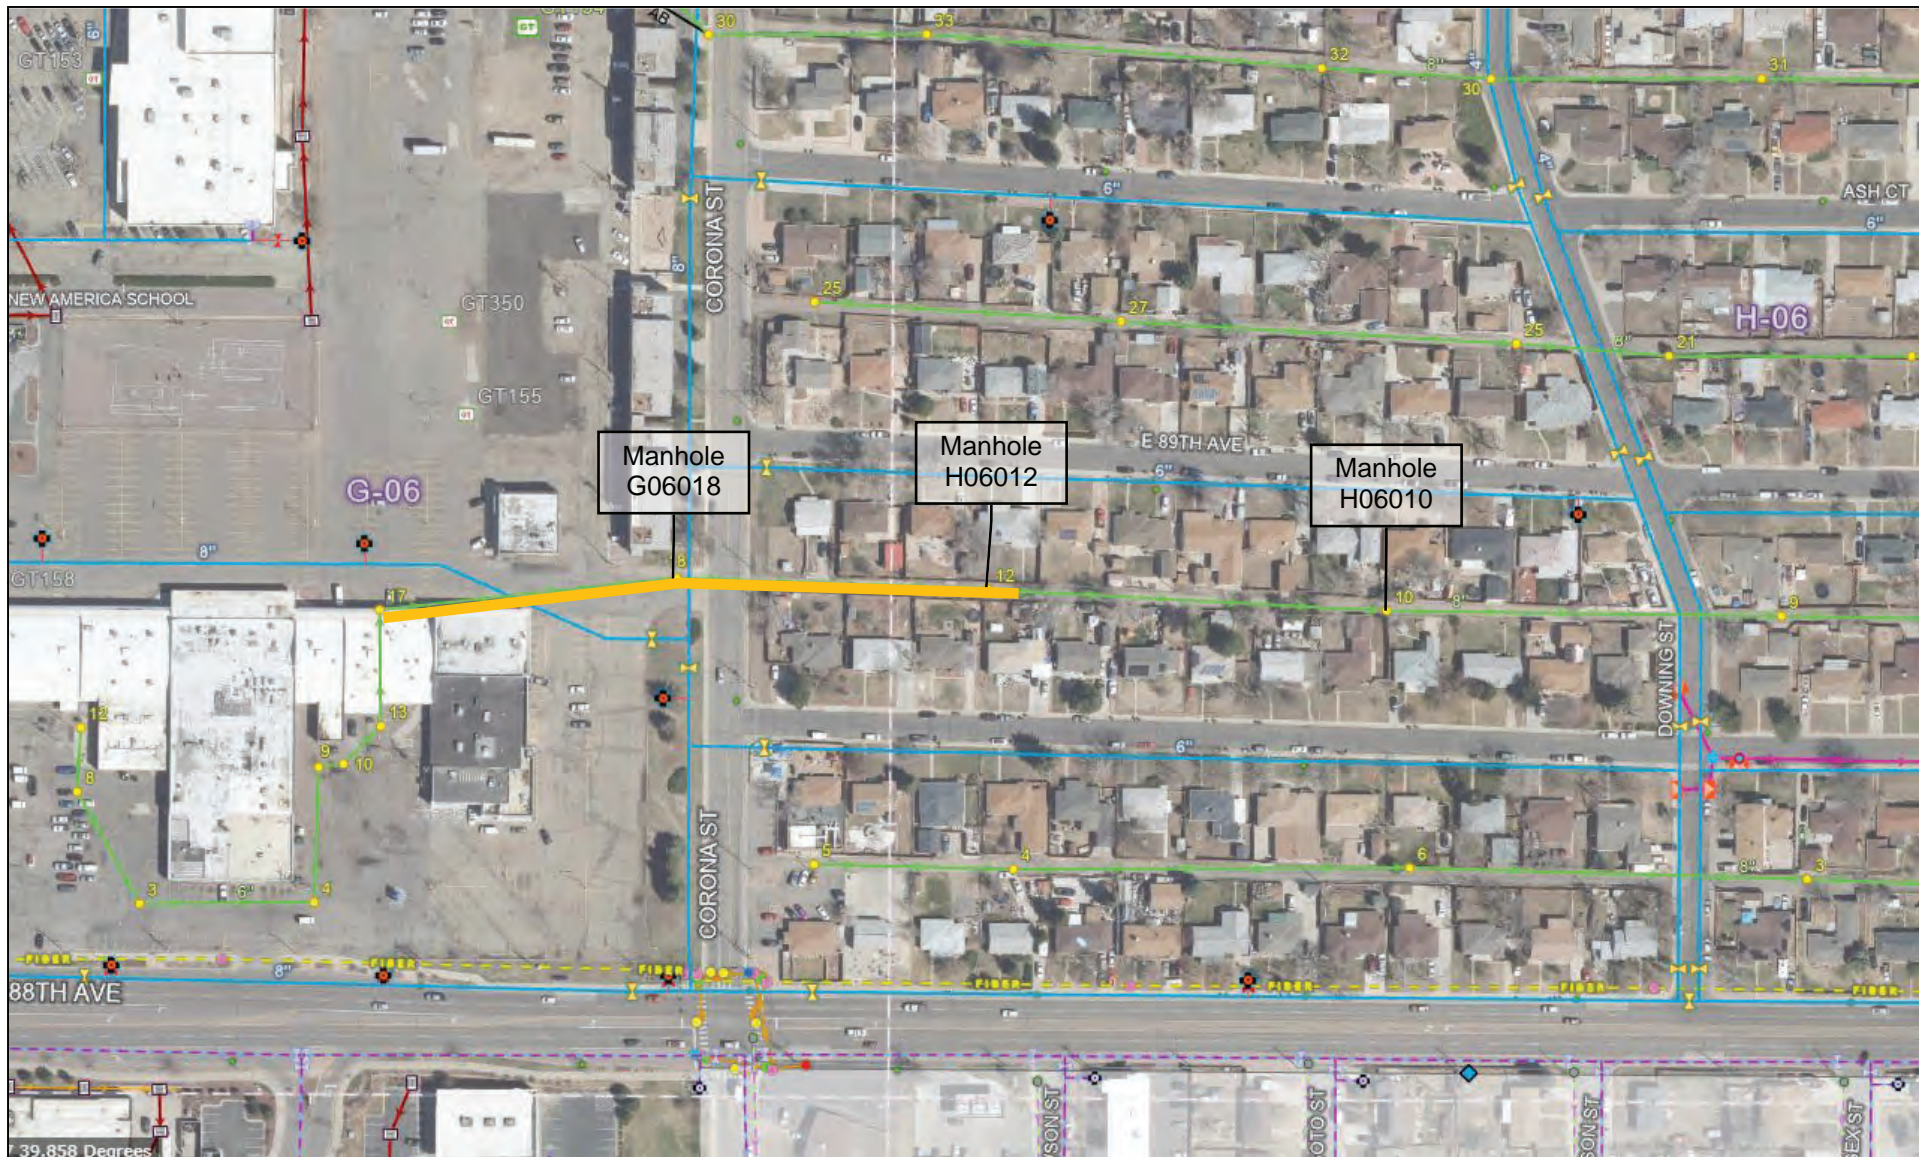
# Thornton Shopping Center - Off-Site Sanitary Sewer Scoping

The sanitary sewer line easterly of manhole G06018 and Corona Street is currently listed as an 8-inch PVC line with notations that the line was part of the original sanitary sewer line and was replaced in 1987 (City of Thornton 2025). Routine camera inspection footage was obtained from the City of Thornton Utilities Department for the sections manholes G06018 and H06012 and was reviewed for indications of potential release points (Figure 5). Screen shots of the initial camera view are provided in Appendix D. About 20 feet of footage downstream of manhole H06012 was available, however an extended service line into the sewer main prevented any further video of the pipe. The results of the review of off-site sewer inspection footage are highlighted below:

Based on the reviewed footage for off-site sewer utilities, the off-site footage confirms that the service main line is PVC, consistent with City of Thornton Utilities database. Further evaluation of the sewer corridor is recommended to be contingent on results of off-site plume assessment being conducted under the LTGMP.

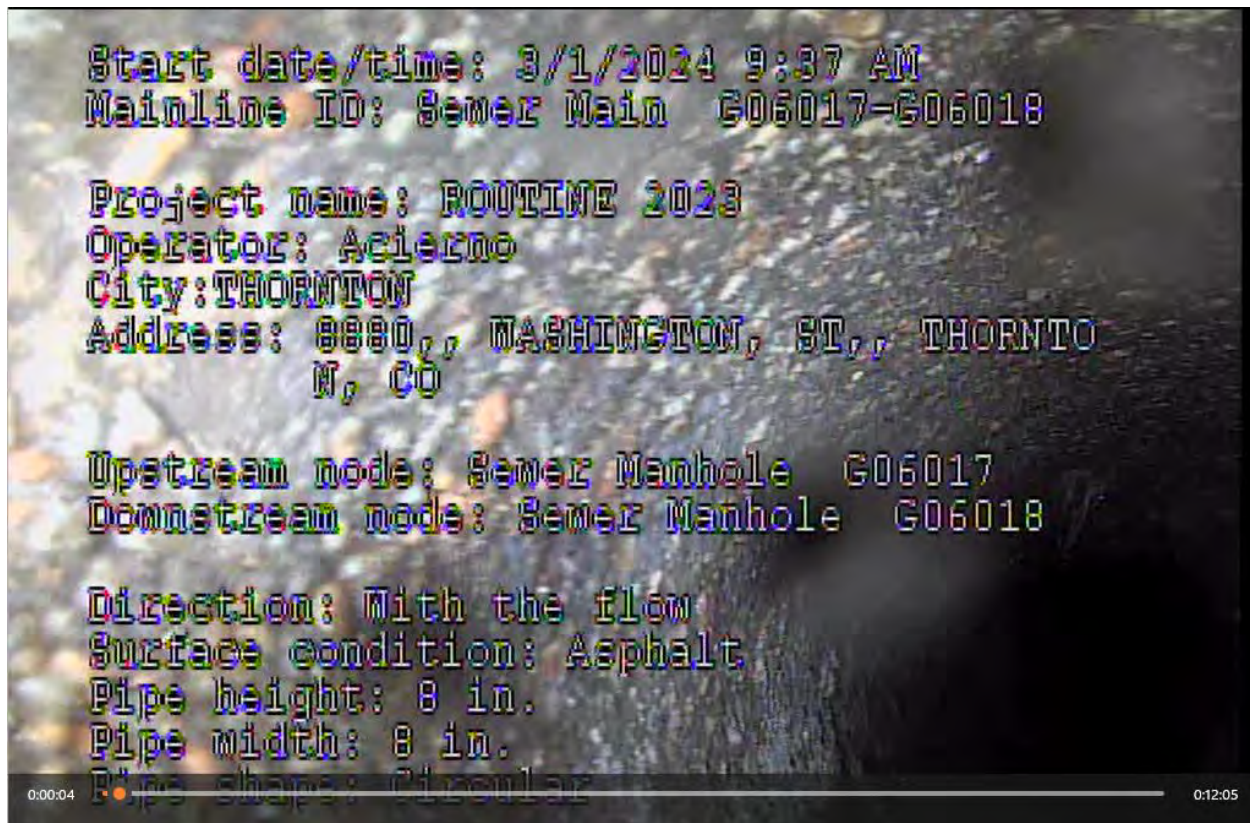
**Manhole G06017 to G06018**

**Total length:** 296 feet, full length surveyed

**Breaches/offsets:** "Hole" in pipe at 230 feet from G06017

**Date of Survey:** 3/1/24

The sanitary sewer line between manholes G06009 and G06018 is planned for removal as part of site remedial excavation activities. The sewer line will be excavated, sewer utility trenching and surrounding soils will be inspected for indications of release, and representative soil samples along the corridor will be collected to document conditions. Further details of the on-site sewer excavation will be provided in the source area excavation workplan.

Based on the review of available footage for on-site sewer utilities, removal and assessment of subsurface conditions during the removal of the sewer utility between manholes G06009 and G06018 will identify and characterize potential release points within the corridor. This removal will be incorporated into the workplan referenced above in Section 7.1.

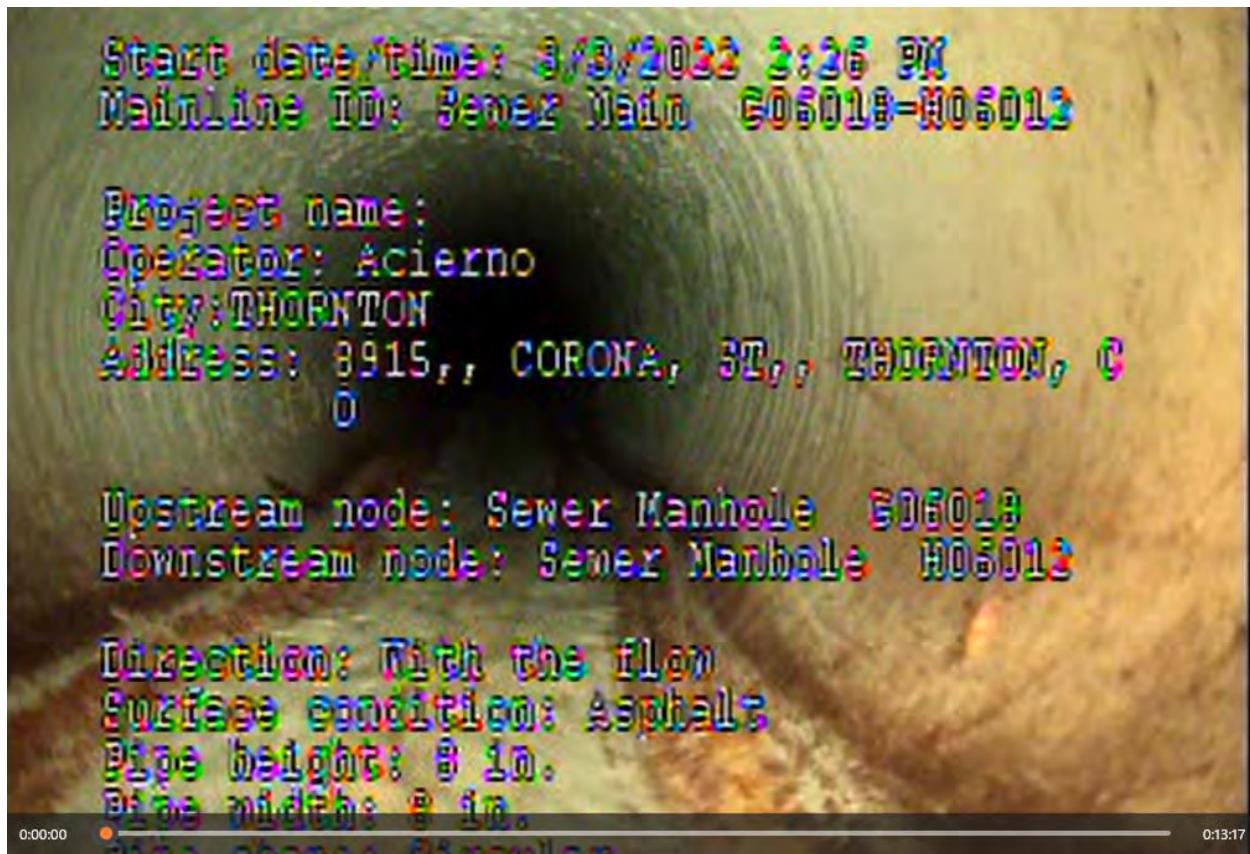
**Manhole G06018 to H06012**

**Total length:** 313 feet, full length surveyed

**Breaches/offsets:** None

**Date of Survey:** 3/3/22

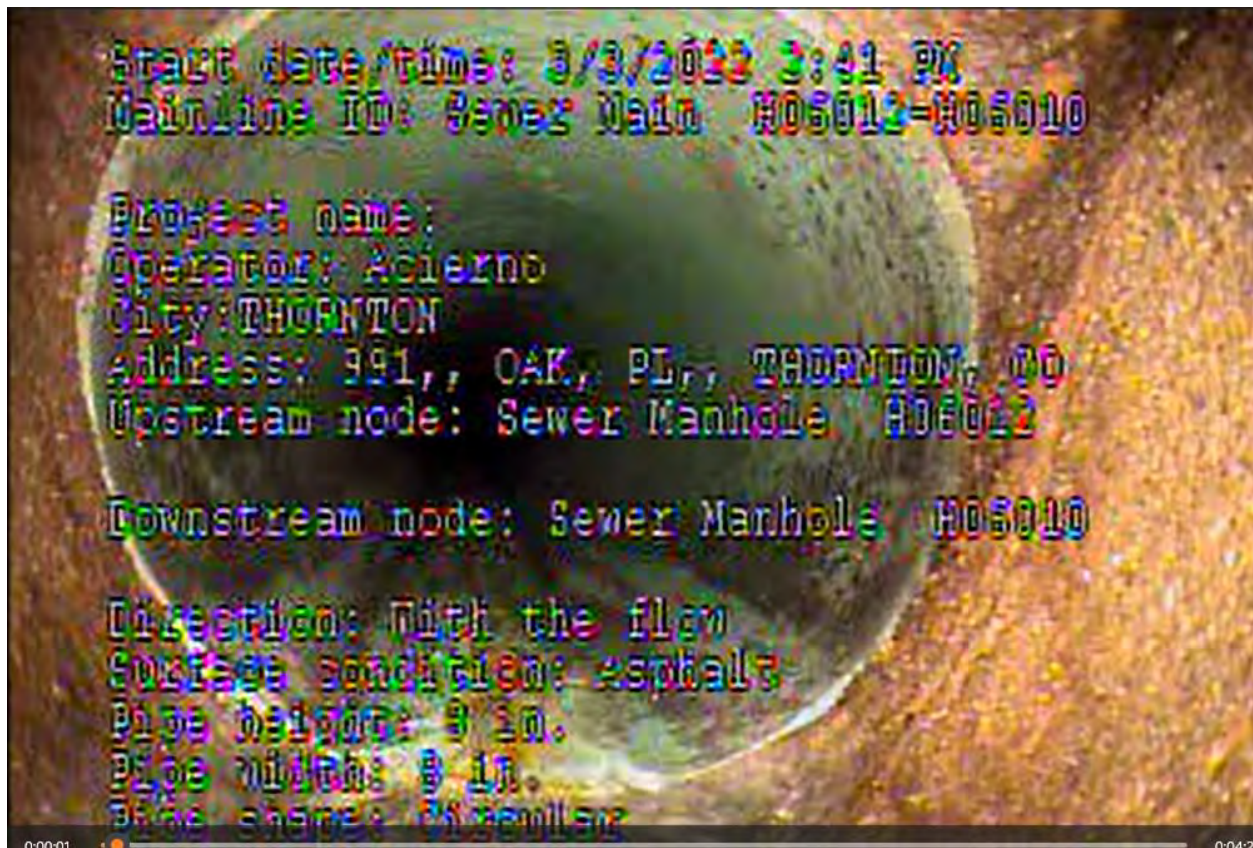
**Manhole H06012 to H06010**

**Total length:** 400 feet, only 20 feet accessible due to extended service line

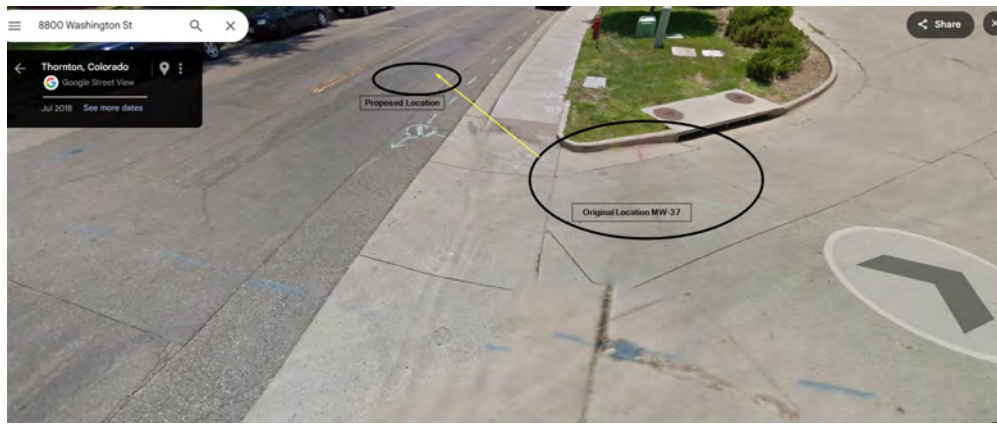
2. **LTGMP Well MW-37 relocation** – ERO assessed the proposed location for well MW-37 as previously approved in 2022 and anticipates significant utility conflicts with the location originally proposed and approved in the May 3, 2022 email from CDPHE to John Dellaport. The screen capture from Google Streetview shows water, sewer, electrical and telecom utilities all within the originally proposed location. To accommodate the anticipated utilities, ERO requests approval to shift the location into the Corona Street right-of-way, about 24 feet southeast. This new location appears to continue to be downgradient of OFS-1 and should fulfill the same intended purpose of performance monitoring.
