**Big Dry Creek Recreation & Floodplain  
Restoration Master Plan**

**February, 2018**

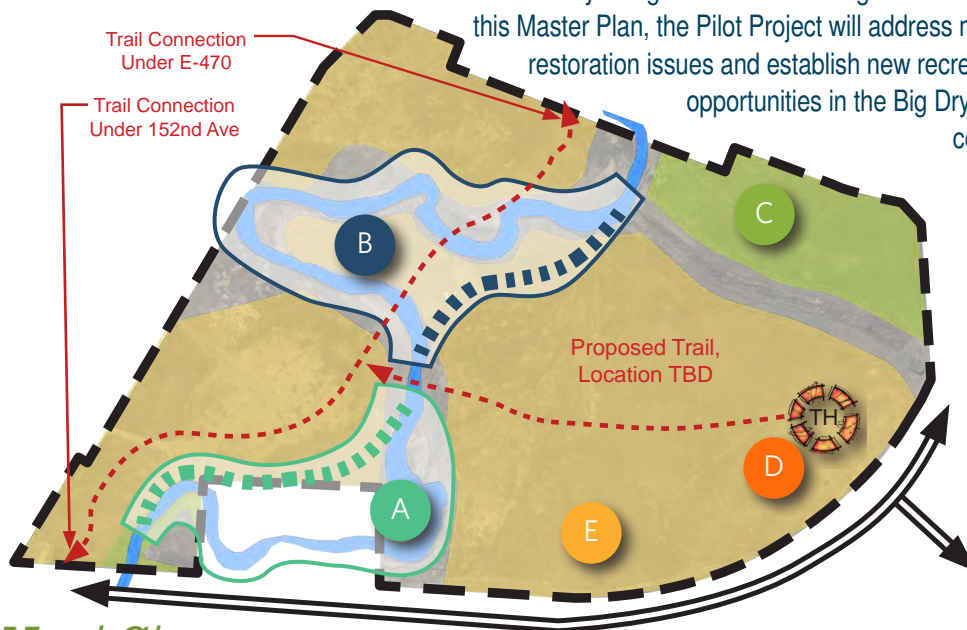
**A**

**Issues**

- Lateral Migration
- Erosion
- Habitat degradation

The Big Dry Creek Pilot Project will set the example of restoration in the corridor. By using the Toolbox strategies developed in this Master Plan, the Pilot Project will address multiple restoration issues and establish new recreational opportunities in the Big Dry Creek corridor.

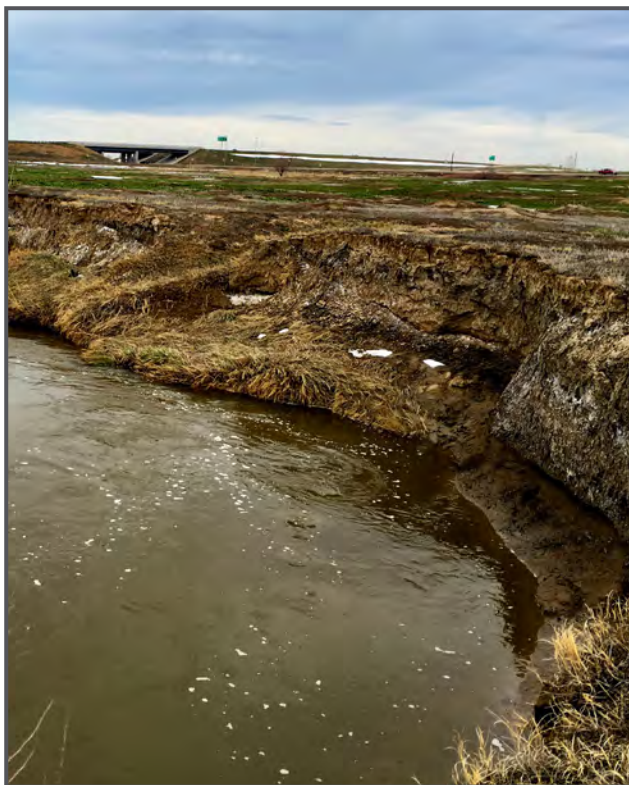
Vertical cut bank on Big Dry Creek

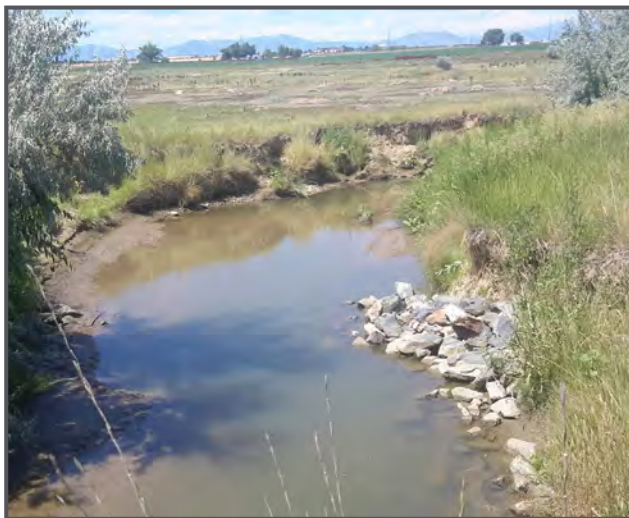
Rubble and cut banks on Big Dry Creek

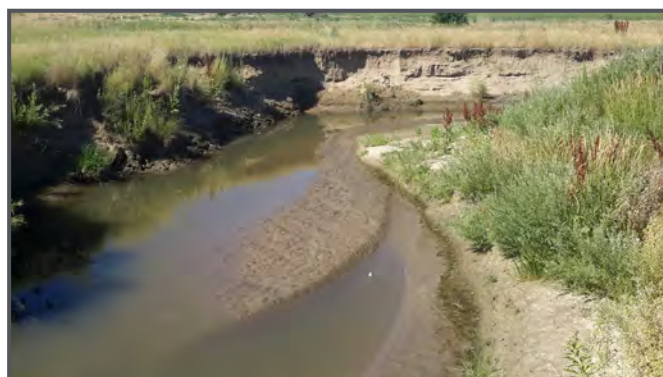
*Outer bend bank erosion and inner bend sedimentation in Parcel I*

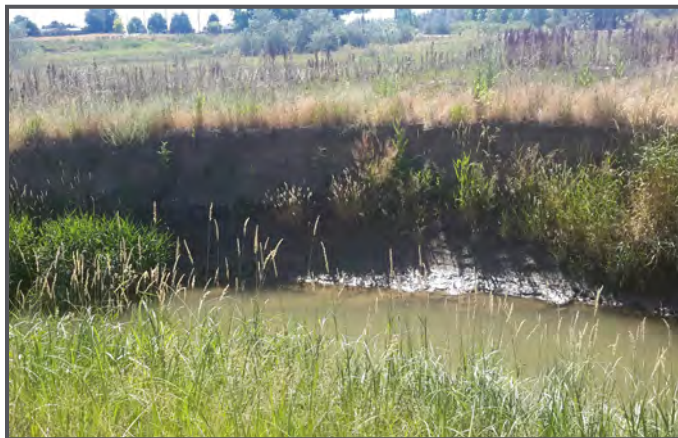
Cut bank on the outside bend of Big Dry Creek in Parcel II; sloughed sediment from the bank can be seen at the base of the creek

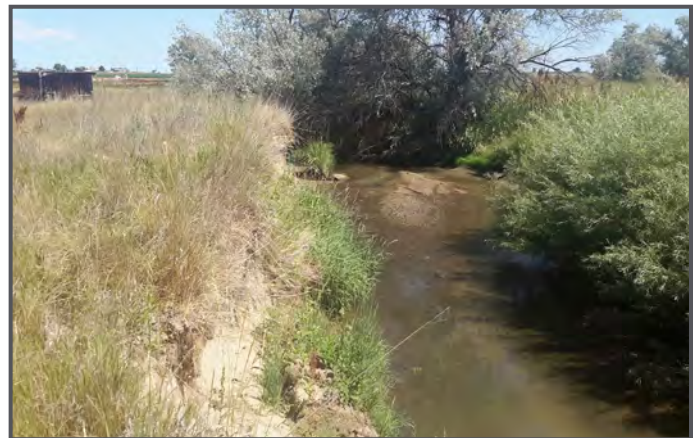
Riparian vegetation growing into sloughed sediment in Parcel II

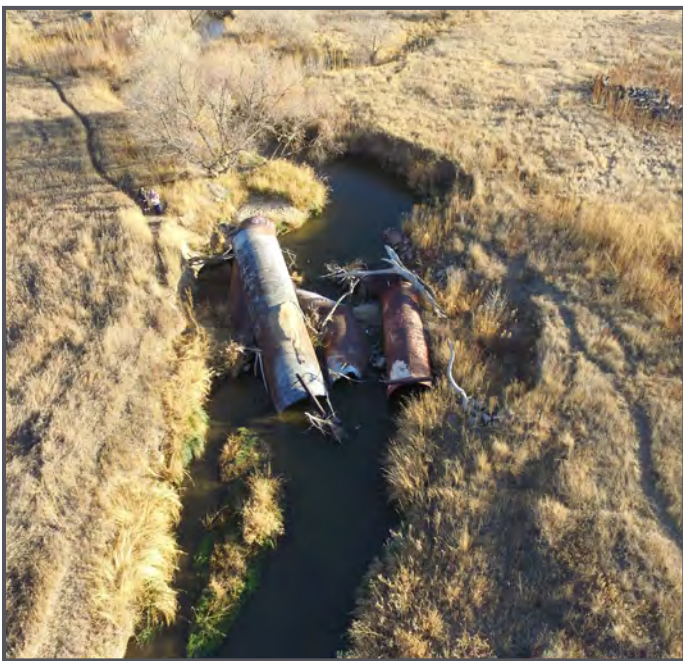
Failed culvert crossing within High Priority Reach 5 in Parcel III

High Priority Reach 5 is near an adjacent HOA -owned playground in the northern portion of the parcel. Some improvements have been made in this reach, however, it is evident that the public accesses the stream in this location via a steep and eroded bank. This activity along an unstable bank is causing additional bank erosion in this area. There is also a failed culvert crossing which appears to be currently serving as a grade control for the channel. In the event these culverts are completely washed out, there is the potential for a headcut to form and migrate upstream. These culverts should be removed and grade control measures should be implemented.

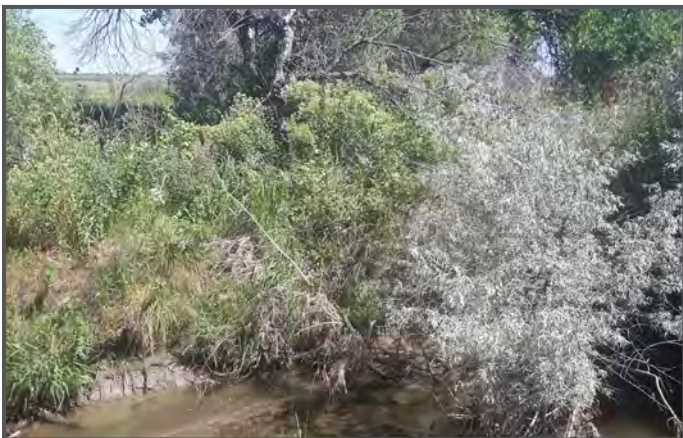
Riparian vegetation and Russian olive trees growing along the banks of Big Dry Creek in Parcel III

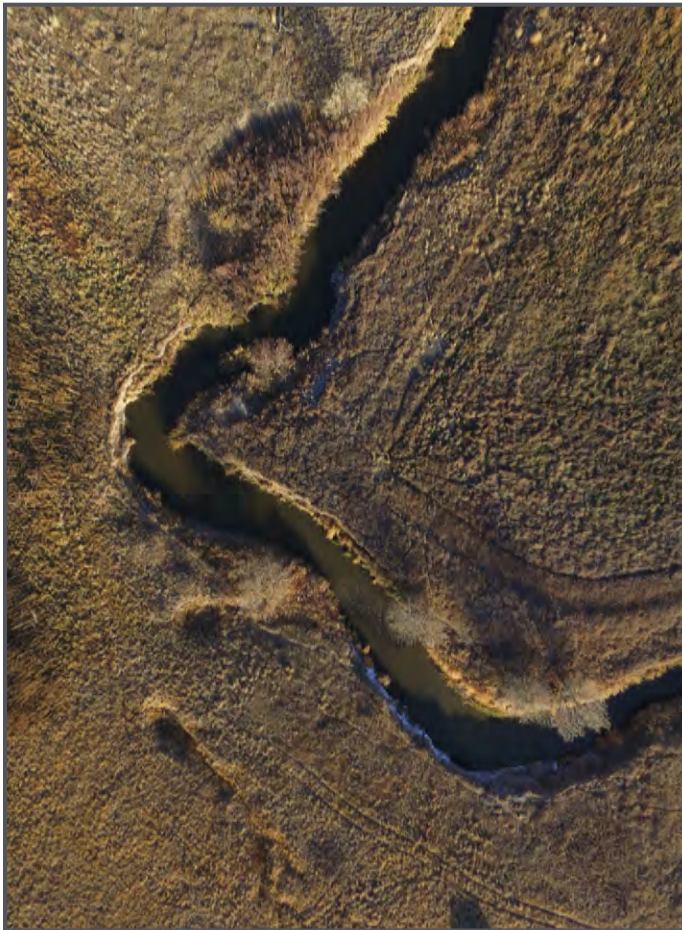
Sharp bend on Big Dry Creek in Parcel IV

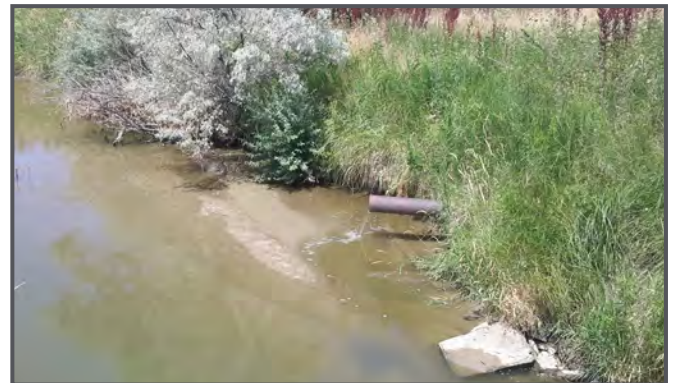
Small outfall pipe draining into Big Dry Creek in Parcel IV

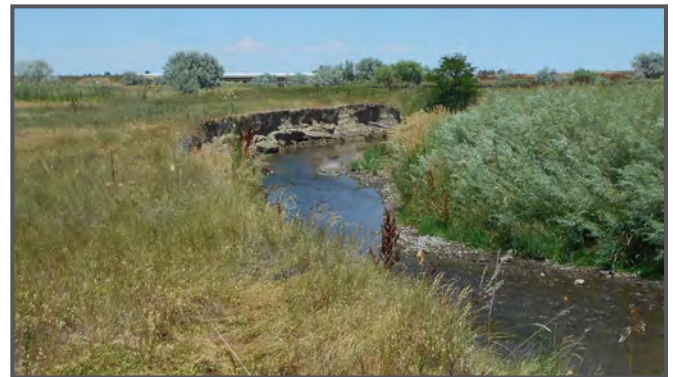
Erosion on outer bank of Big Dry Creek Parcel IV

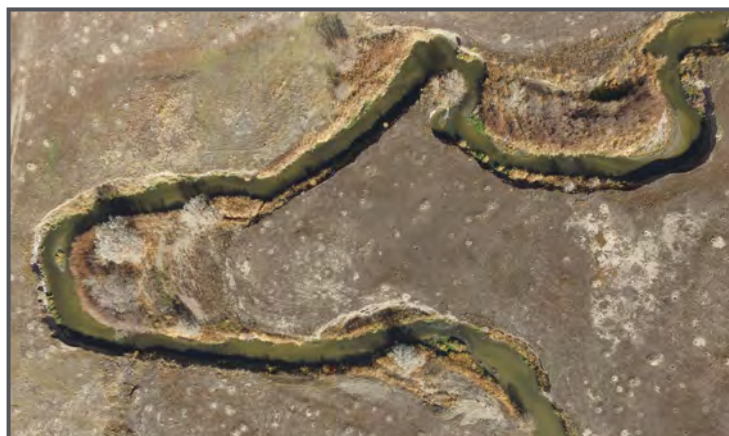
Aerial image of high priority reach in Parcel V

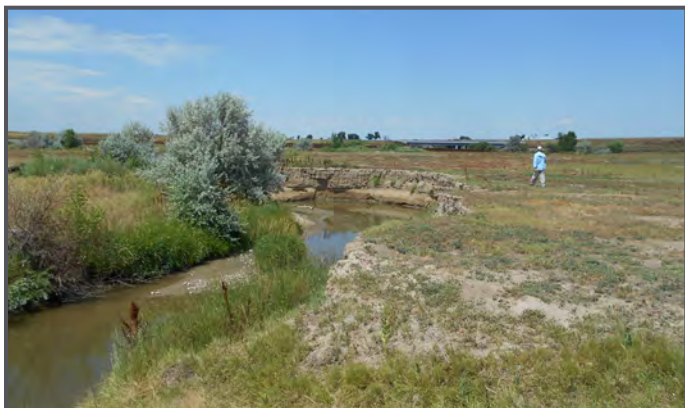
Vegetation on inner bank in Parcel V; vertical cut bank on outer bank

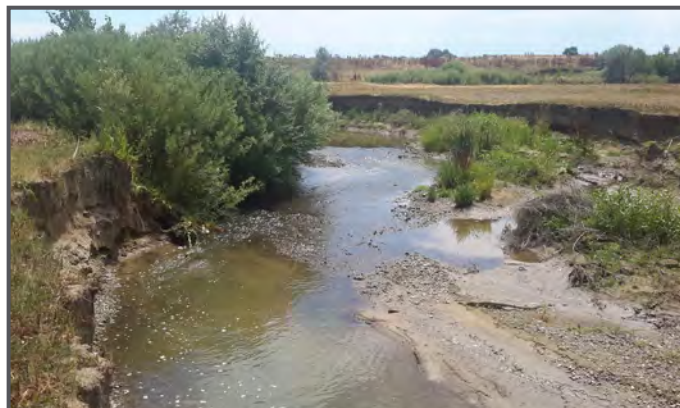
Inner bank in Parcel V that would benefit from revegetation

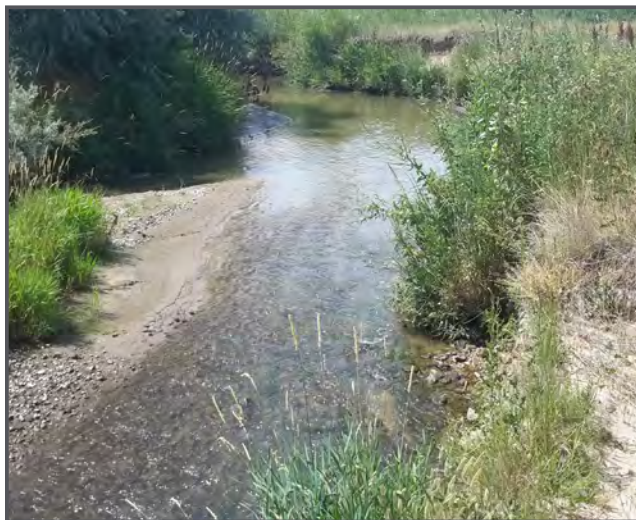
*Bank slough and sedimentation with vegetation in Parcel VI*

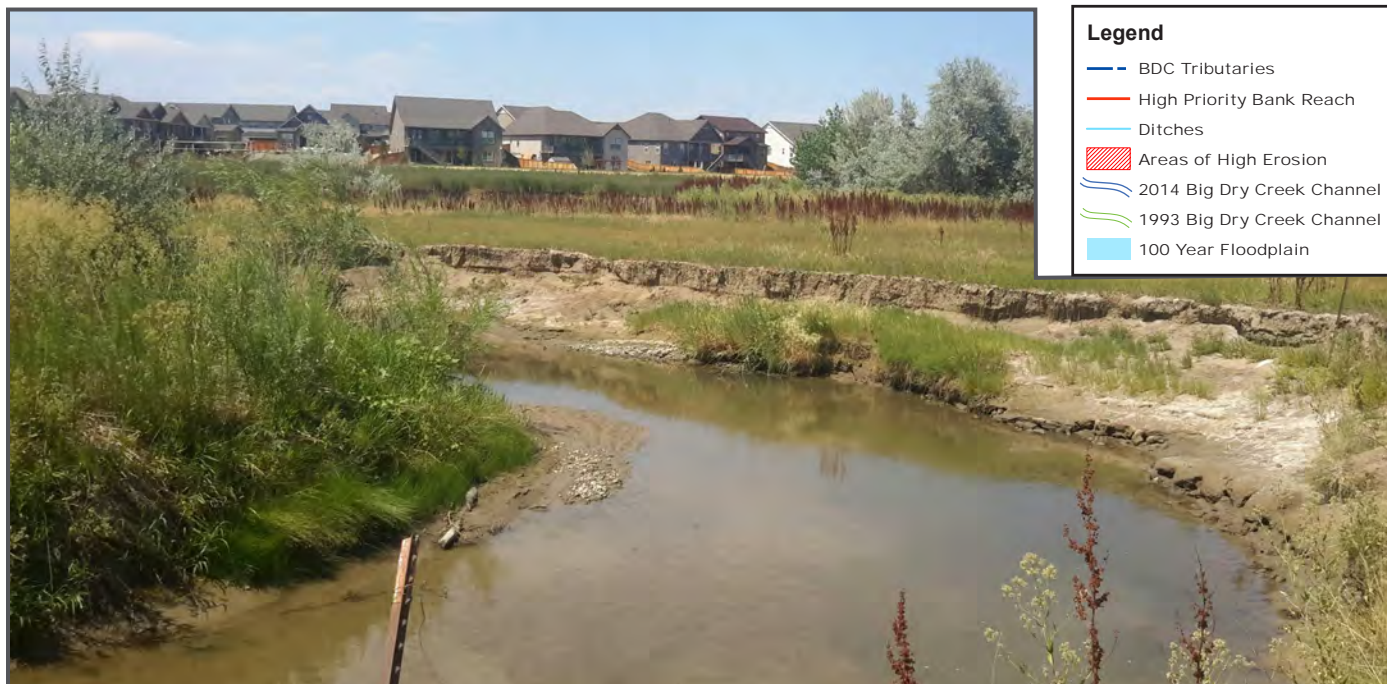
Erosion and sloughed banks in Parcel VII

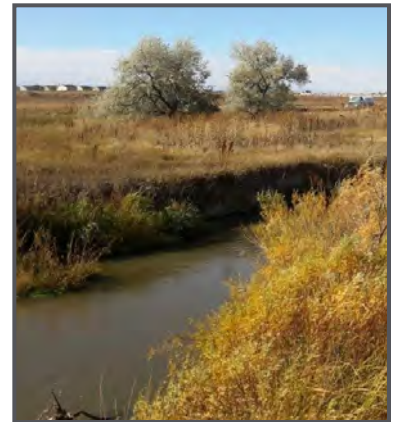
Outer cut banks in Parcel VIII

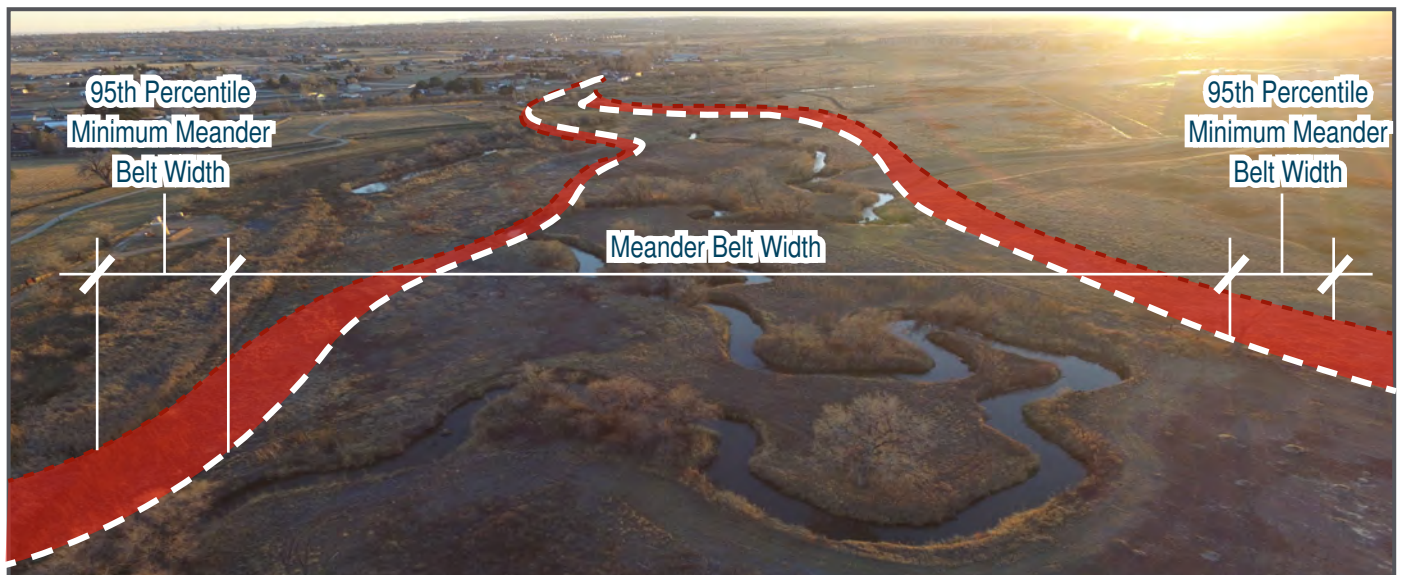
The meander belt identifies an area adjacent to the stream, where land is subject to erosion by the stream channel; this meander belt width is overlaid on an aerial of Parcel III

The Big Dry Creek corridor is subject to a high probability of erosion as the channel migrates laterally over time. Consequently, a meander belt width analysis was conducted. A meander belt width analysis is intended to estimate the area in which a meandering stream may occupy as it changes over time. In other words, the meander belt width analysis identifies an area adjacent to the stream which can be considered an erodible corridor where land in this area is subject to erosion by the stream channel. This analysis can be used in future planning for various stream stabilization measures, locating engineered hard points which reduce the potential for continued lateral movement,

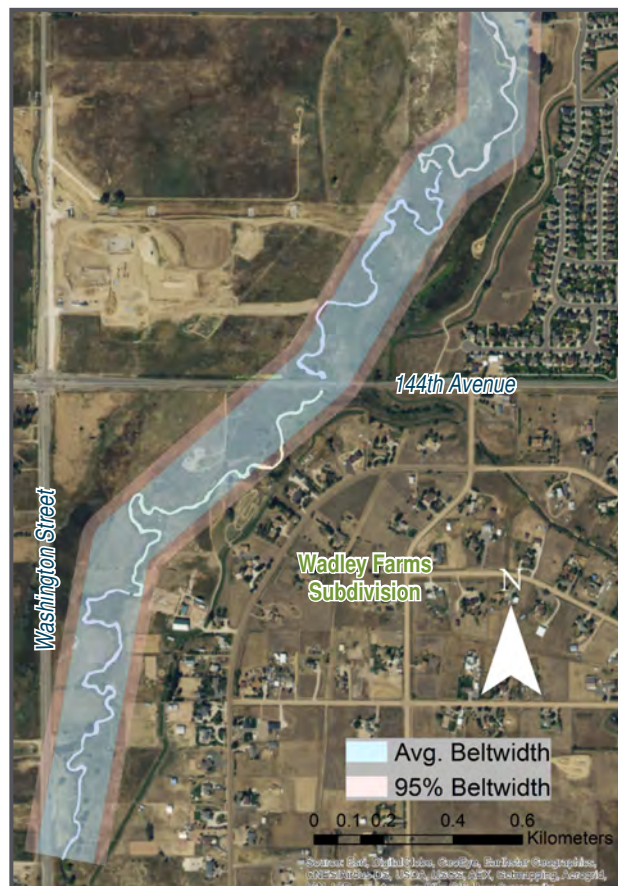
*Estimated Average and 95th Percentile Meander Belt width for Big Dry Creek through the southern project area*

A more detailed discussion of this analysis is provided in “Appendix C: Meander Belt Width of Big Dry Creek in Thornton, CO”. A visual summary of the estimated average and 95th percentile minimum meander belt width of Big Dry Creek through the project area is provided in the meander belt maps at right. Areas within the meander belt have a high probability of erosion as the channel migrates over time. However, areas outside of the meander belt are not necessarily immune to erosion, nor should the channel be re-aligned simply to fit within this calculated meander belt. Existing creek meanders which are located near the edge of the meander belt should be considered good locations for bank armoring to prevent further lateral migration of the channel outside of the corridor. This calculated minimum meander belt width can be used as an estimate to locate areas with a high probability of erosion along the channel corridor where infrastructure may be subject to damage from lateral channel migration.

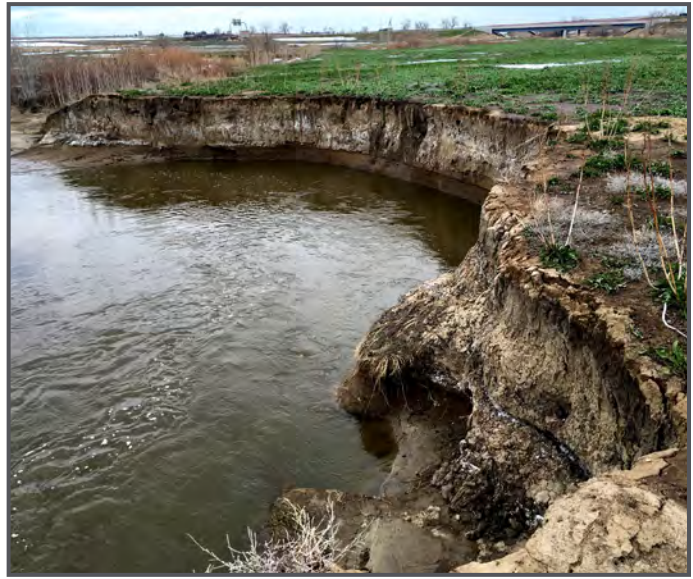
*Frequently varying baseflows in Big Dry Creek contribute to bank erosion*

As discussed previously, Big Dry Creek is never really dry due to wastewater return flows and irrigation releases from Standley Lake to the creek. The variability of these baseflows are contributing to bank erosion due to water surface fluctuations resulting in undercutting and sloughing of the channel banks. In order to help mitigate this issue, an assessment of seasonal baseflow rate and depth fluctuations through the Master Plan area was conducted so that stream bank or other stream restoration practices can be adequately sized and designed to reduce bank undercutting and sloughing during low-flow periods. Daily average streamflow data as well as average daily flow values for each point source WWTP inflow or diversion outflow were used to develop seasonal flow duration curves during the non-irrigation and irrigation season. These flows were then input into the Big Dry Creek Hydrologic Engineering Center-River Analysis System (HEC-RAS) model, developed as part of the Big Dry Creek FHAD (UDFCD, 2012), to

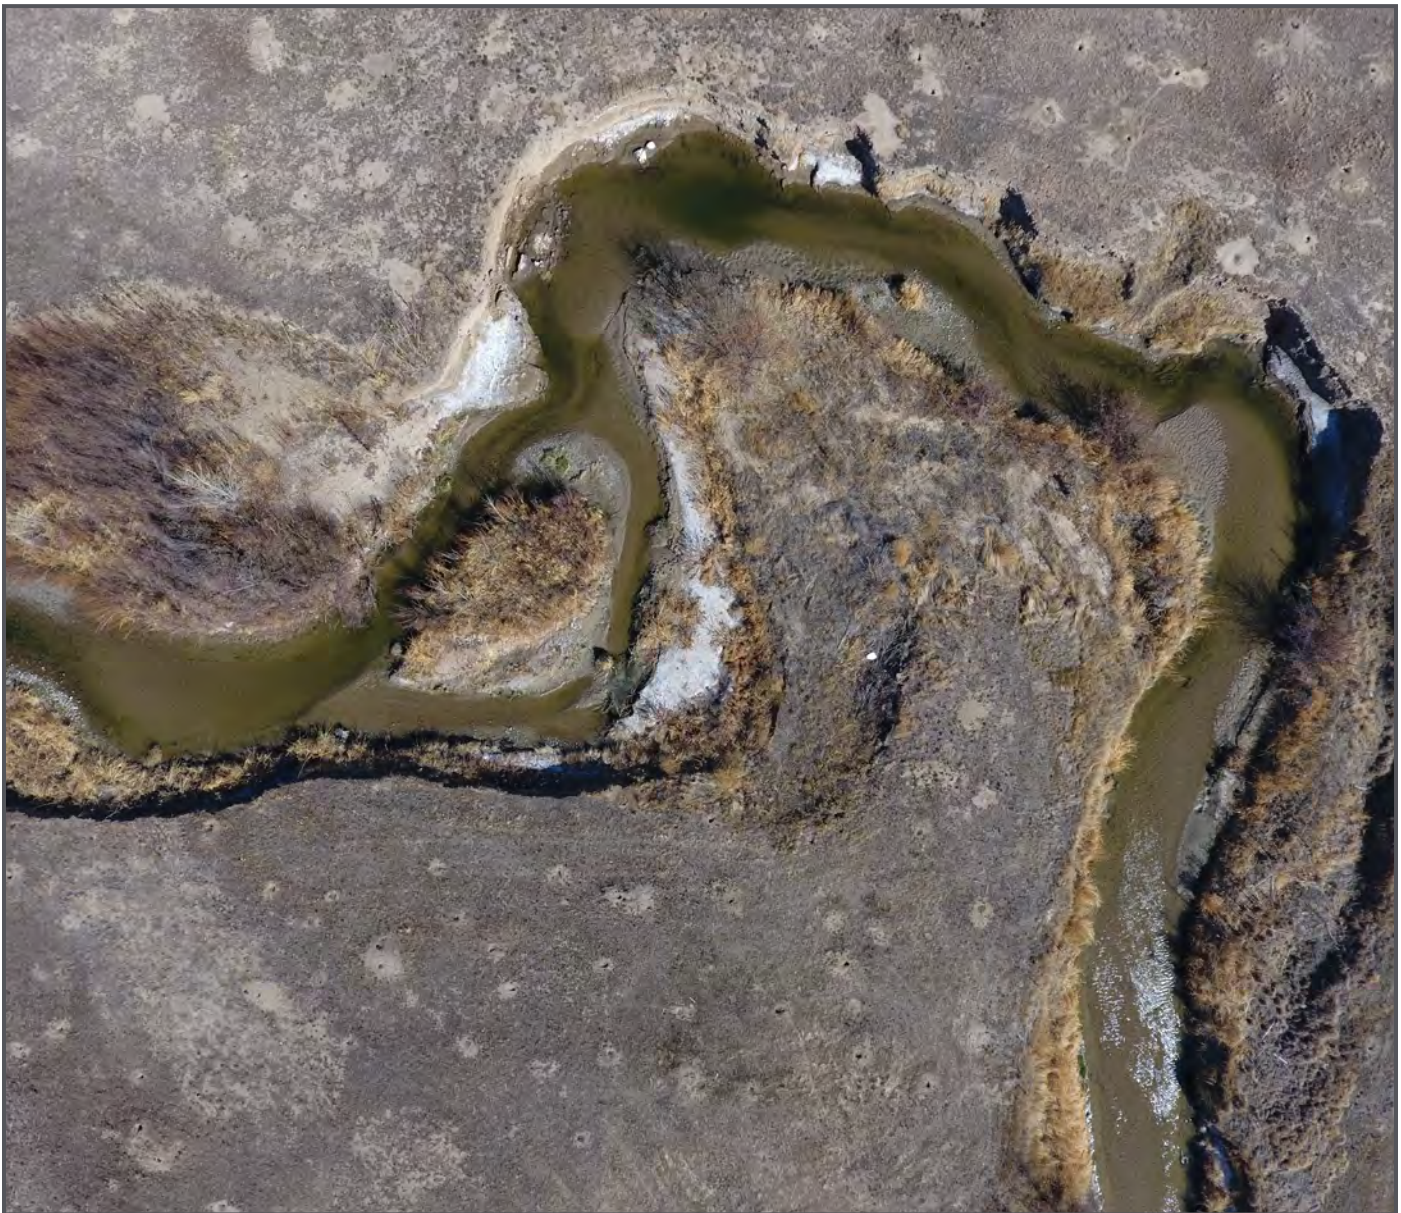
*Big Dry Creek channel meandering through Parcel V; areas of erosion and sedimentation can be seen along the banks*

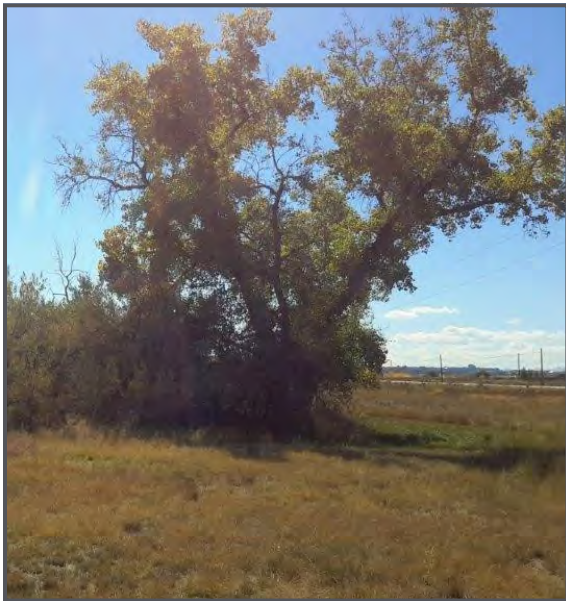
Photo 1: Parcel I Uplands

**Uplands:** The uplands located in the southern half of Parcel I have healthy established native and non-native grass establishment, including subplots 2, 3, 4, 6, 8, and 9. Upland grass species include smooth brome (*Bromus inermis*), wheatgrass (*Agropyron* spp. and *Thinopyrum* spp.), sand dropseed (*Sporobolus cryptandrus*), crested wheatgrass (*Agropyron cristatum*), and Canada wildrye (*Elymus canadensis*). These uplands have some minor weed issues, such as kochia (*Kochia scoparia*), Russian thistle (*Salsola tragus*), curly dock (*Rumex crispus*), prickly lettuce (*Lactuca serriola*), horseweed (*Conyza canadensis*), common burdock (*Arctium minus*), and Canada thistle (*Cirsium arvensis*), both along BDC and within upland areas. There is also Russian olive tree (*Elaeagnus angustifolia*) establishment, and some minor prairie dog habitat, as shown in the photos on this page. These subplots have few prairie dog burrows and are far enough from the established prairie dog towns located in the northern portion of the parcel to remain healthy and well established. Only uplands located in subplot 7 are heavily browsed by prairie dogs as a small prairie dog town is located in this subplot.

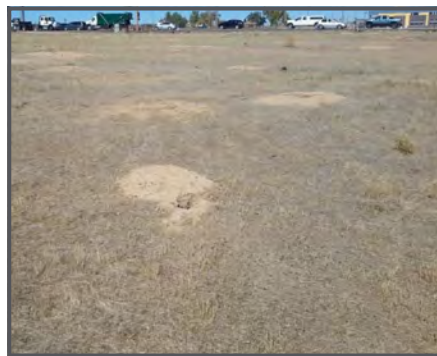
Photo 2: Parcel I Uplands with prairie dog town

Uplands located in the northern half of Parcel I vary from good grass establishment with some prairie dog browse and minor weed issues (subplots 13, 14, and 19) to heavy prairie dog browse with heavy weed infestation (subplots 11, 12, 16, 17, and 18). Of these subplots, areas 11, 16, 17, and 18 are most bare due to heavy browse from the existing prairie dog towns and weedy species establishment as shown in Photo 2. Russian olive trees are also located in subplots 11 and 13 mainly along Big Dry Creek.

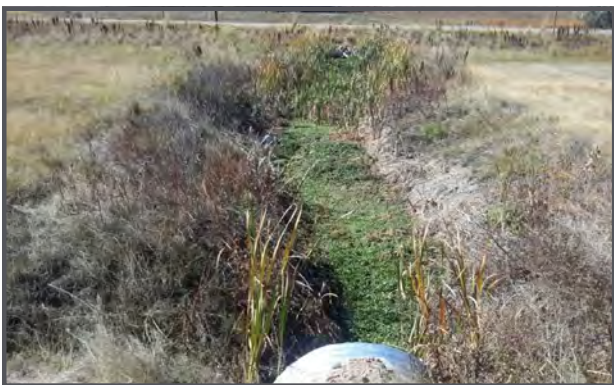
Photo 3: Parcel I Riparian

**Riparian:** There are two channels entering Big Dry Creek from the west. The first one, McKay Lake Drainageway, is located in the very southwestern corner of Parcel I. This channel was excavated recently and only a small wetland fringe remains on the northern bank. It is approximately 30 – 35 feet wide and up to 1 foot deep in flowing water. This channel has perennial flow and drains directly into Big Dry Creek. The second channel, a small drainageway in subplot 5, is located slightly to the north of this first channel and is more of a wetland feature which connects flows to Big Dry Creek (see Photo 3).

Big Dry Creek itself winds through Parcel I with many steeply eroded banks. In some locations, there is benching along the creek with wetland/transitional established grasses, herbaceous plants and shrubs. This benching has a healthy mix of reed canarygrass (*Phalaris arundinaceae*), rabbitfoot (*Polypogon monspeliensis*), barnyard grass (*Echinochloa crus-galli*), prairie cordgrass (*Spartina pectinata*), wild licorice (*Glycyrrhiza lepidota*), snowberry (*Symphoricarpos occidentalis*), wild rose (*Rosa woodsii*), teasel (*Dipsacus fullonum*), milkweed (*Asclepias speciosa*), goldenrod (*Solidago canadensis*), sandbar willow (*Salix exigua*), and primrose (*Oenothera* spp.)

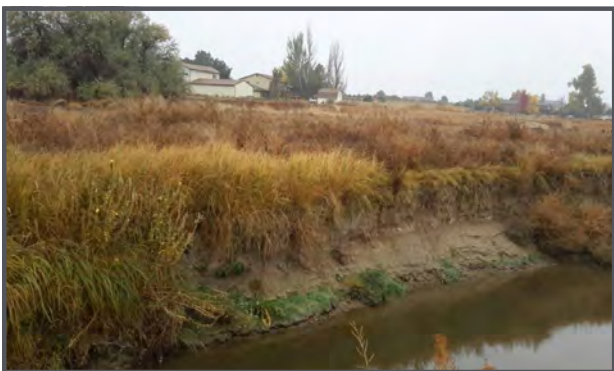
Photo 4: Parcel I Riparian

In other locations along Big Dry Creek, there are healthy stands of sandbar willow stabilizing the banks. Big Dry Creek has steep cut banks in many locations in Parcel I especially at the bends of the creek where creek velocities abut up to the bank edge, as shown in Photo 4. There are few riparian trees located along the creek and pockets of willows and riparian shrubs only. Cottonwood (*Populus deltoides*), peachleaf willow (*Salix amygdaloides*) and mainly Russian olive trees are found along Big Dry Creek throughout this parcel.

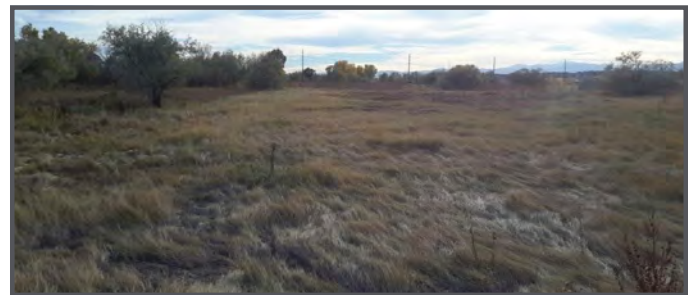
Photo 6: Parcel II Uplands

shrubs in this location. Uplands located on the east side of Big Dry Creek have established native and non-native upland grasses with some bare sandy areas and an active prairie dog population which increases as you move further to the north, as shown in Photo 6.

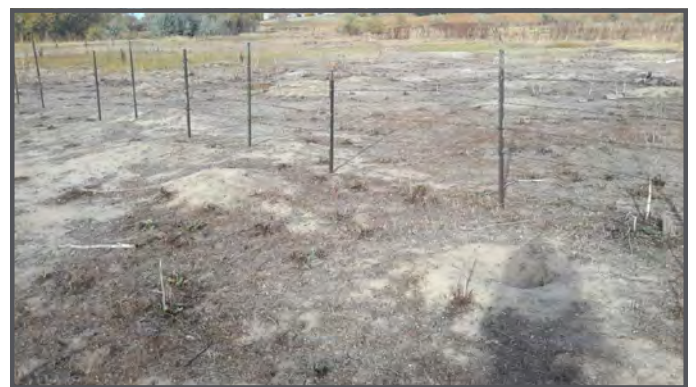
Photo 7: Parcel II Uplands

The prairie dogs and available vegetation seem to be in better balance in this location. There is also a fallen snag located in the southern part of subplot 21 which likely provides good wildlife habitat. In subplot 25, the grasses are more browsed due to active prairie dog establishment. There are more patches of bare and sandy soil than the grassland to the south, as shown in Photo 7.

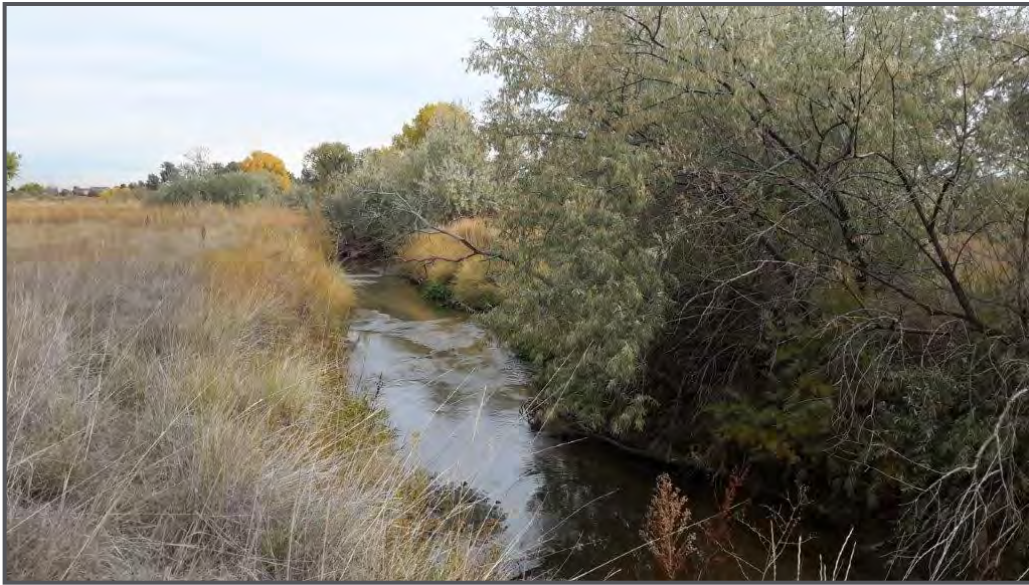
*Photo 8: Parcel II Riparian*

**Riparian:** The riparian area banks located along Big Dry Creek in Parcel II are incised with steep banks mainly along bends where increased water velocities break off soil from the banks. There are locations where slopes are more graded and vegetation has established, as shown in Photo 8. In some locations, the bank is more gradual and established with sandbar willow (*Salix exigua*). However, Russian olive trees are abundant along Big Dry Creek in Parcel II. A few cottonwoods and peachleaf willows are also established along Big Dry Creek.

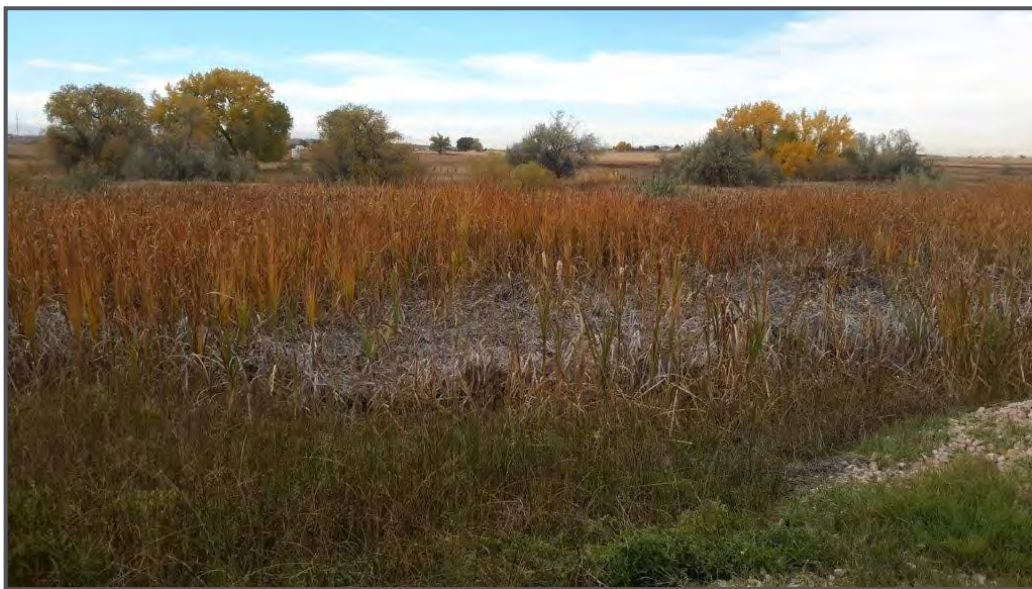
*Photo 9: Parcel II Wetlands*

**Wetlands:** A healthy wetland is located east of Big Dry Creek in Parcel II, as shown in Photo 9. The wetland (see subplot 22) has moist soil and established wetland plants such as rush and threesquare in the southern portion. The wetland has stronger hydrological conditions to the north which allows for cattail, sedge, rush, threesquare, and spikerush establishment. The wetland is invaded by Russian olive trees throughout in Parcel II.

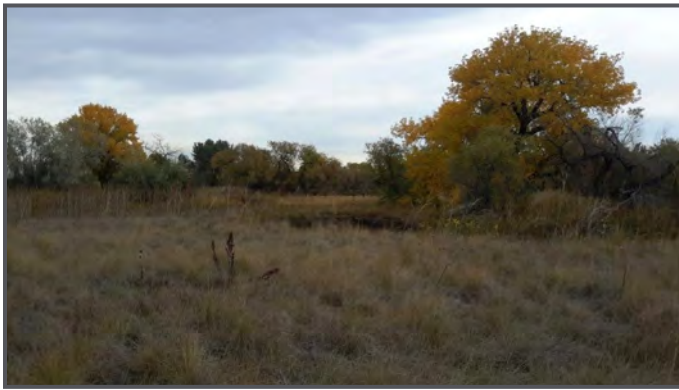
Photo 10: Parcel III Uplands

**Uplands:** Uplands located west of Big Dry Creek in Parcel III include excellent native and non-native grass establishment in subplot 31. This secluded area, as shown in Photo 10, is located in a bend of Big Dry Creek and provides important natural habitat for a protected natural site.

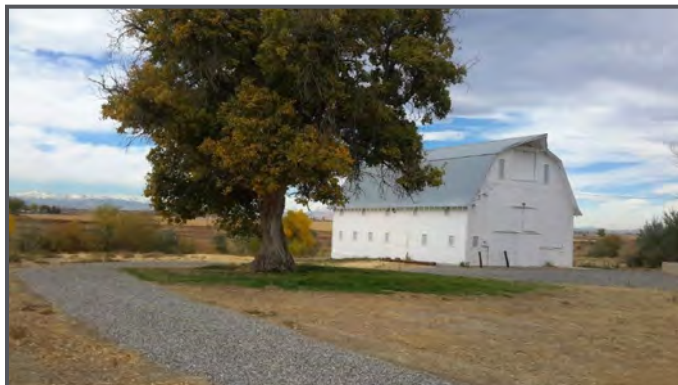
*Photo 12: Parcel III Uplands*

Uplands located in subplot 37 have well established tall grasses and herbaceous species with less weedy patches. There are also no active prairie dogs located here. The next set of uplands located east of Big Dry Creek include uplands located around the existing historic barn. There are beautiful cottonwoods located just south of the barn, but mowed grasses with lots of bare and weedy patches are located in the under-story around the barn as shown in Photo 12.

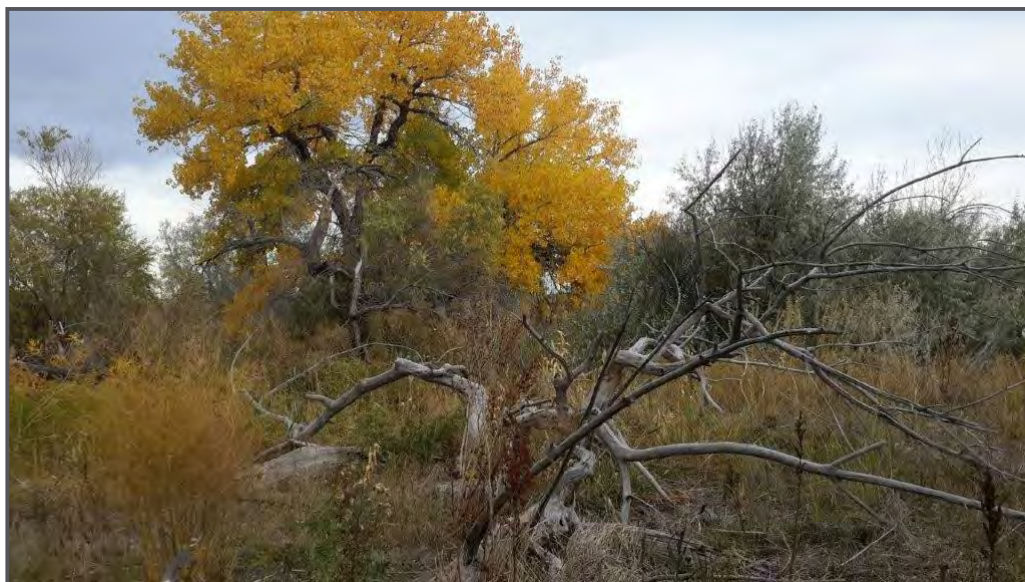
*Photo 13: Parcel III Riparian*

**Riparian:** The riparian area located in the southern third of Parcel III is a good reference for the rest of the riparian area in the open space in terms of number and species of riparian trees and shrubs present. There are many beautiful cottonwoods and peachleaf willow trees located along Big Dry Creek in this location. Several snags located along the riparian area, shown in Photo 13, create excellent wildlife habitat.

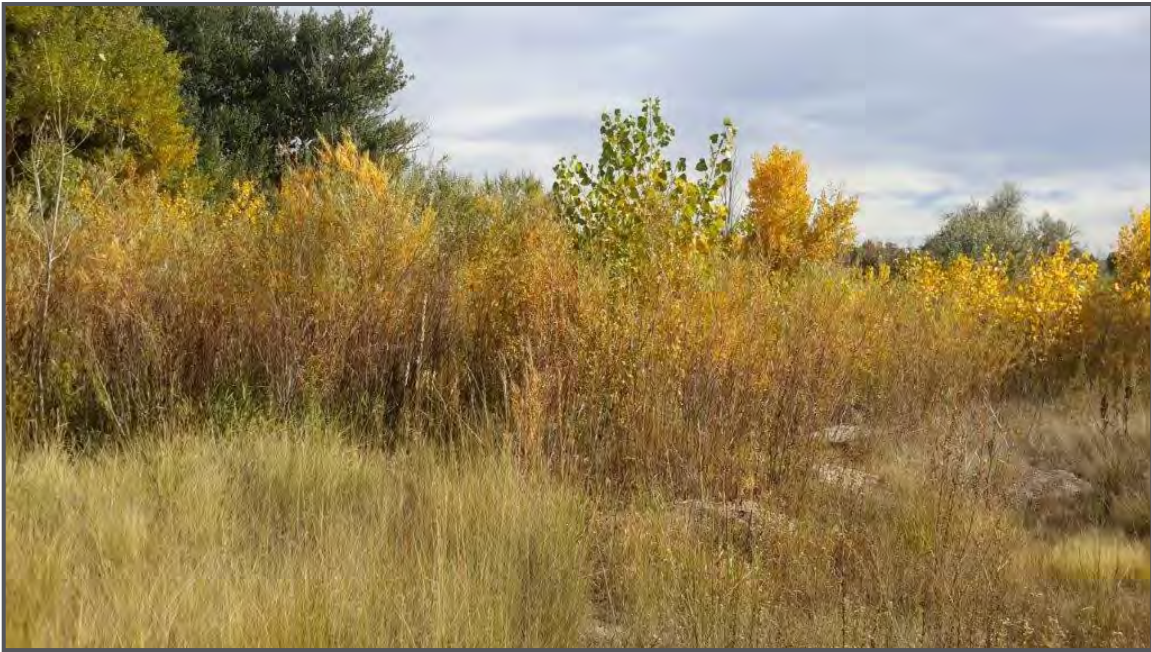
*Photo 14: Parcel III Riparian*

Within this parcel, there are creek stretches that are well vegetated with riparian grasses, shrubs, and herbaceous species, shown in Photo 14. There are some vertically eroded slopes along this stretch of creek also, as shown in Photo 15. Some Russian olive trees have established along this stretch of creek. The number of trees and shrubs, particularly in the southern third of Parcel III, have created a well balanced riparian ecosystem. Overall, the riparian vegetated condition along the creek throughout this parcel is good.

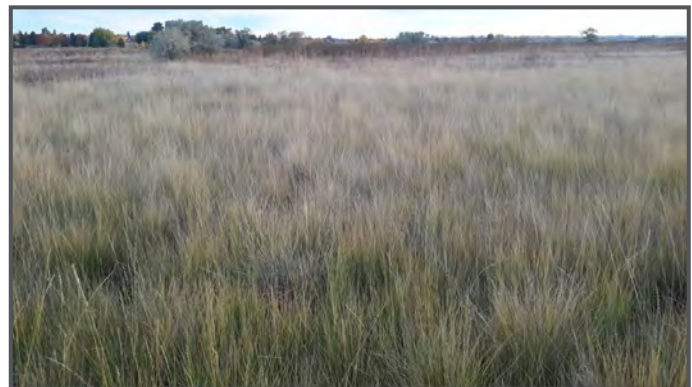
Photo 16: Parcel IV Uplands

**Uplands:** Uplands in Parcel IV located west of Big Dry Creek include well established wheatgrasses with patches of curly dock and teasel, as shown in Photo 16.

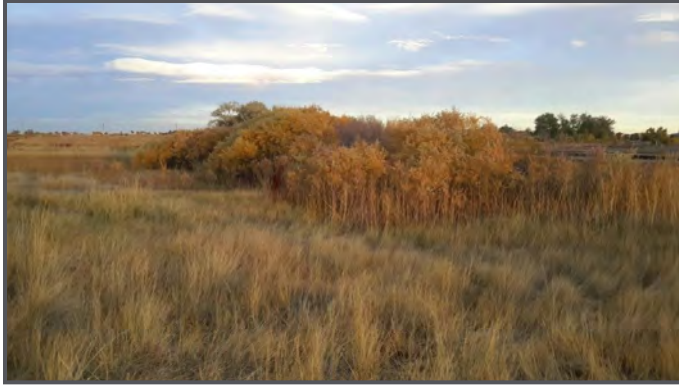
Photo 19: Parcel IV Riparian

**Riparian:** Big Dry Creek winds through Parcel IV with some nicely vegetated sections including sandbar willow, grasses and herbaceous species, as shown in Photo 19. Many stretches of the creek in this parcel are vertical and bare with eroding banks. In addition, there are few trees established along this entire stretch of creek and most are Russian olive trees.

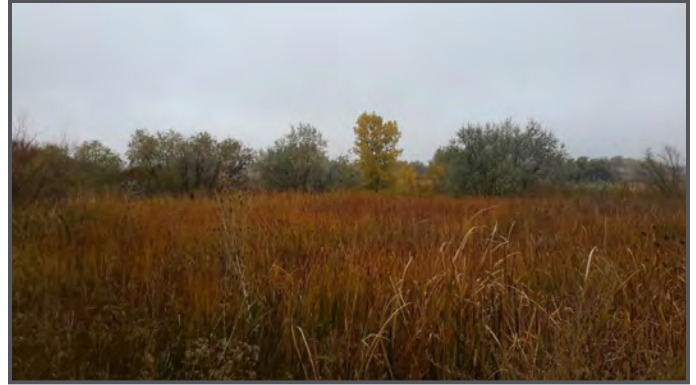
Photo 20: Parcel IV Wetlands

**Wetlands:** The only wetland located near this parcel as shown on Photo 20 is located just north of Parcel IV on E-470 ROW in what is mapped as subplot 63. It is dominated by cattails and teasel and surrounded by mainly Russian olive trees.

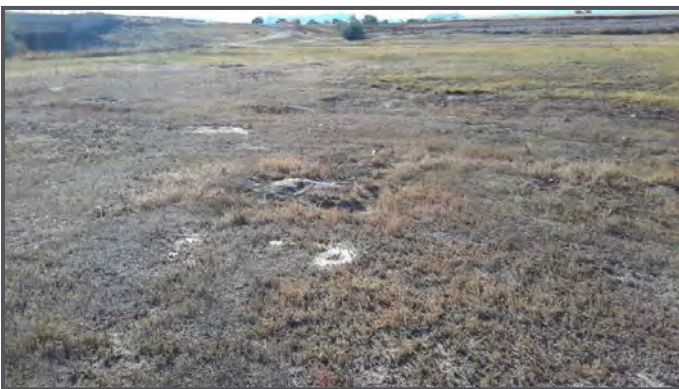
Photo 21: Parcel V Uplands

**Uplands:** Uplands located west of Big Dry Creek in Parcel V include mainly mowed and browsed native and non-native patches with a moderate abundance of prairie dog burrows throughout. The vegetation is sparse and there are lots of weedy low-lying patches interspersed between prairie dog burrows, as shown in Photo 21.

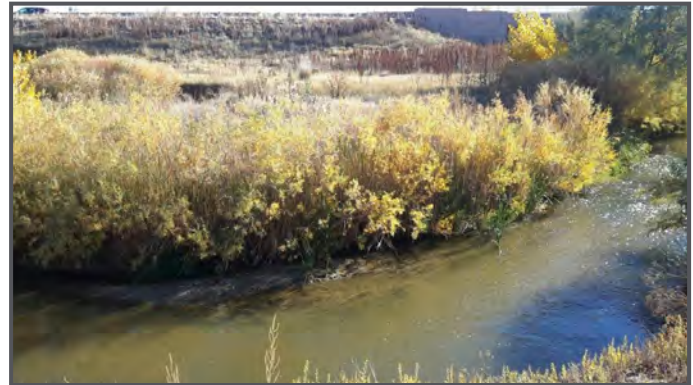
Photo 23: Parcel V Riparian

Sandbar willow is well established along Big Dry Creek in the southern portion of the parcel. Subplot 64 has good cottonwood, sandbar willow, riparian grass and cattail establishment, as shown in Photo 23.

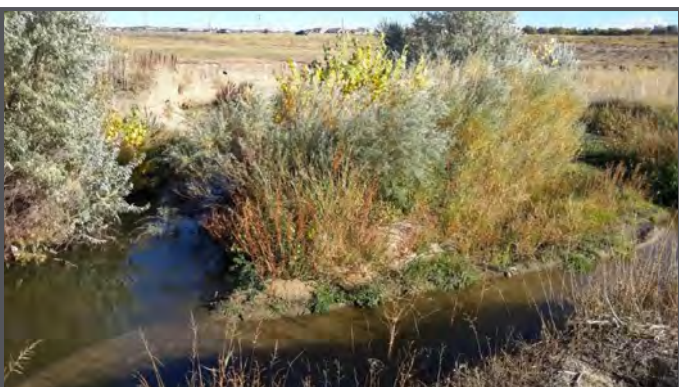
Photo 24: Parcel V Riparian

Russian olive and thistle control is needed however. Vegetation includes cottonwood and peachleaf willow trees, sandbar willow, barnyard grass, rabbitsfoot grass, ladythumb (*Polygonum persicaria*), bulrush (*Schoenoplectus* spp.), reed canarygrass, spikerush, threesquare, teasel, and curly dock. Russian olive trees and Canada thistle need to be controlled. Two erosional features involving sloughed off side banks are also vegetated with riparian trees, shrubs, grasses and herbaceous plants stabilizing the sloughed material, as shown in Photo 24.

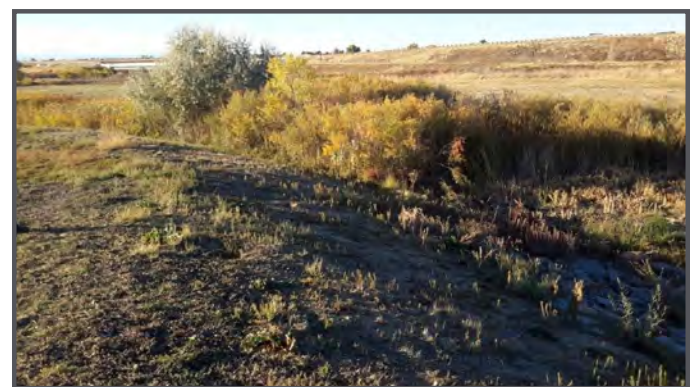
Photo 25: Parcel V Wetlands

**Wetlands:** There are wetlands located on the fringe of riparian benching throughout this parcel. Depending on the proximity of the bench to the surface water below and established vegetation, the benching may or may not meet wetland criteria. Parcel V has a good variety of vegetated side banks with both wetland and riparian vegetation. In addition, Wadley North Creek, a wetland channel, enters Parcel V from the east drainage into Big Dry Creek, as seen in Photo 25. This approximately 50-foot wide channel is dominated by cattails with willow, sedge, rush, and three square establishment.

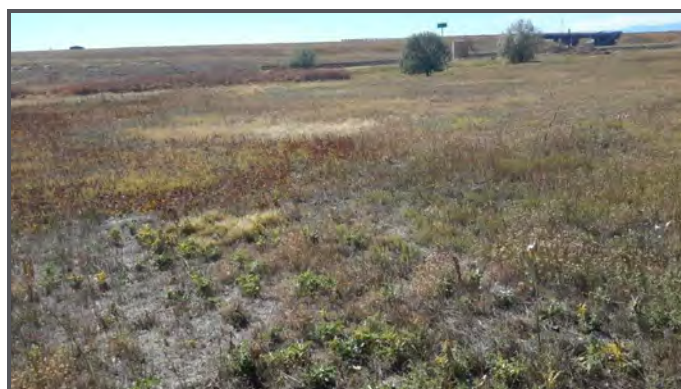
Photo 27: Parcel VI Uplands

This drainage has upland grasses and weedy patches. Subplot 82 has well established upland grasses with some weedy patches but no evidence of prairie dogs as seen in Photo 27.

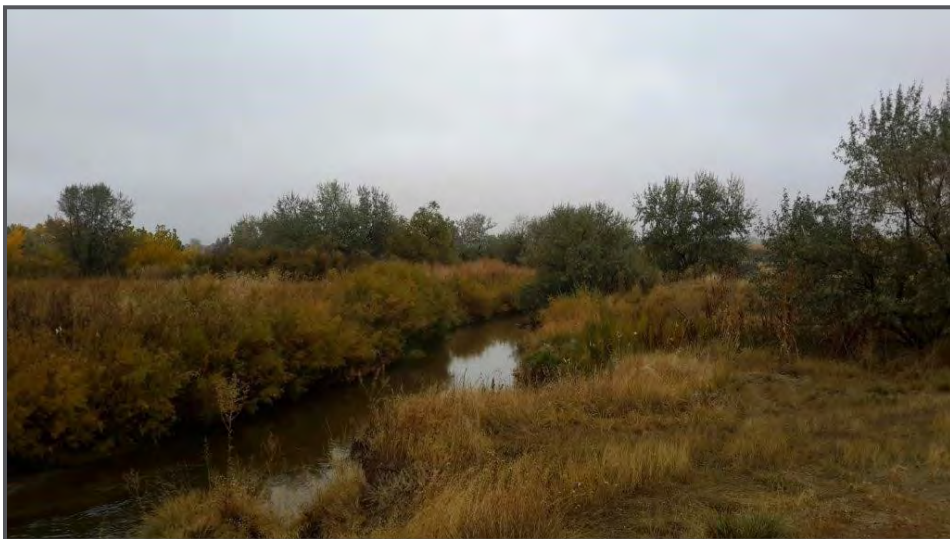
*Photo 28: Parcel VI Riparian*

**Riparian:** Big Dry Creek winds through this upland parcel with good riparian tree, shrub, grass and herbaceous species establishment, as shown in Photo 28. There are also steep vertical eroding banks located in stretches along the creek. There are many Russian olive trees located along the creek. There is also some lower benching with establishing rabbitsfoot, barnyard grass, reed canarygrass, wheatgrass, mustard, curly dock and horseweed.

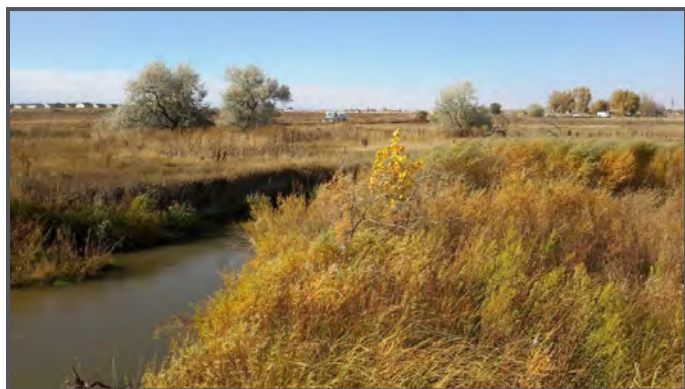
Photo 32: Parcel VIII Riparian

**Riparian:** There are several lower terraces along Big Dry Creek in this location. The lower terraces have cottonwood, peachleaf willow, sandbar willow, teasel, reed canarygrass and other riparian vegetation establishment, as shown in Photo 32.

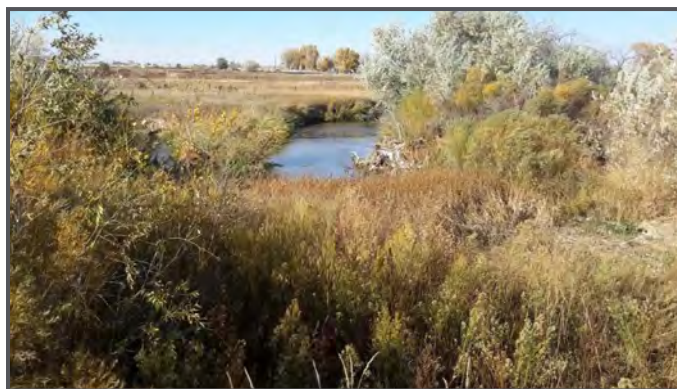
Photo 33: Parcel VIII Wetlands

**Wetlands:** Wetlands are located in pockets within the lower terracing and benching along Big Dry Creek. The vegetation includes cattail, rush, sedge and threesquare, as shown in Photo 33.

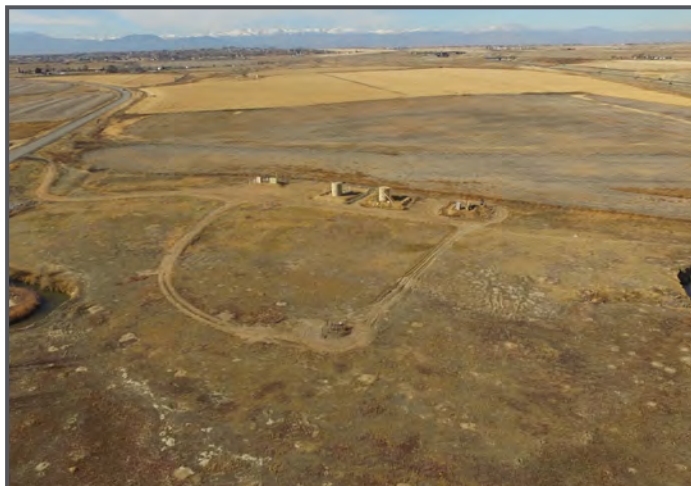
*Oil and gas pad and access roads adjacent to Big Dry Creek Parcel V*

While all of these companies have active operations in the open spaces, their mining operations vary in regards to the type of natural resources they extract as well as their levels of activeness. Most, if not all of the operations have access roads to their operation site. Although the project team reached out to these companies to investigate details of the operations and possible future partnerships, no successful partnerships were made. Great Western did however provide useful information about the operations. Typically, these wells have a lifespan of 20 to 40 years and the wellpad is reclaimed back to natural contours and vegetation once the lifespan of the well is done. The operating company is responsible for maintaining their access roads, and although they typically are not used for formal trails or paths, some companies may be open to discussions on shared use.
