**Big Dry Creek Recreation & Floodplain  
Restoration Master Plan**

**February, 2018**

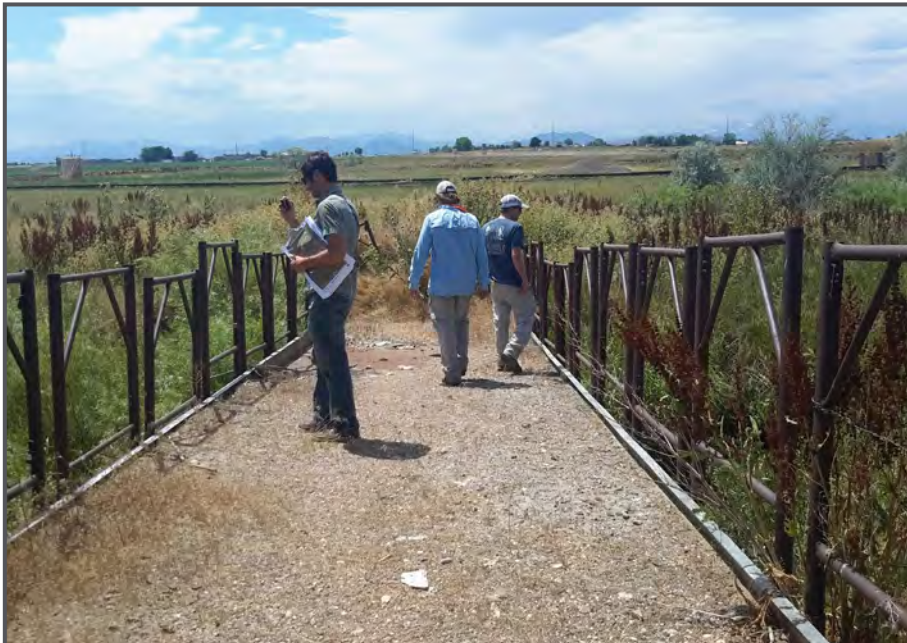
Existing metal pedestrian bridge that currently crosses Big Dry Creek in Parcel IV will need to be removed and replaced as part of the Big Dry Creek recreation improvements.

As the Big Dry Creek Trail continues north of Parcel III, a portion will be constructed as part of the Fairfield Subdivision until it turns northwest into Parcel IV. As shown on the Parcel IV Trails Map at right, it is recommended that the Big Dry Creek Trail avoid the healthy upland areas in Parcel IV. The section of the proposed Big Dry Creek crossing has been identified as a High Priority Reach geomorphically, and it is likely that a single project could create the trail connection as well as geomorphic, hydraulic and environmental benefits. Although there is an existing bridge on Parcel IV, it is an old, metal pedestrian bridge that is neither safe nor suitable for a regional trail and would require removal or complete replacement.

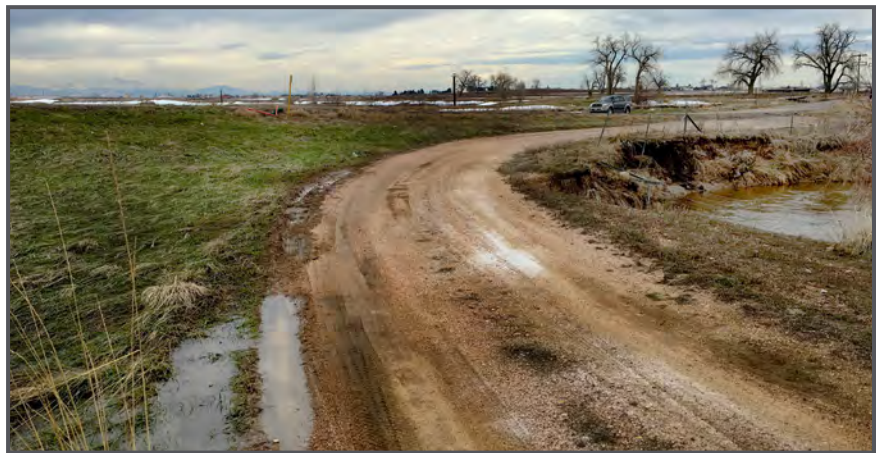
Big Dry Creek moving laterally into the oil/gas access road SW of Parcel VI

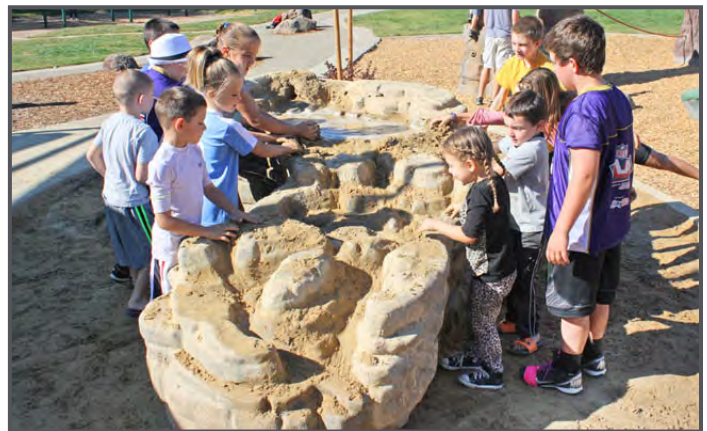
*Water play area where children can learn how rivers and creeks work*

- > **Movable sand/soil/small rocks:** While access into Big Dry Creek is not recommended, environmental play areas can be designed to teach the hydraulics and creek mechanics taking place along Big Dry Creek. Whether it is a pre-manufactured 'water play table' or a custom designed water play system in the ground, children can have the opportunity to 'move the ground' and see the effects it has on a simulated stream system.

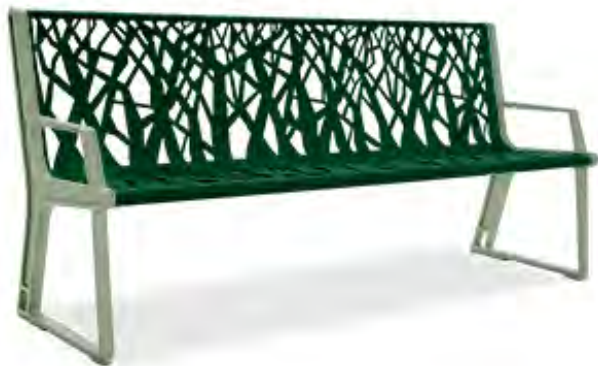
*Annova Site Furnishings Airi Stix Contour bench*

Annova Site Furnishing's 6' Airi Stix Contour bench (or approved equal) should be used as possible along the Big Dry Creek Trail. These benches are constructed of powder coated steel and aluminum components. The frame color shall be 'Sage' and the seat color shall be 'Pine.'

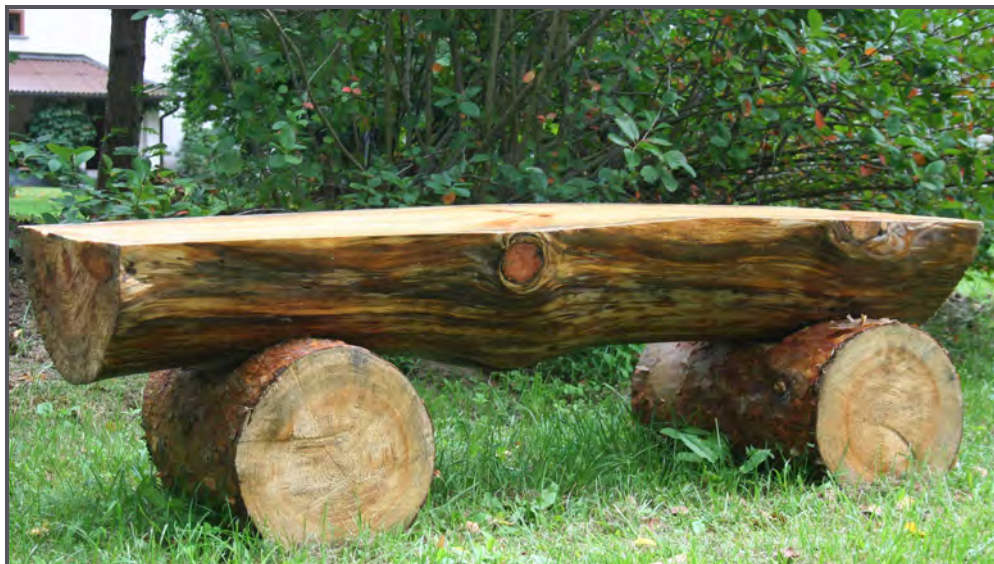
*Example of a simple log bench made from fallen trees*

Along soft surface trails, benches crafted from reclaimed tree trunks will provide a Heritage Trail themed element that is in keeping with the character of Big Dry Creek. These benches should be constructed from on-site fallen trees whenever possible. While each bench will be unique and one-of-a-kind, they should all be designed and built in a similar fashion.

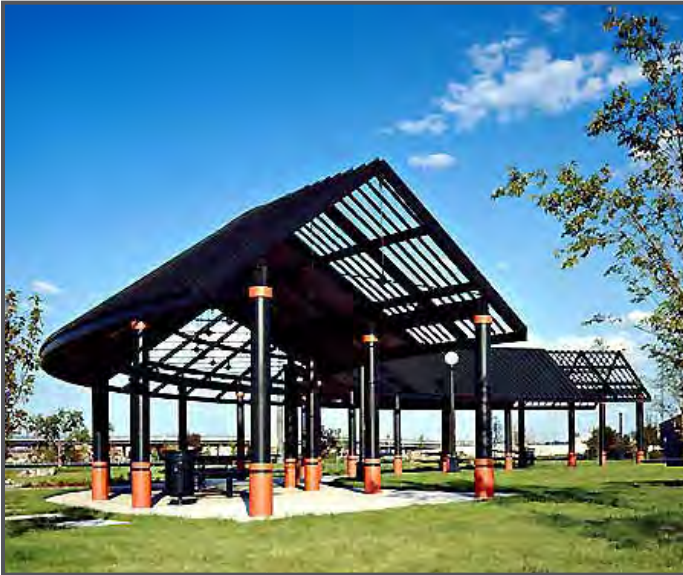
*Large shelter with curved design & combination slatted and solid roof*

At trailheads, shelters similar to those shown above (or approved equals) should be used. These shelters fit the Big Dry Creek aesthetic character through the use of thick columns, angled roof lines and slatted roofs. Corrugated metal panels can be used on top of the slats for additional protection. Metal columns can be accented with natural stone. Colors and materials should be picked to match other Big Dry Creek amenities. Along the trails, the smaller shelters should match the aesthetic and design of the larger shelters.

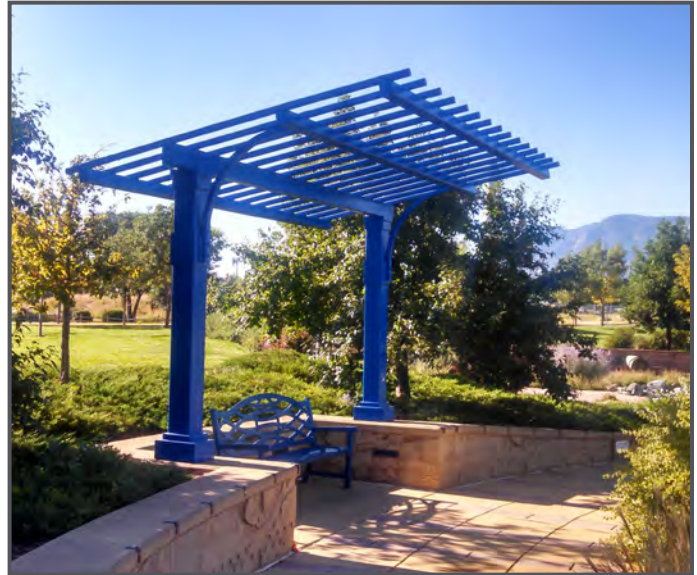
*Small shelter with slatted roof design*

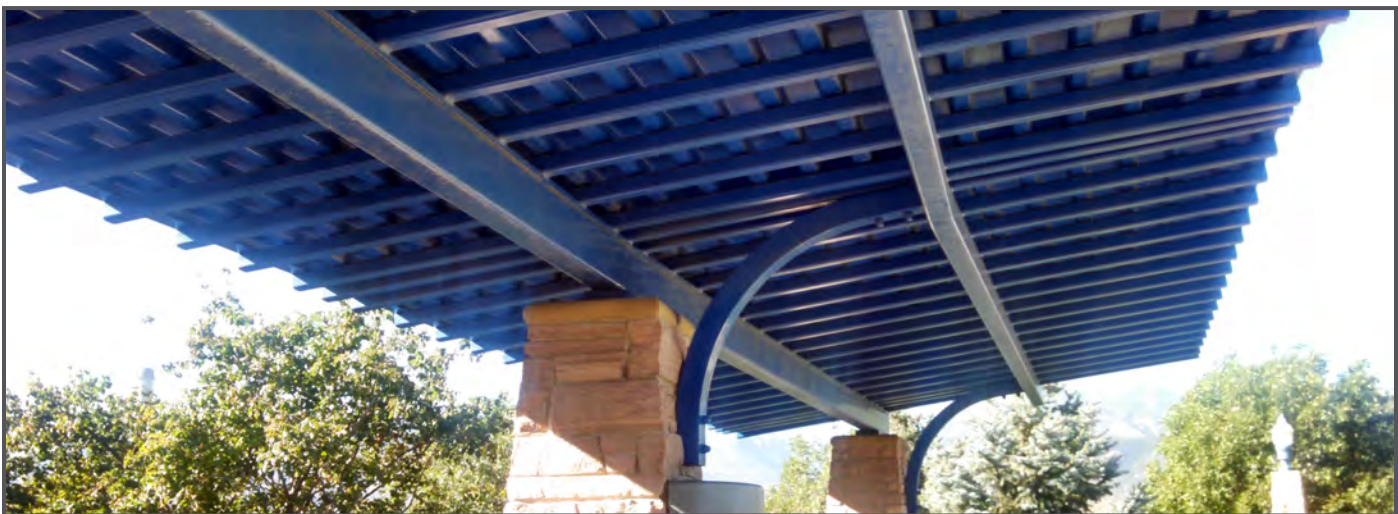
*Small shade shelter with slatted/trellis roof; smaller shelters should match the design, color and aesthetic of the larger structures*

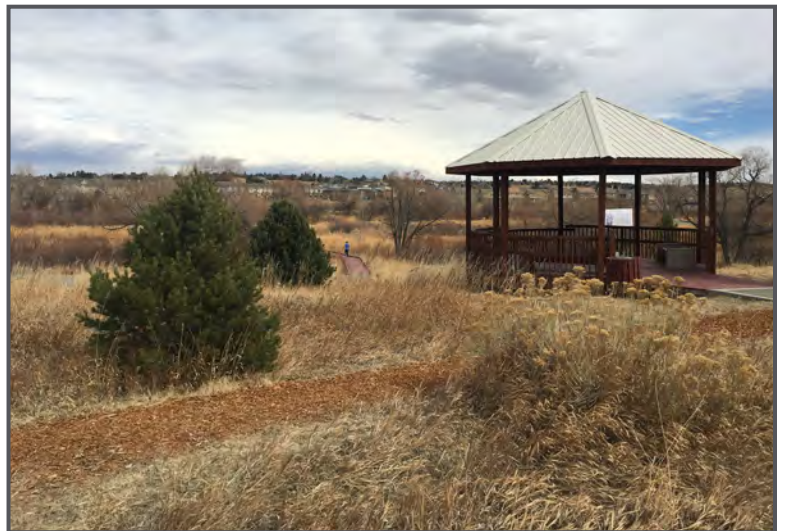
*Elevated overlook using the grading of floodplain terraces to extend the overlook out over the floodplain*

Opportunities to utilize existing or proposed grade to create elevated overlooks with Heritage Trail signage should be investigated. These could vary from a portion of boardwalk that is elevated to a seating area that is built off of an existing high point. Elevated overlooks can provide a better understanding of the larger context of the area, as well as the impacts small actions can have.

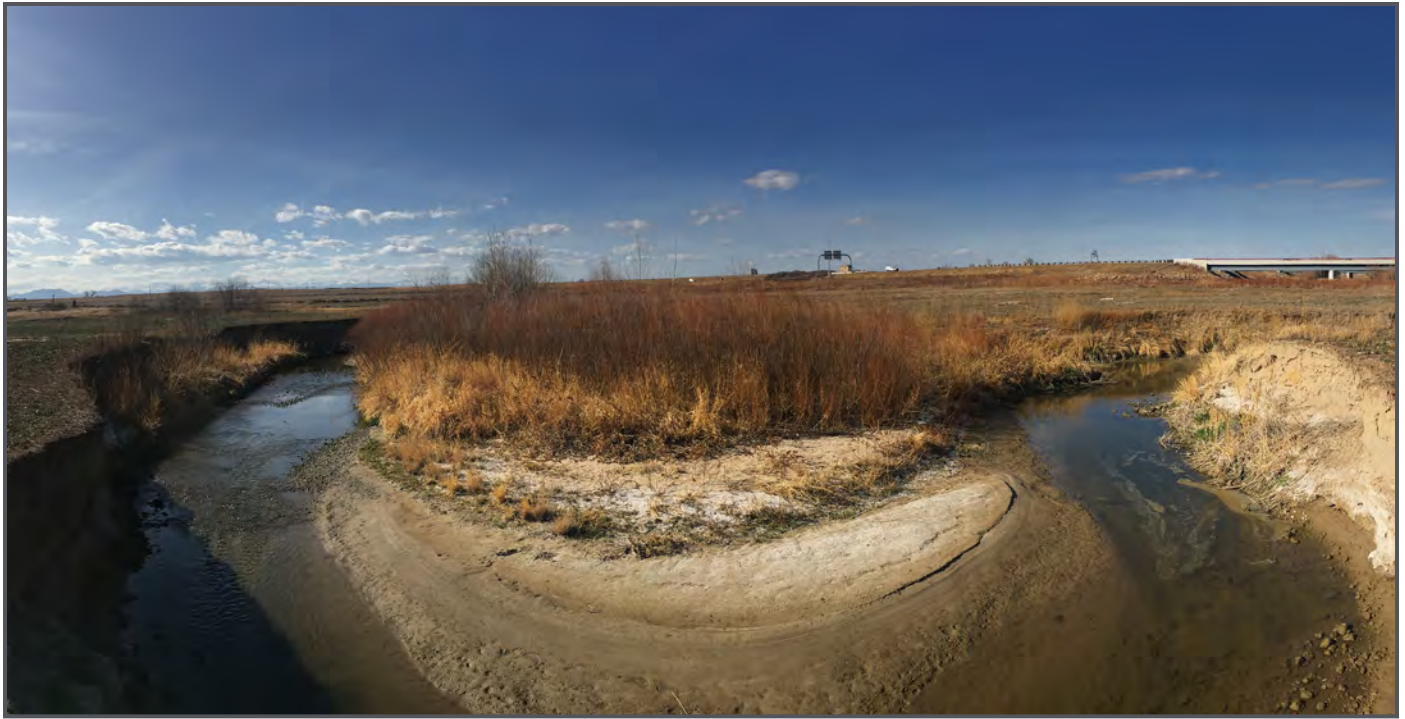
*Meander curve of Big Dry Creek in Parcel V*

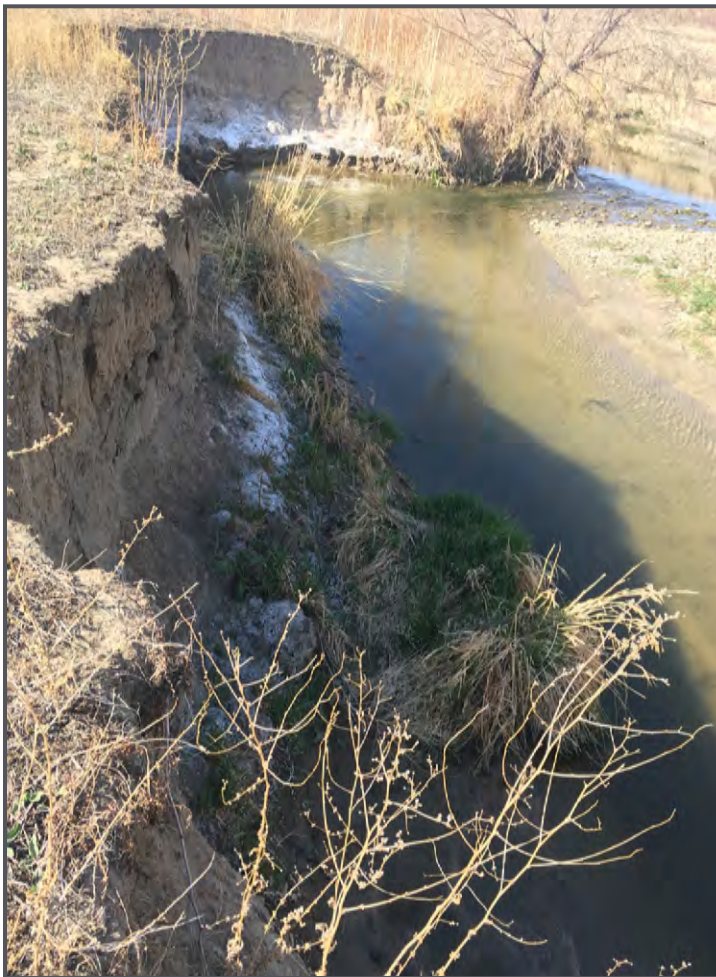
*Vertical cut bank on Big Dry Creek*

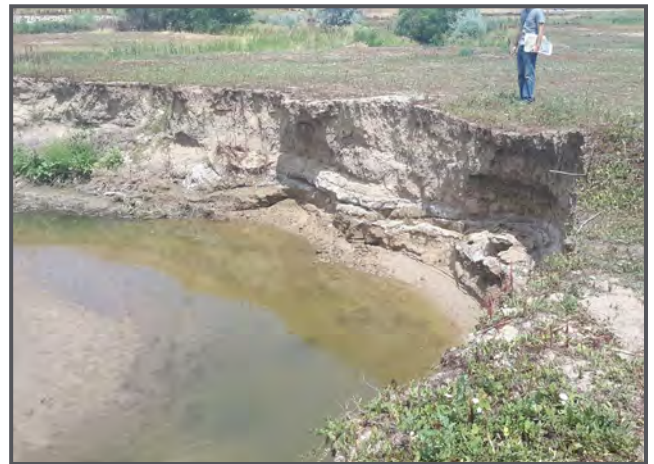
*Cut bank erosion caused by flow changes and freeze/thaw damage*

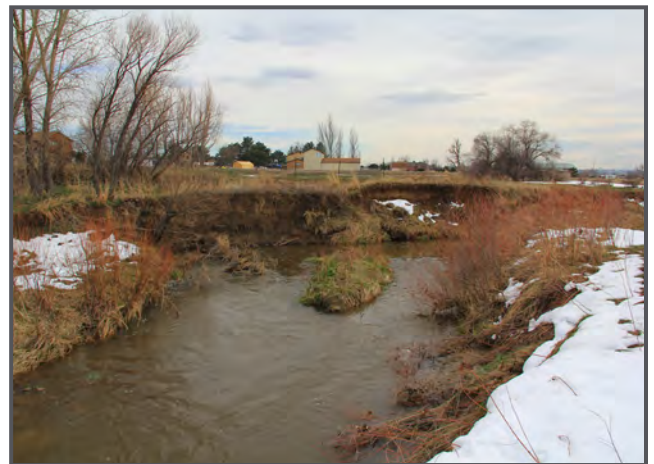
*Incised channel along Big Dry Creek*

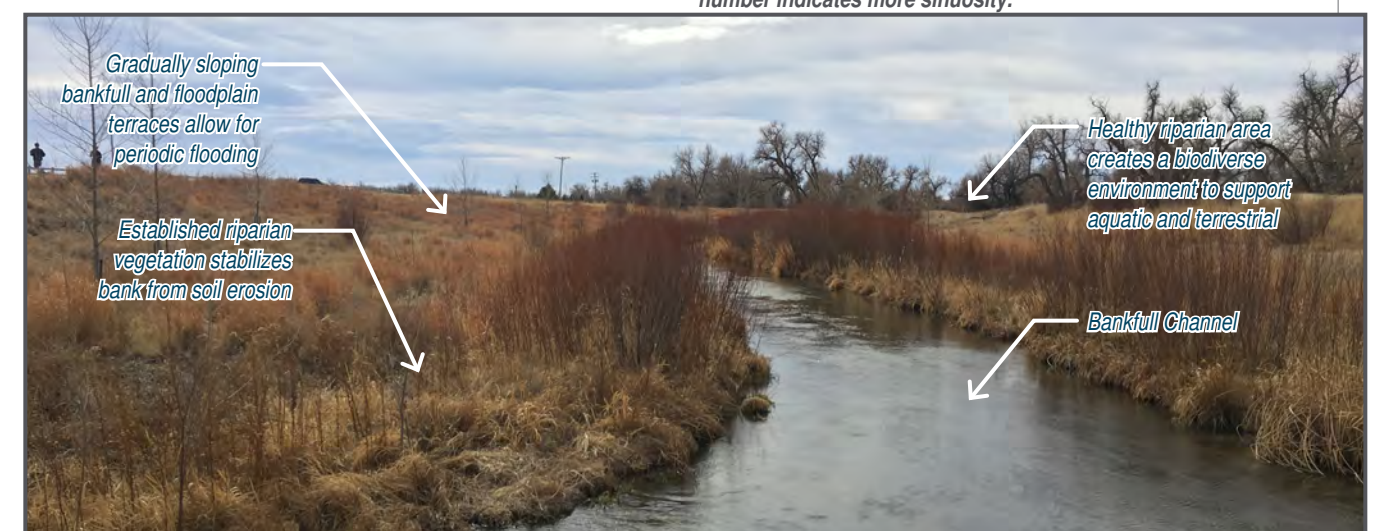
*Example of a healthy floodplain and channel on Cherry Creek; the water is able to safely rise on a regular level and inundate the bankfull benches*

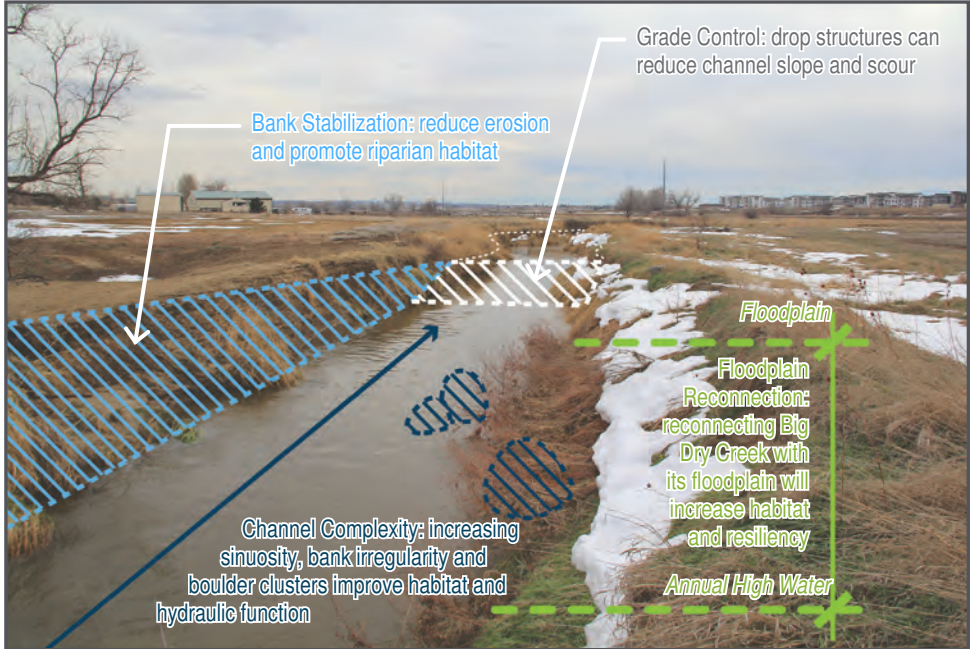
This picture demonstrates where each of the overall strategy categories could be used along a stretch of Big Dry Creek

1. Floodplain Reconnection and Restoration
2. Bank Stabilization
3. Channel Complexity
4. Grade Control

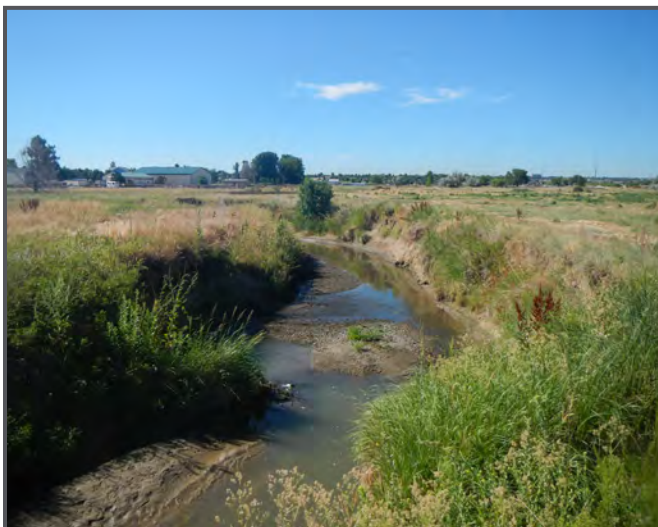
*Entrenched channel results in the creek being disconnected from the floodplain*

Throughout the project area, Big Dry Creek is not well connected to its floodplain. There are many areas where the banks are so tall that it would be difficult for the floodwaters to actually reach the floodplain. Where the floodplain is not connected, the majority of the flow will be conveyed through the incised channel at high velocities, causing additional erosion. The bankfull elevation of the 1.5-year storm is used to demark the limit of when the channel should be reconnected to the floodplain because even frequently occurring storms (statistically occurring every 1.5 to 2 years) cause significant erosion through the creek channel. The floodplain could be connected throughout the corridor to provide for a more resilient creek.

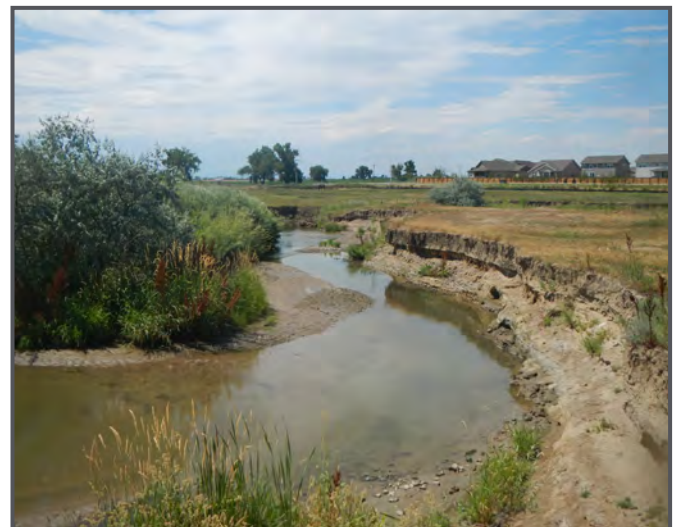
*Lack of bank vegetation on Big Dry Creek with eroding banks*

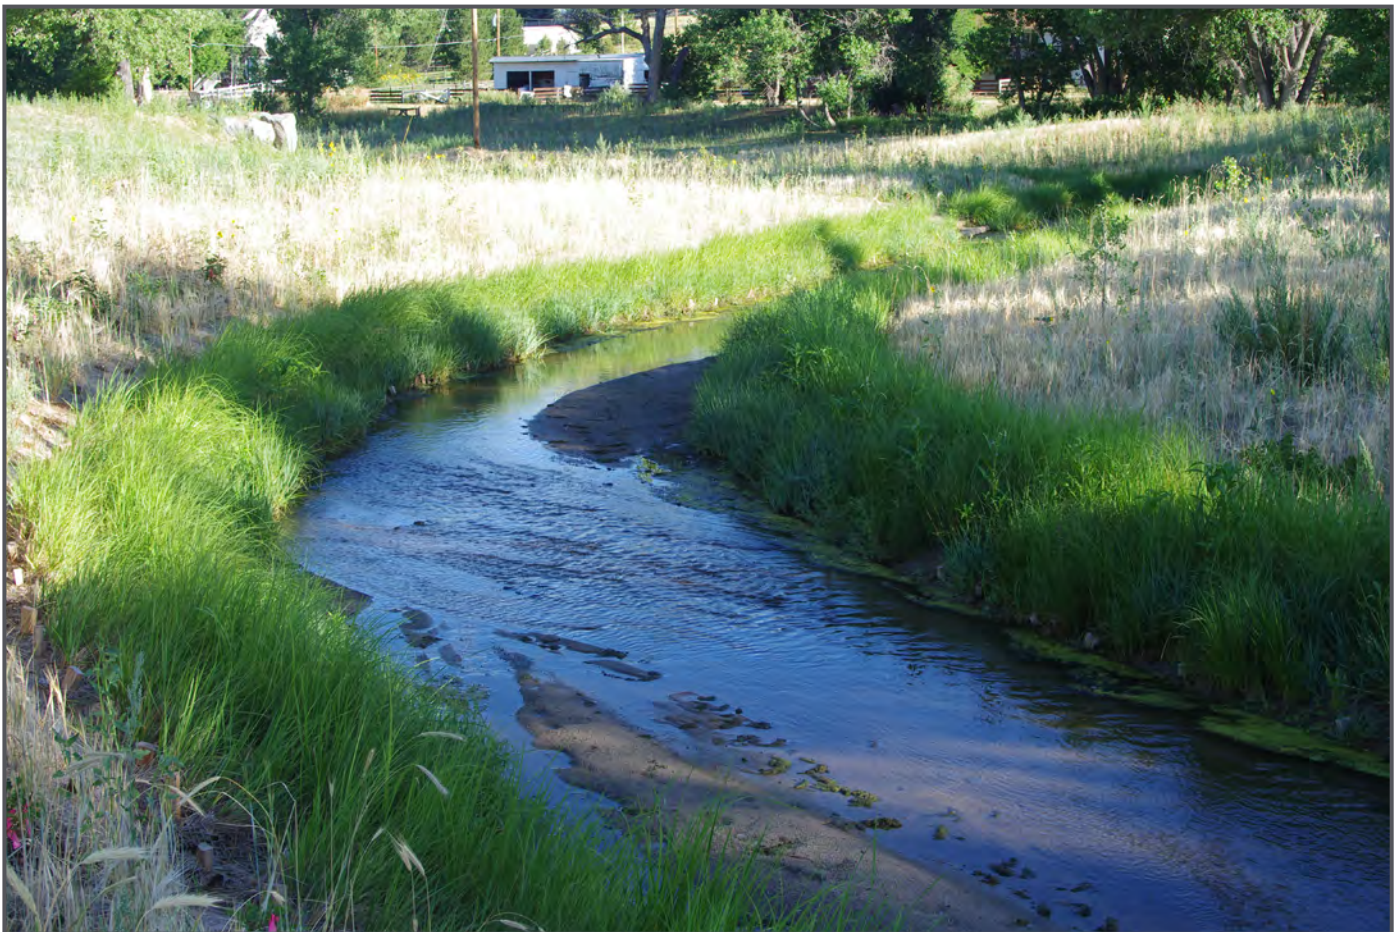
*Wetland sod installed at the toe of the bank can provide immediate vegetative establishment for high priority areas*

To promote revegetation in aquatic and upland areas, sod mats can be installed with appropriate plant species that are native to their respective saturation zone within the stream corridor. It is critical that the species are checked and placed in areas where design velocities and shear stresses are low enough for the plant material to withstand larger storm or flood events. Wetland sod mats are typically used on the lower terraces of streambanks, where their roots will have access to moisture from typical low flows. They are especially useful in situations where it is desirable for plant communities to be established quickly and fully. More expensive than typical seeded or hand planted wetland plantings, wetland sod mats establish faster and more consistently. Wetland sod mats can be used for key design areas on a project, while the larger areas receive the less costly wetland plugs and seeding treatments.

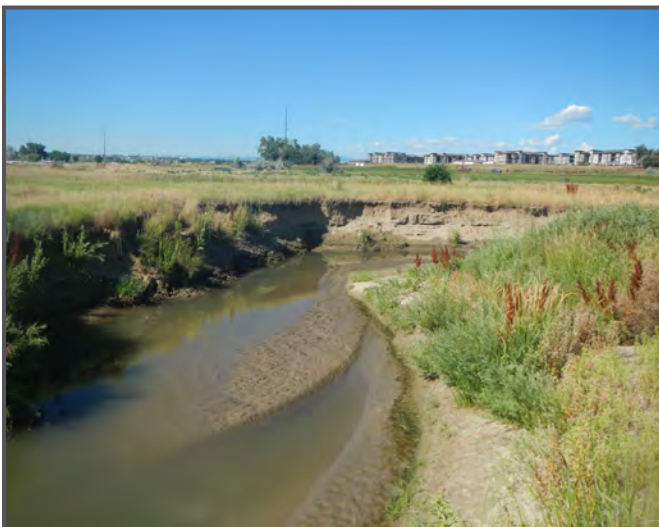
*Eroding banks on outer bend*

Bank stabilization along Big Dry Creek could take place in the majority of the corridor due to the entrenched nature of the creek. It also could take place around the outside bends where erosive velocities are being encountered, at crossing locations where flow is rapidly constricted and then expanded, and where other material has been used to stabilize the banks improperly.

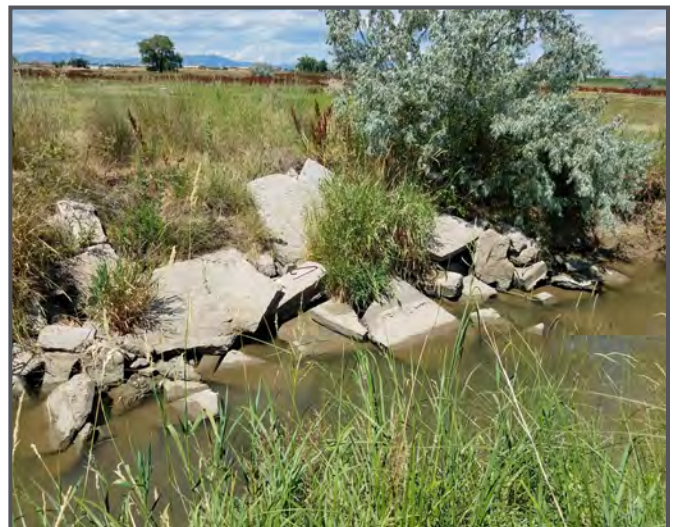
*Eroding banks protected incorrectly with concrete scraps*

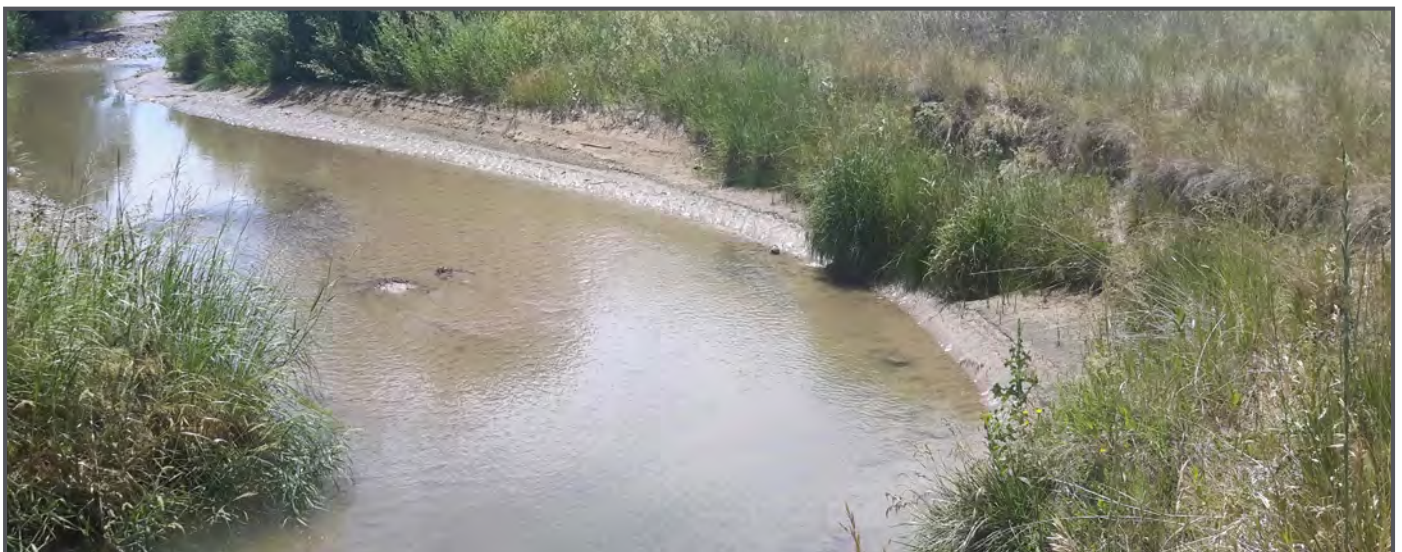
### Bank Shaping *Section View*

Where possible, degraded or unstable banks should be re-shaped to a stable design geometry with the use of channel grading and laying back of banks prior to using any of the other measures listed here. A bankfull channel with an inlaid low flow channel and terraced floodplain should be used to accomplish this goal. These dimension of the various channel parameters are set by the hydraulics associated with the specific site.

Eroding banks along Big Dry Creek in need of stabilization through re-shaping and vegetation

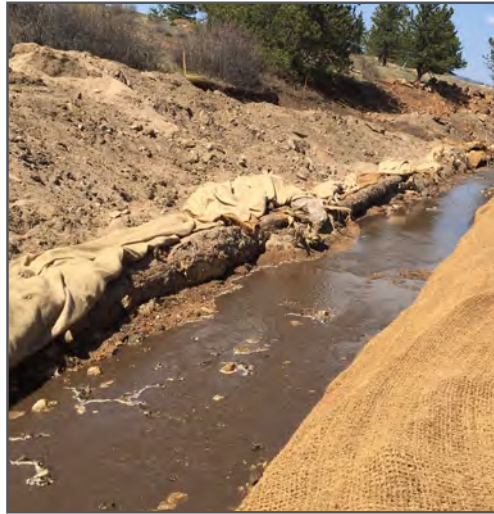
Log Toe

Log toes are constructed by partially burying a log into the creek bank to resist moderate velocities. The species and diameter of the logs will vary based on availability on site

and height of the banks. A log toe can consist of multiple logs stacked on top of each other to achieve the desired height. At least 2/3 of the log toe structure should be buried into the existing grade to reduce the chances of undercutting. Log toes will help prevent bank erosion thus giving vegetation enough time to establish along the channel and riparian benches and can be used in combination with boulders to lock the structures in place.

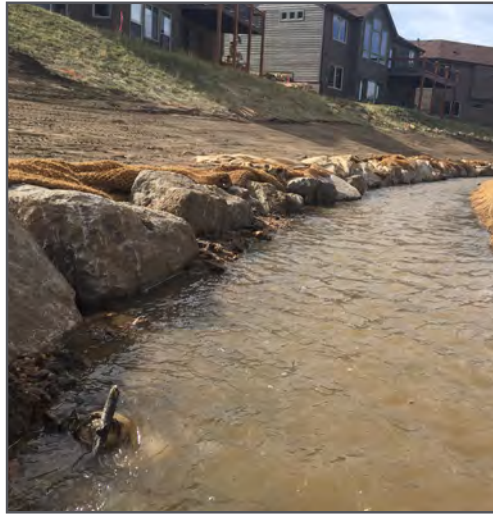
*Boulder Toe*

Boulder toes are bank stabilizing tools that can resist high velocities and are usually positioned on the outside bends of the channel. Boulder toes consist of 1, 2 or 3 boulders of varying sizes stacked on top of each other and buried 2/3 into the exiting grade. In cobble soils, the bottom of boulder toes can be installed on existing bed material. In sandy soils, structural fill or geotextile fabric should be installed underneath the boulder toe to prevent the structure from sinking or moving. Boulder toes will reduce erosion along banks and allow vegetation to re-establish and take hold. Willow stakes can be installed in-between the boulders during construction to mitigate the visual impact, provide additional habitat and increase the strength of the boulder toe over time.

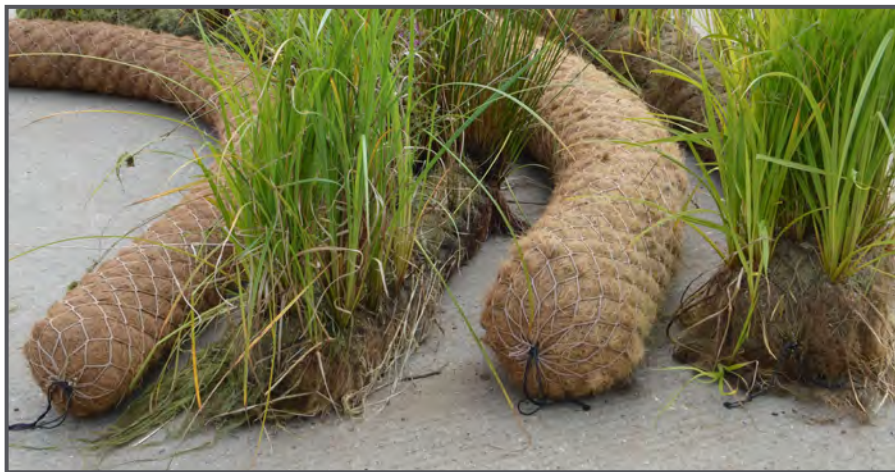
Coir logs are tightly bound cylinders of coconut fibers or soil held together by a coconut fiber netting made from coconut twine, or other biodegradable products. Coir logs act as a structural support of the soil behind it, but also trap water and sediment to support the vegetation planted behind the coir log. Layering coir wrapped soil in a stair stepping application can provide erosion control and structural support to a bank in areas of reduced velocity. Additionally, vegetation can be used in the logs and between the layers to provide further stabilization and plant growth for the floodplain.

Coir logs with vegetation (photo credit: salixrw.com)

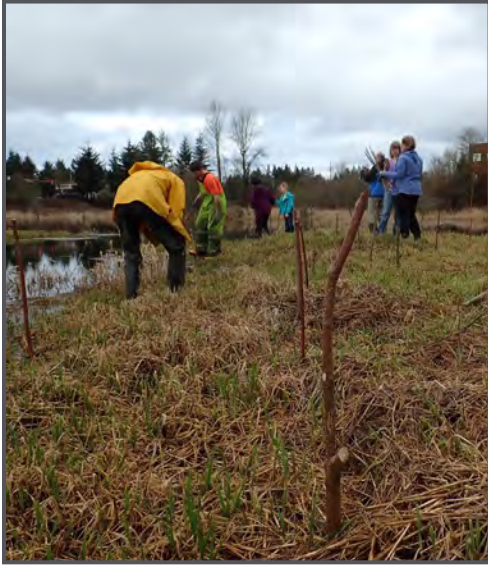
Willow stakes can often be installed by volunteers

Planting live willow stakes and cottonwood poles along degraded stream banks not only increases stream stability but improves riparian habitat. This approach is applicable where banks experience relatively low shear stresses and velocities. Typically, cottonwood and willow stakes/poles can be harvested on-site or on nearby sites. This provides a higher probability of survival and a lower probability of creating an imbalance in the ecosystem.

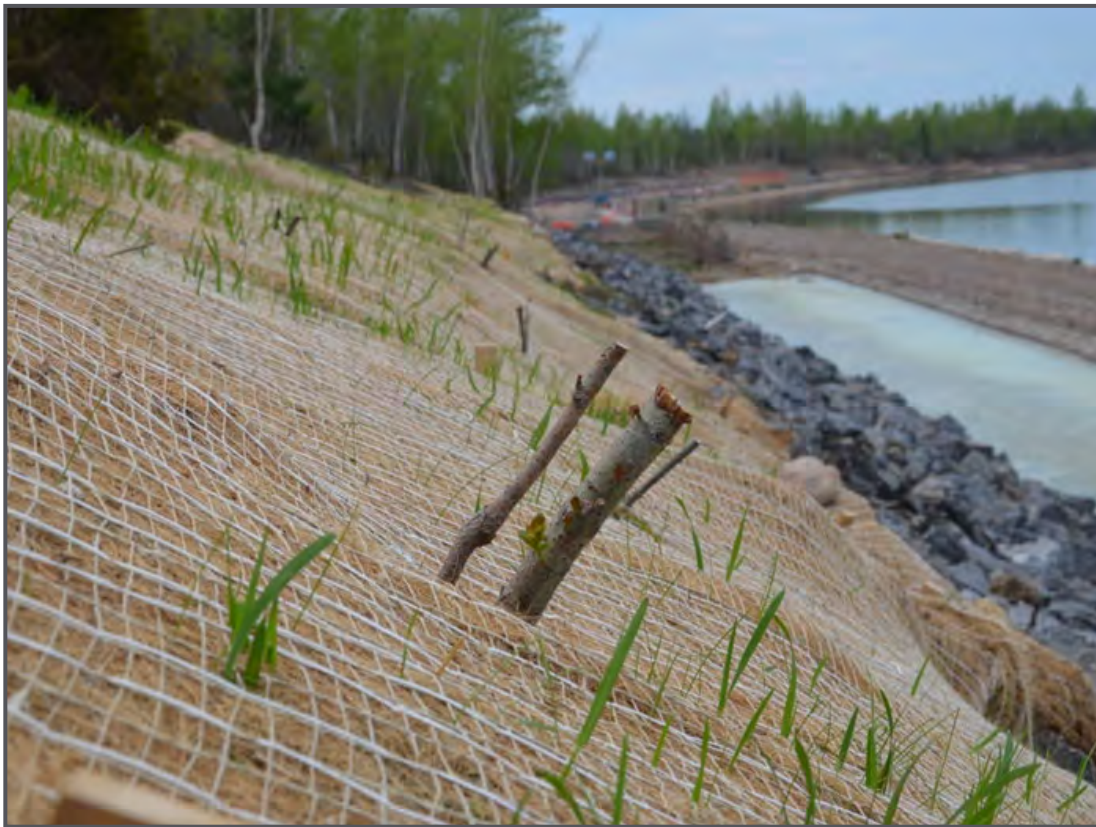
Geotextile stabilization consists of using a blanket of interwoven generally biodegradable fibers laid down on sloping exposed soils to reduce the potential for erosion and increase the potential for vegetation to establish. Geotextile fabrics or blankets can be an effective means of stabilizing banks to allow enough time for vegetation to take root and stabilize the bank on its own.

*Geotextile bank stabilization used for revegetation*

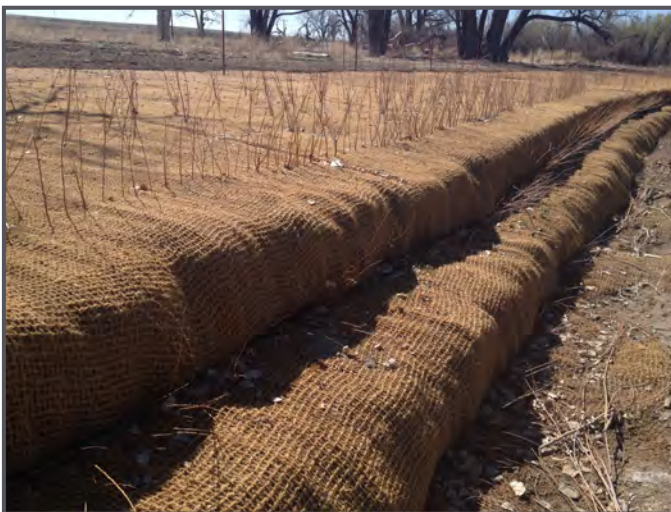
Willow stakes installed as part of a vegetated soil lift bank stabilization (at time of installation)

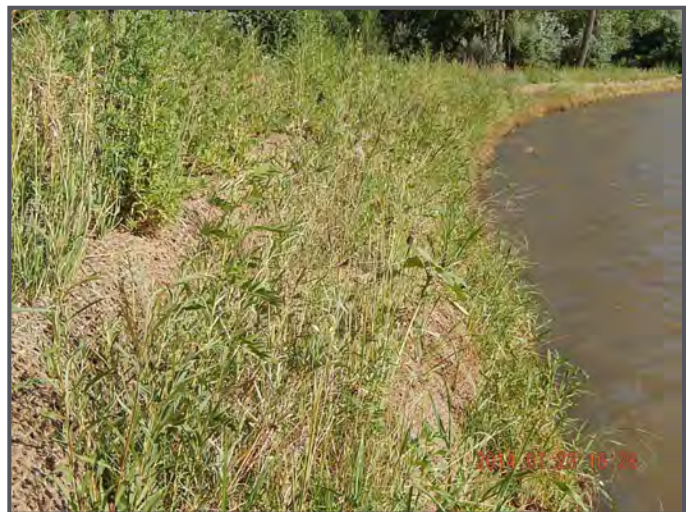
Willow stakes installed as part of a vegetated soil lift bank stabilization (after establishment)

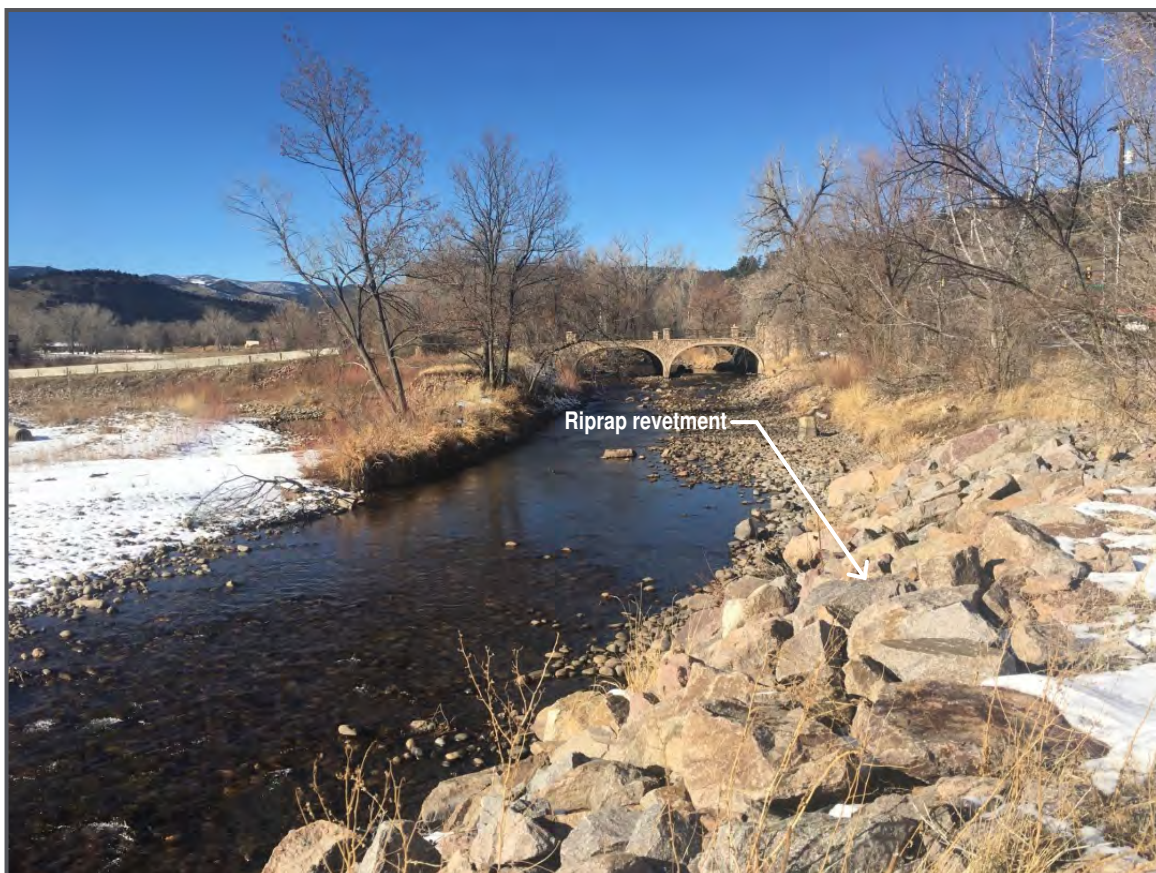
*Example of a riprap revetment (armoring)*

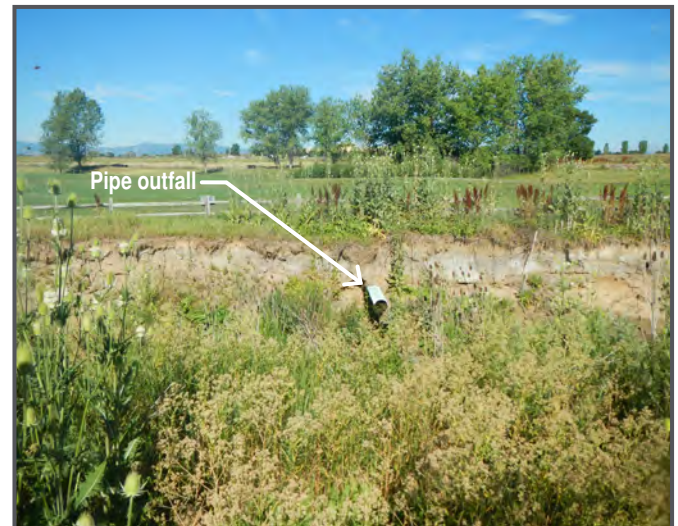
*Bank erosion has caused this pipe outfall to be exposed with no protection*

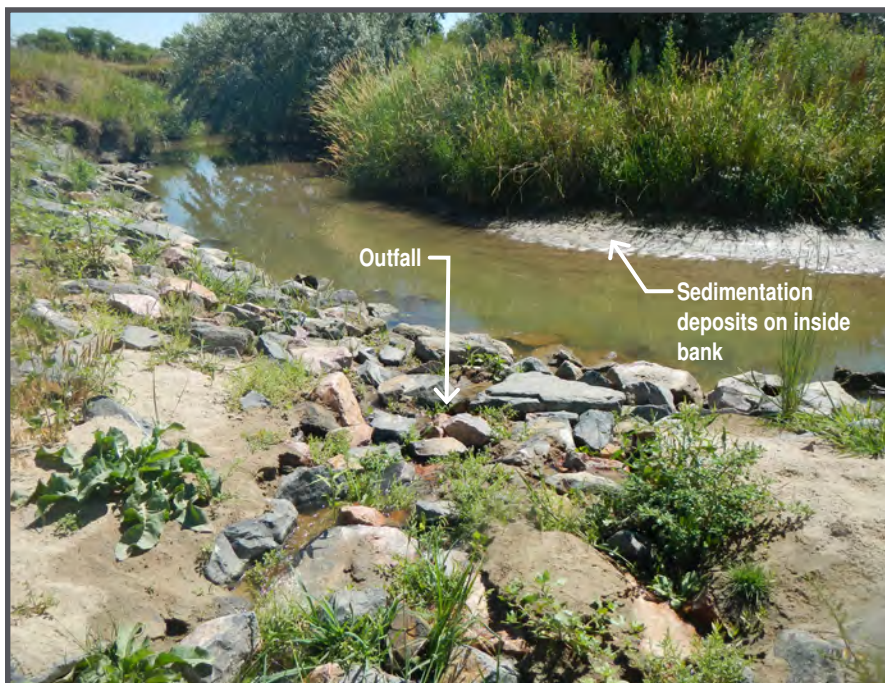
*Although this outfall is stabilized with riprap, added vegetation will improve stability to the sides of the outfall*

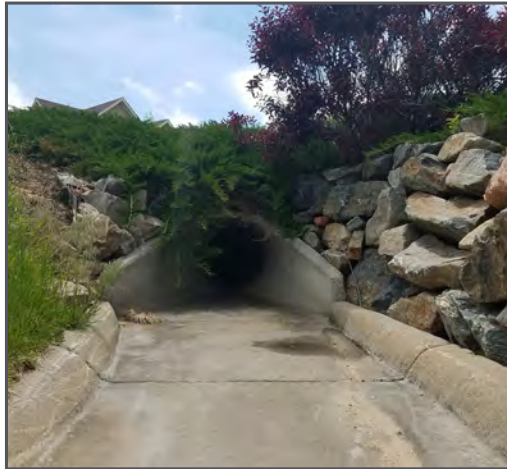
In addition to inlet and outlet protection blankets, flared end sections should be used at pipe inlets and outlets. Flared end sections allow for a gradual tapering of the channel inlet and outlet so that the crossing embankment does not have to be as vertical. Flared end sections reduce the potential for erosion at both the upstream and downstream end of a culvert. On the upstream end, a flared end section provides protection against seepage; on the downstream end of the pipe, it predominantly protects against erosion and scour. Flared end sections are usually used in combination with an inlet and/or outlet protection blanket and can greatly reduce piping failures as well as overtopping issues.

*Concrete flared end section*

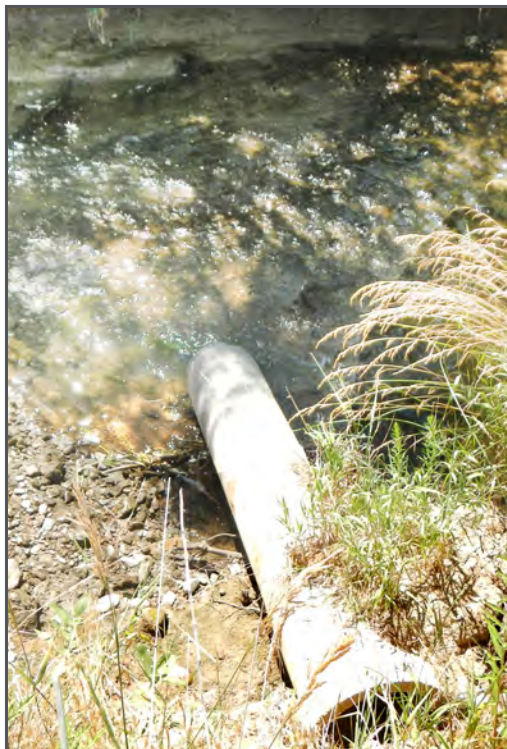
*Pipe failure due to erosion on Big Dry Creek*

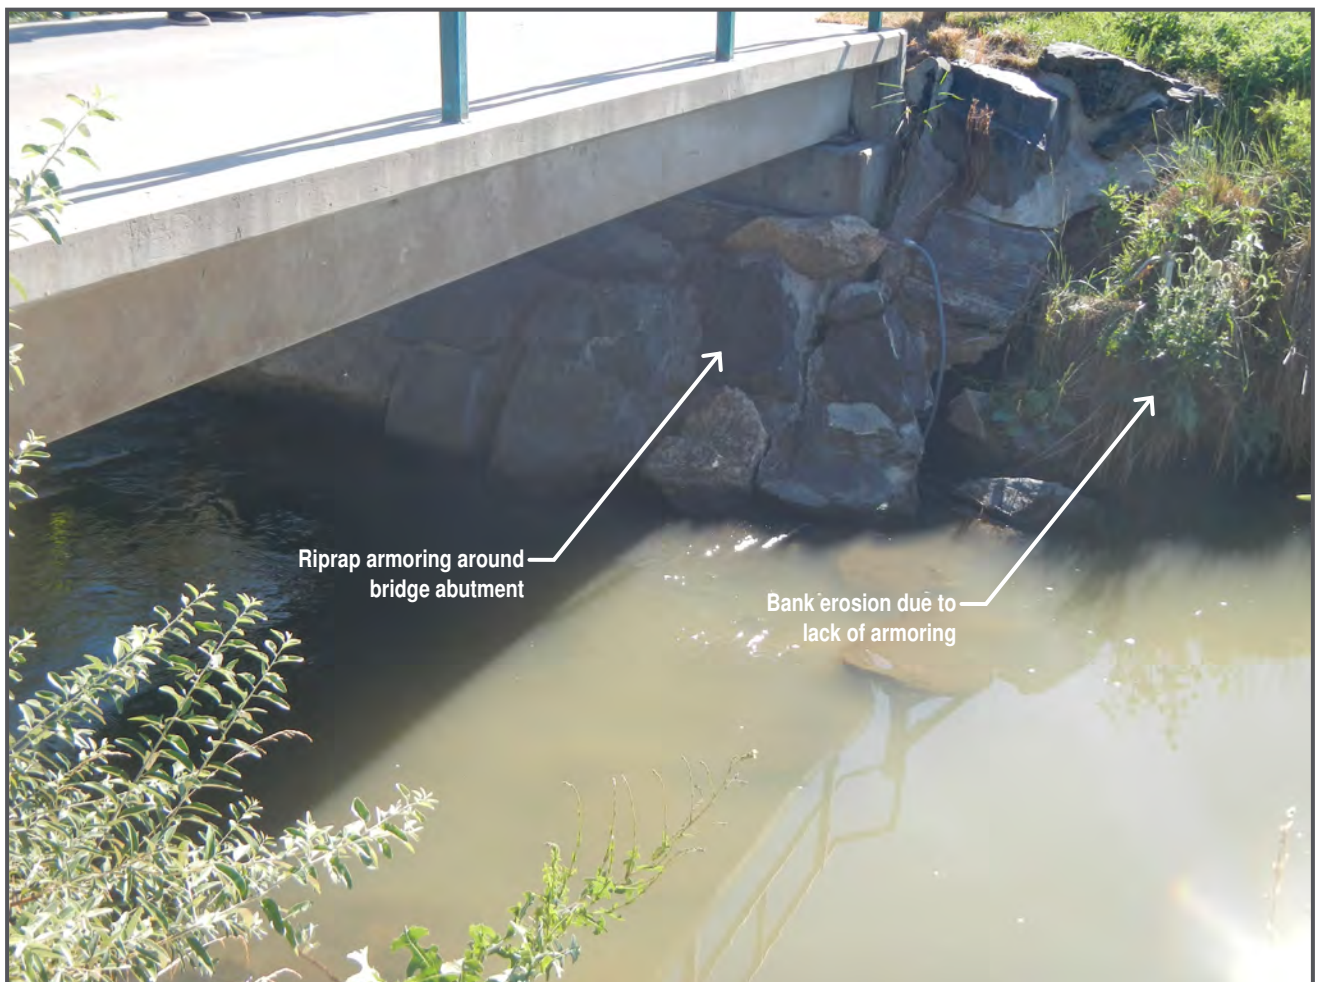
*Abutments failing*

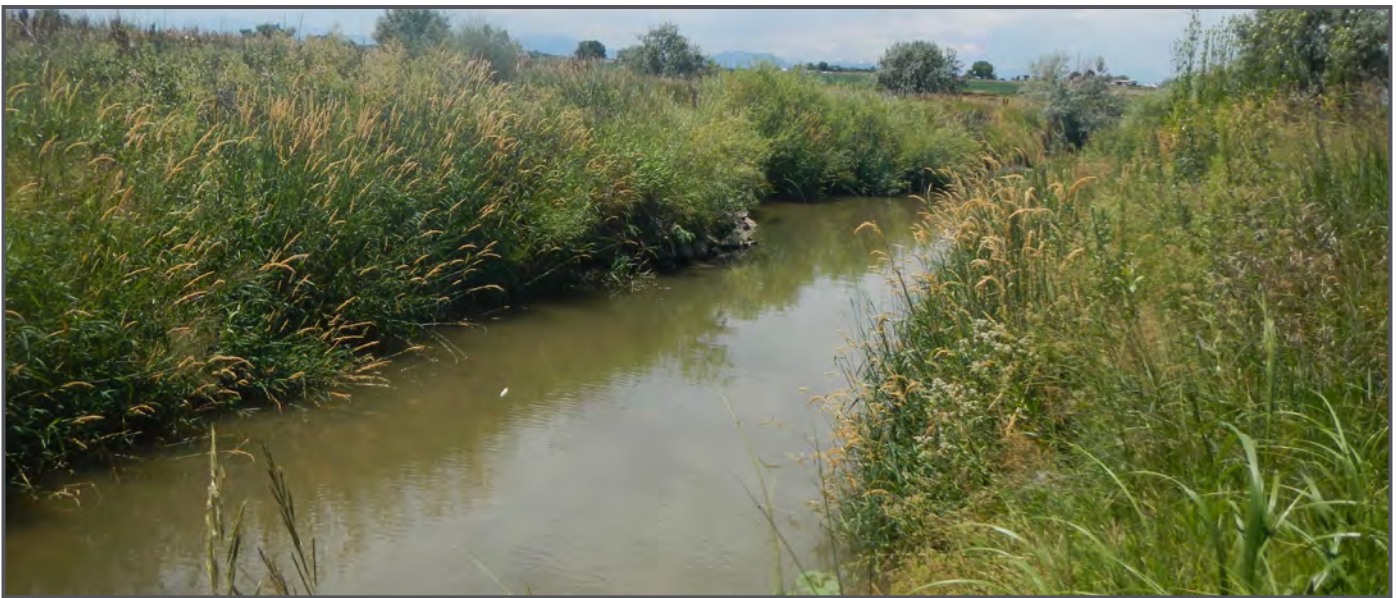
*Section of Big Dry Creek lacking sinuosity and creek edge variation*

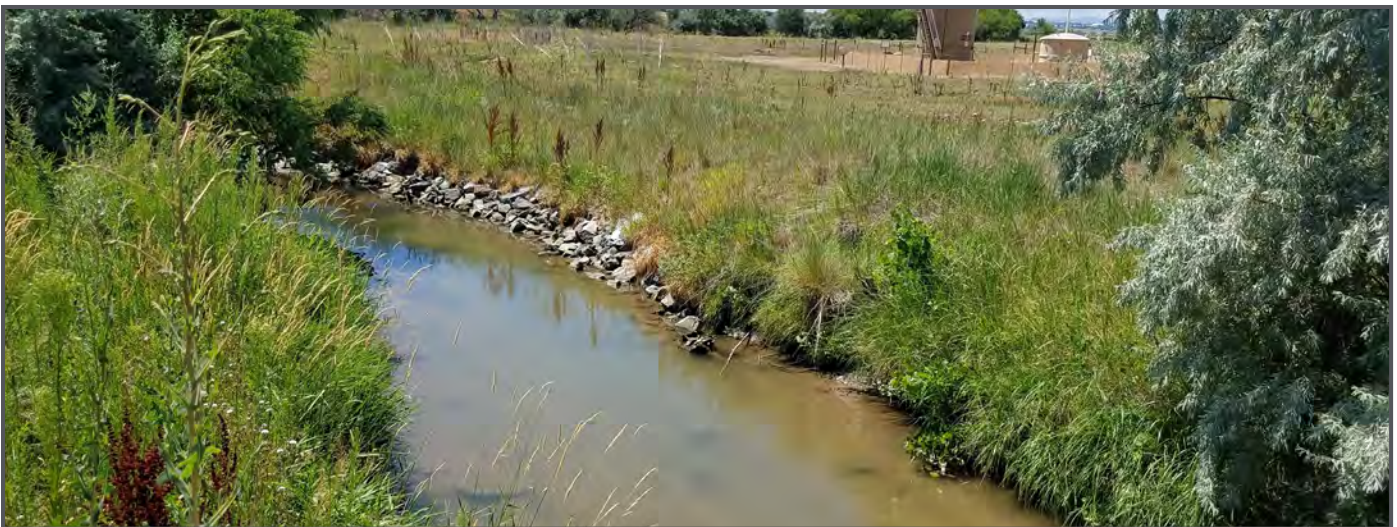
*Section of Big Dry Creek with good channel complexity; sinuosity, variation in type of channel edge and vegetation types*

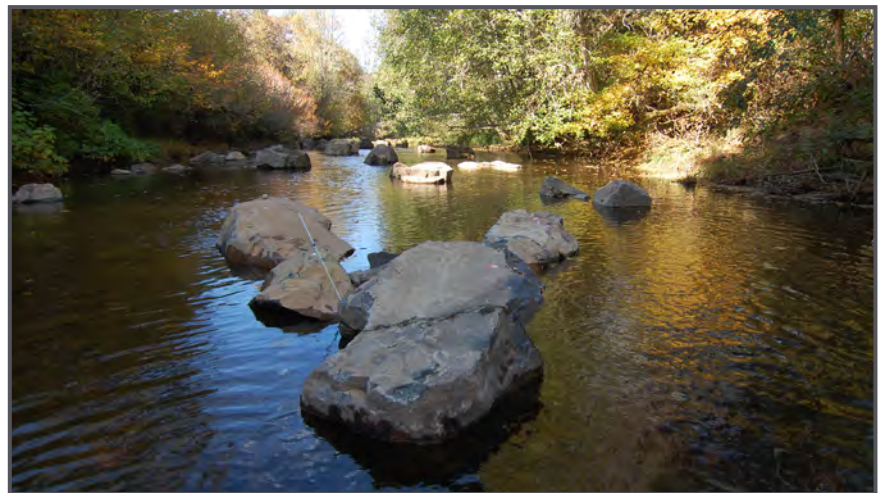
*Boulder clusters installed*
