**Big Dry Creek Recreation & Floodplain  
Restoration Master Plan**

**February, 2018**

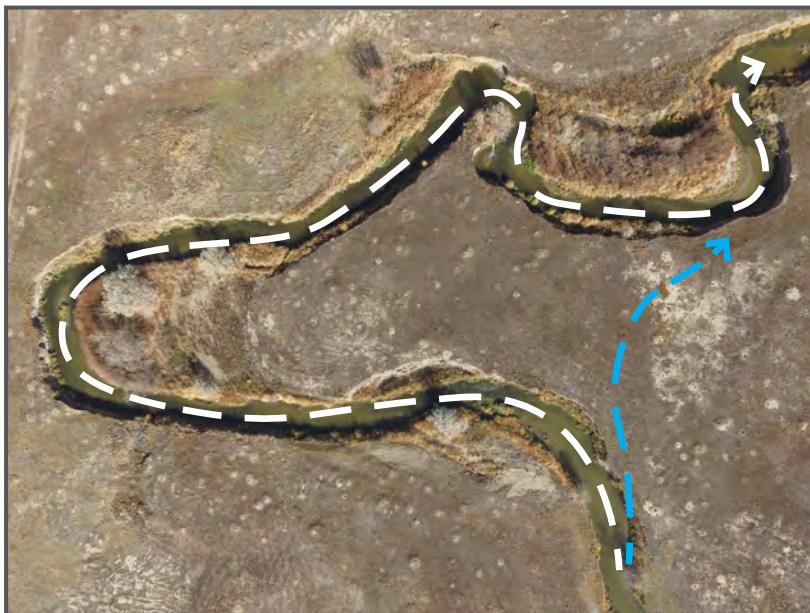
*If the channel's meander is straightened out, the water will be falling the same height over a shortened length, increasing the creek's slope and resulting in the need for grade control structures*

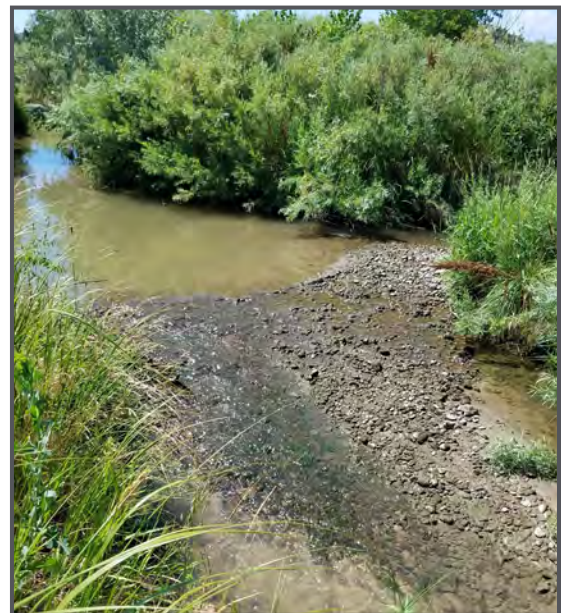
*Failed grade control*

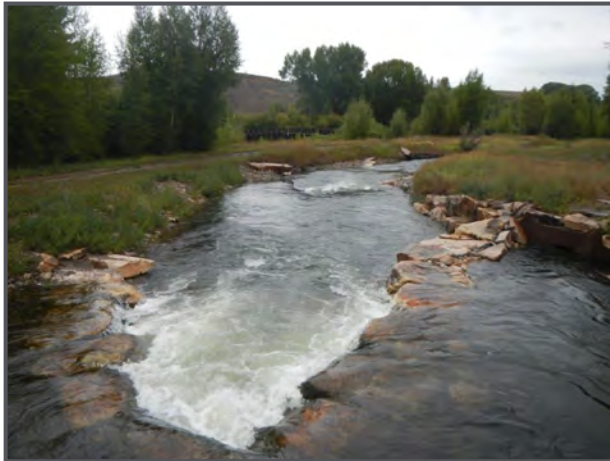
Cross vane example

Cross vanes are a natural way to modify channel slope and the channel width-to-depth ratios. They work by conveying the flows towards the center of the channel, therefore removing stress on the banks. These structures can also be effective at transporting excess bed material, reducing bank

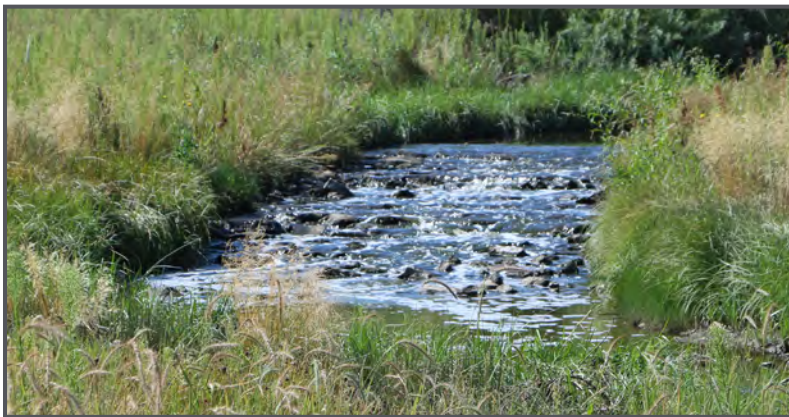
Water flowing over a constructed riffle

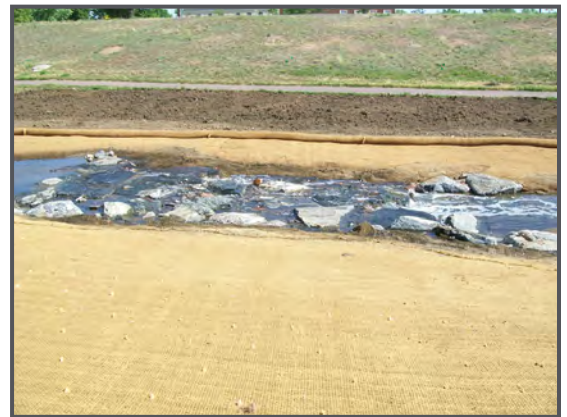
Riffle structure during construction with geotextile fabric along the banks

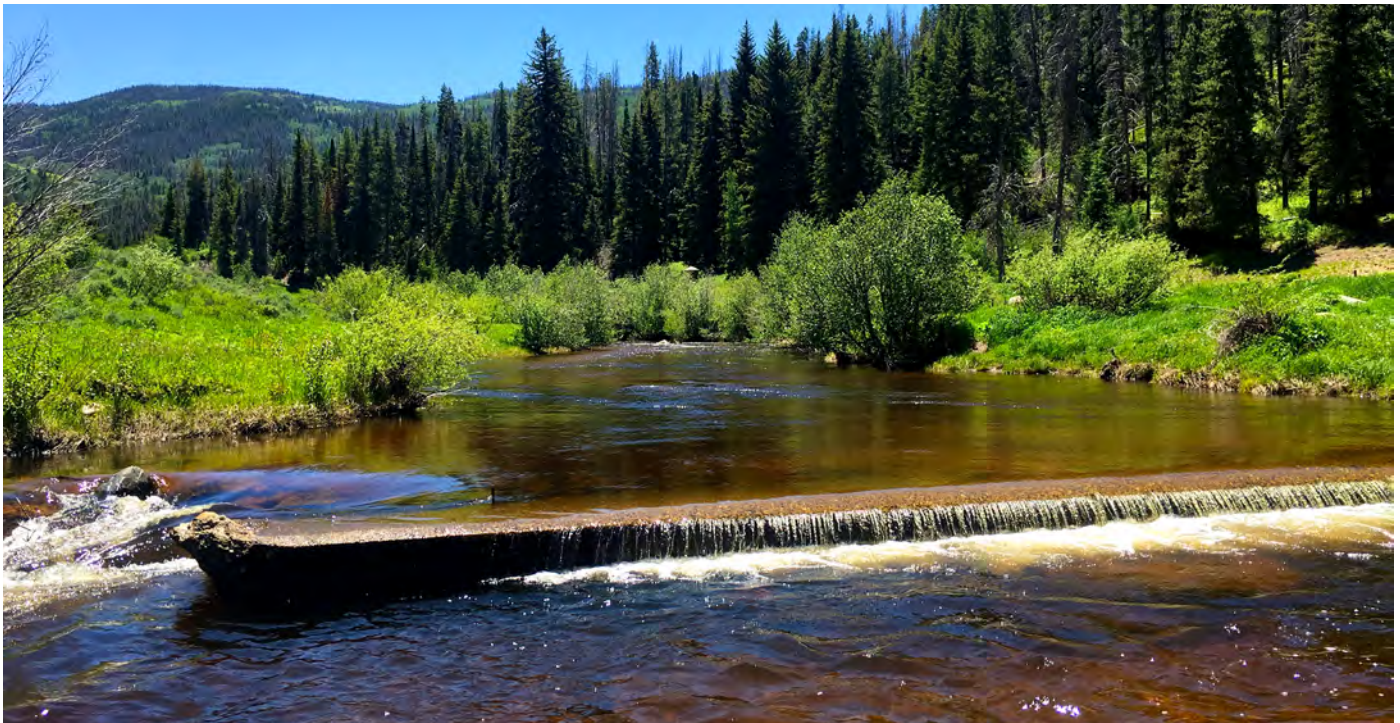
*Example of an in-stream concrete sill*

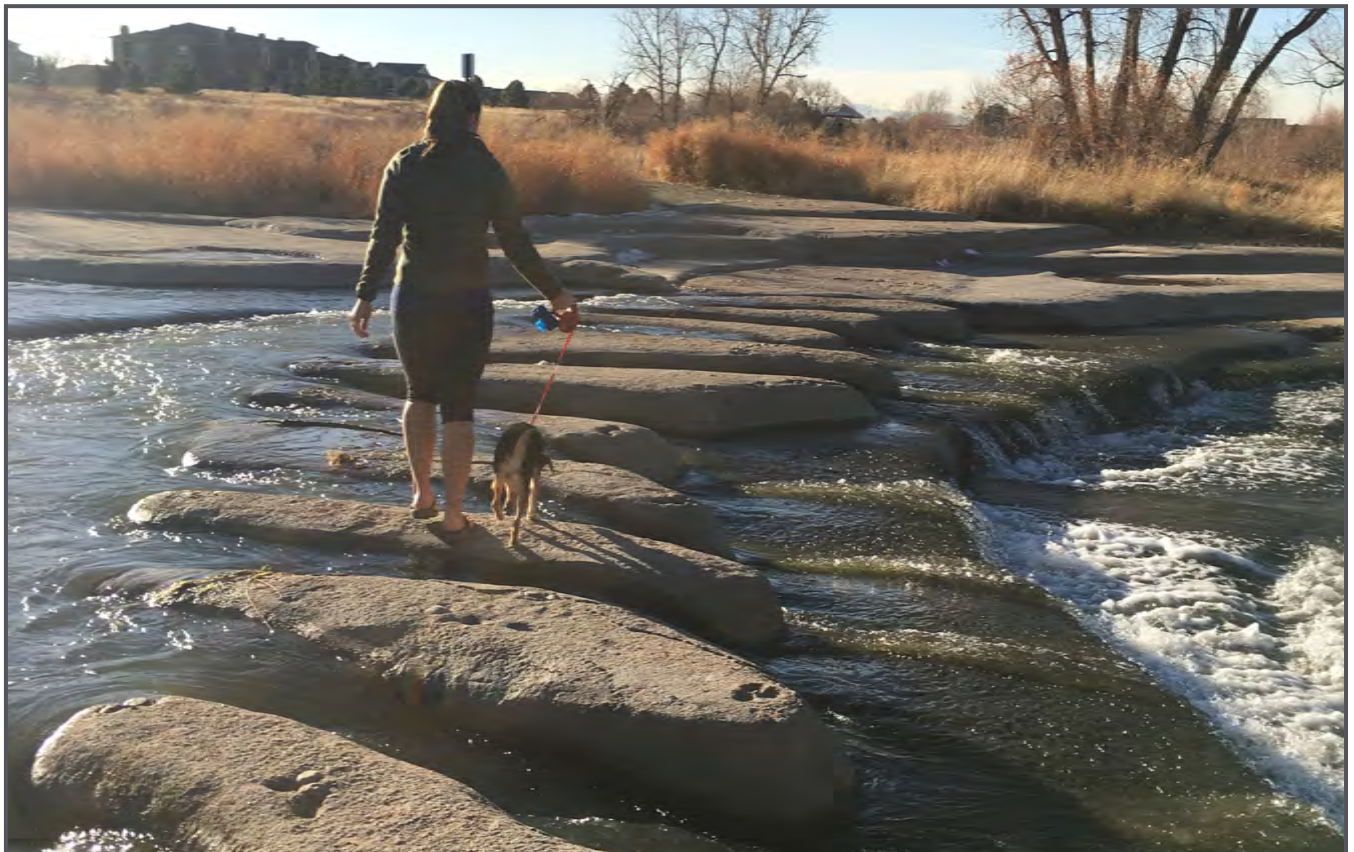
Drops structures along Big Dry Creek could be developed using various design techniques. The more traditional way to construct drop structures is using boulders that are placed in the channel to provide a stable slope and then grouting between the boulders to prevent the bedding and subsequent surface material from being eroded away. It is recommended due to the smaller sediment size that these drops be grouted, but in a situation where fish passage is more necessary it can be advantageous to leave the grout out. Drop structures can also be constructed using sculpted concrete which can be massaged into unique configurations to fit the channel dimensions. These drops structures can also be outfitted with planting locations so that they appear more natural. The sculpted concrete drops structures usually cost more than grouted boulders due to the preparation work.

*Example of a constructed drop structure that is also designed as a low-water crossing*

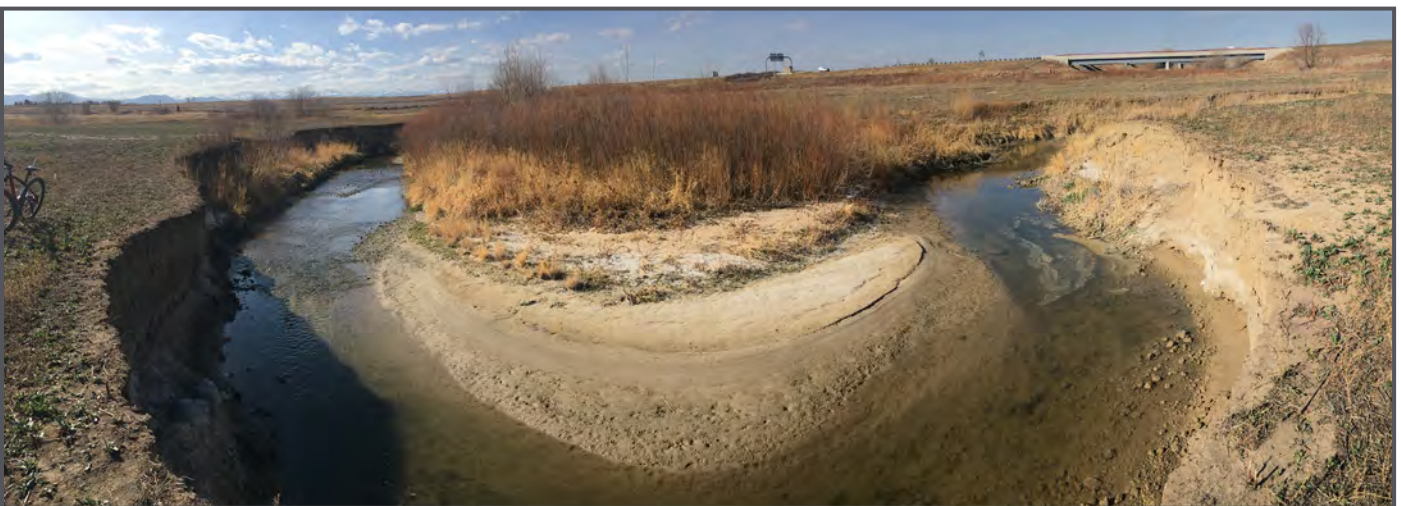
*Sharp meander in Parcel V; if the meander is cut off to protect infrastructure, the previous channel and the inner bend area can be converted into a healthy and productive oxbow wetland*

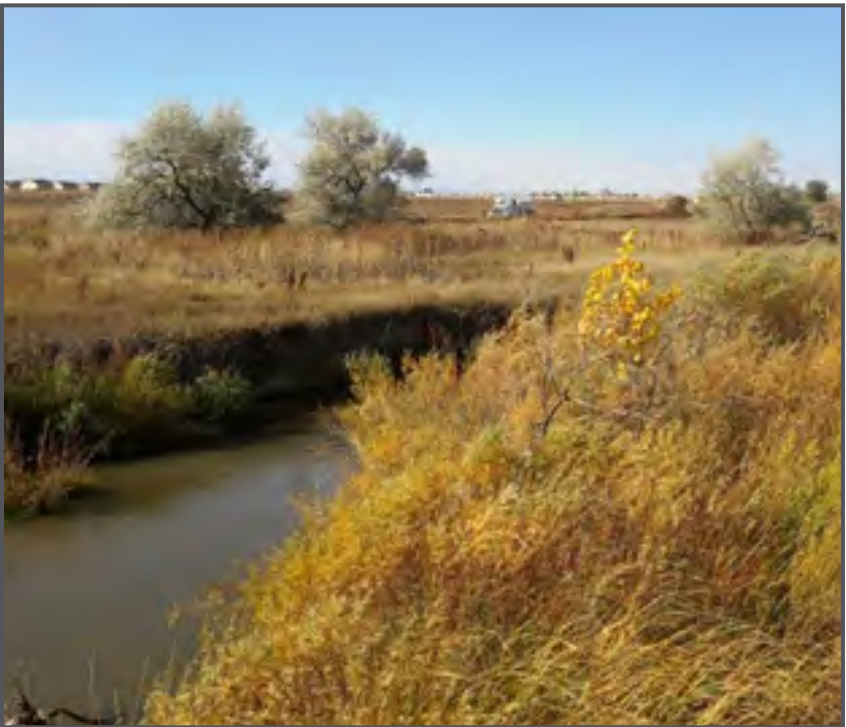
Riparian area within Parcel VIII

**Riparian:** Big Dry Creek is less incised through this parcel with only a few stretches of vertical eroding banks that could be graded back to create benching for wetland and riparian native plant establishment. After weed control and Russian olive removal, the planting of additional native riparian trees and shrubs along the creek would allow for greater riparian plant diversity and overall creek and wildlife habitat health. Follow-up irrigation would be needed over time for the trees and shrubs.

**Wetlands:** Existing wetlands along Big Dry Creek in Parcel VIII may require some spot weed control. These areas could then be planted with wetland and riparian shrubs and trees.

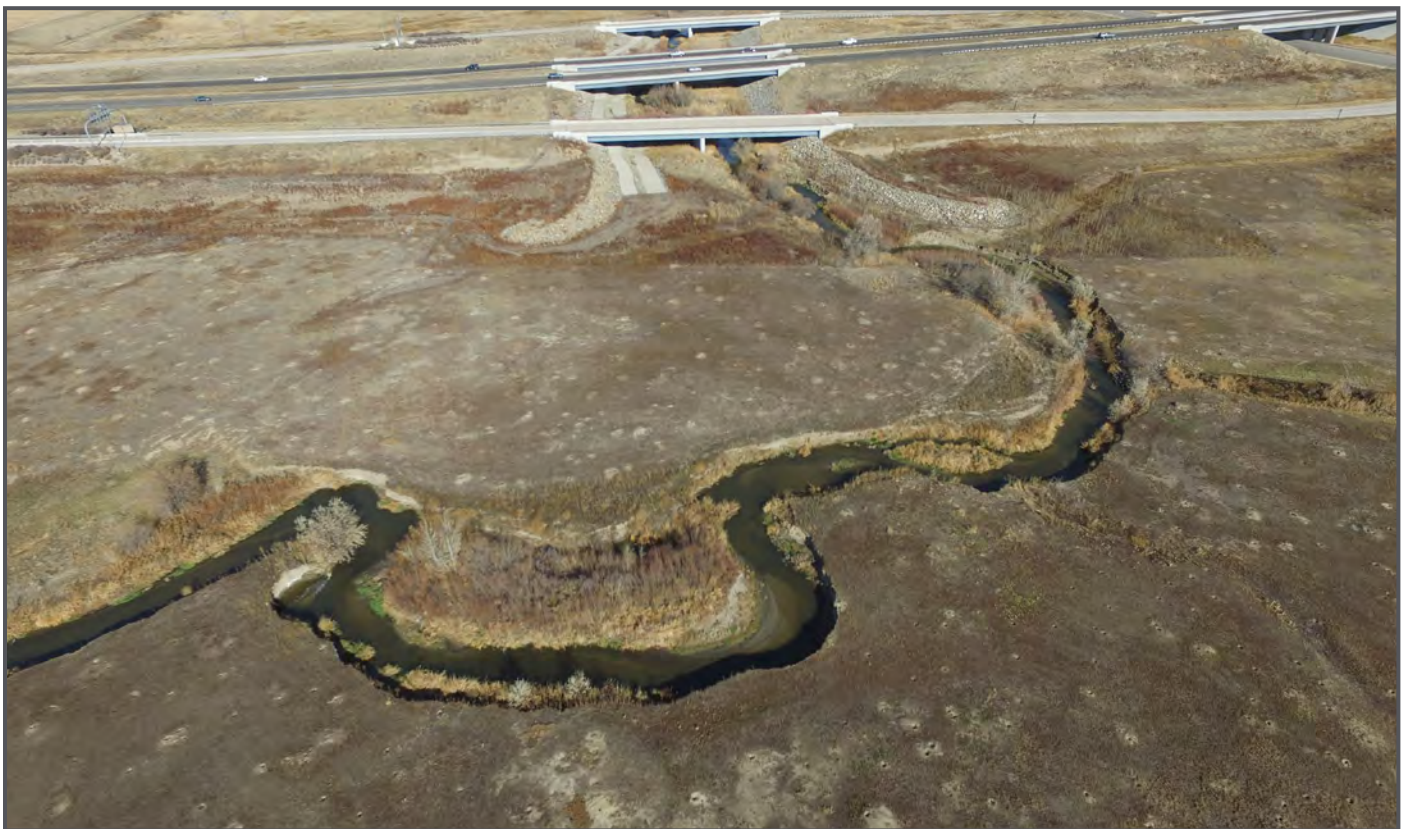
*Projects with major channel impacts such as cutting off an existing meander to create an oxbow wetland are likely to require an Individual 404 permit*

**Individual 404 permits** are required for projects that will have a **significant impact** within the channel. Individual 404 permits require longer review and preparation, thereby causing an increase to permitting costs as well as project completion time.

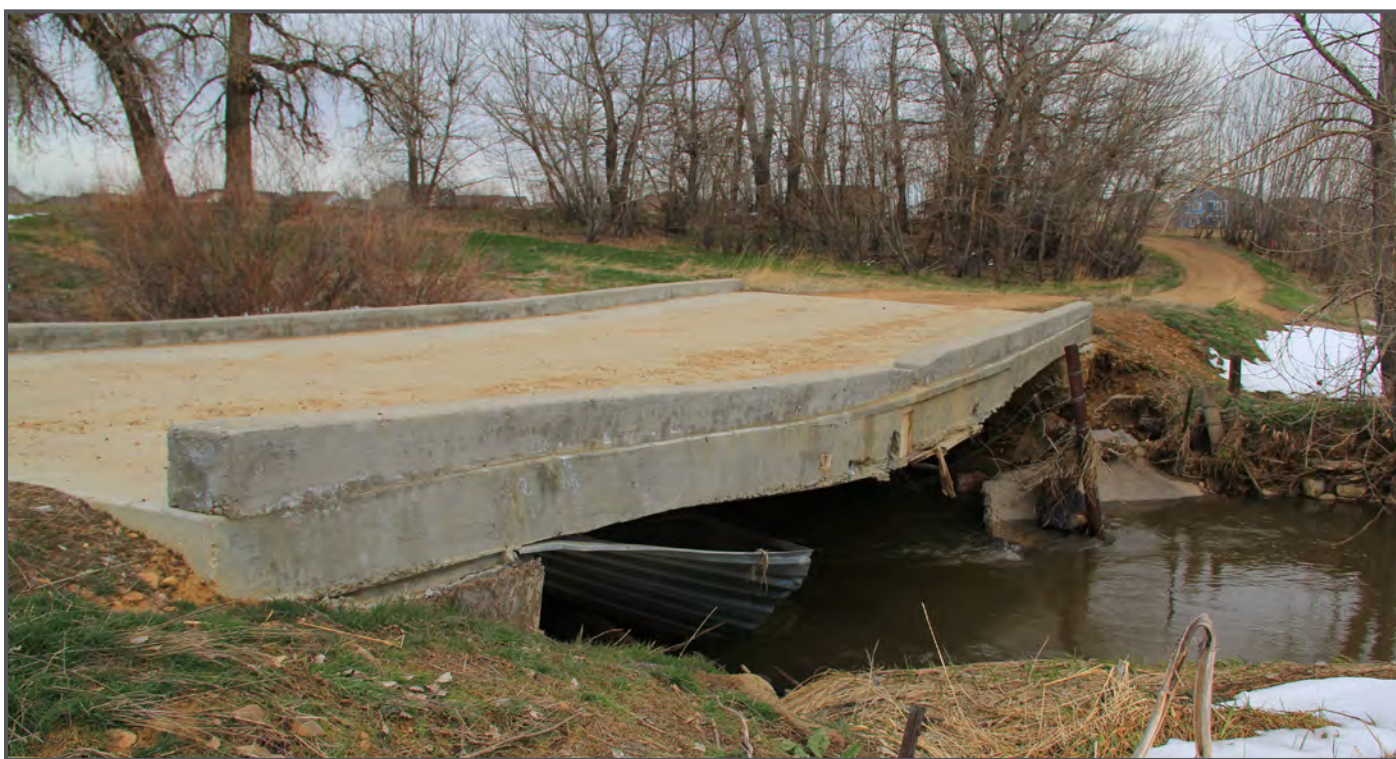
*Corrugated metal hanging off of the bottom of the bridge at Small Project C*

**Small Project C:** This project is the existing oil/gas access bridge near the Big Dry Creek Barn in Parcel III. While this bridge is included in High Priority Reach 4, it could be repaired/improved independently from the rest of the High Priority Reach. The bridge itself requires repair or replacement to improve the abutment and embankment conditions, as well as the capacity/conveyance under the bridge. Currently the bridge has corrugated metal sheets hanging off of the bottom of the bridge into Big Dry Creek. In addition to the bridge repairs, hydraulic conditions need to be improved downstream. Currently the creek channel makes a sharp 90° turn, resulting in a scour pool that is deteriorating the outer bank.

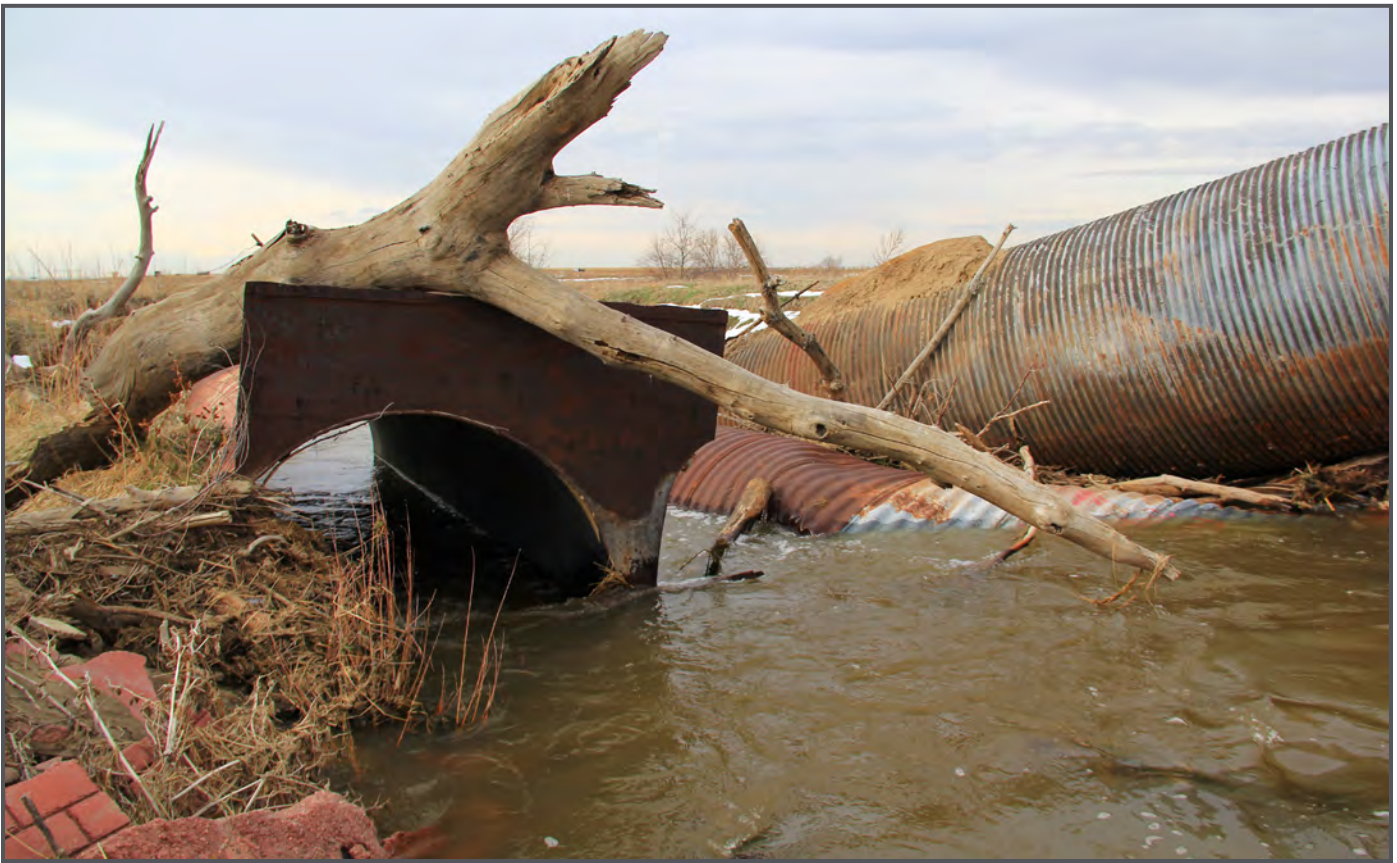
*Small Project D contains blown out culverts that need to be removed from Big Dry Creek*

**Small Project D:** This area contains multiple up-ended and rusting culverts that likely used to be a crossing of Big Dry Creek. The culverts are now causing major hydraulic and safety issues along the creek. The culverts should be removed and it is likely that grade control will need to be installed to avoid/minimize head cutting in the up and downstream reaches of Big Dry Creek. This area is within High Priority Reach 5, but it can be completed independently of the High Priority Reach improvements.

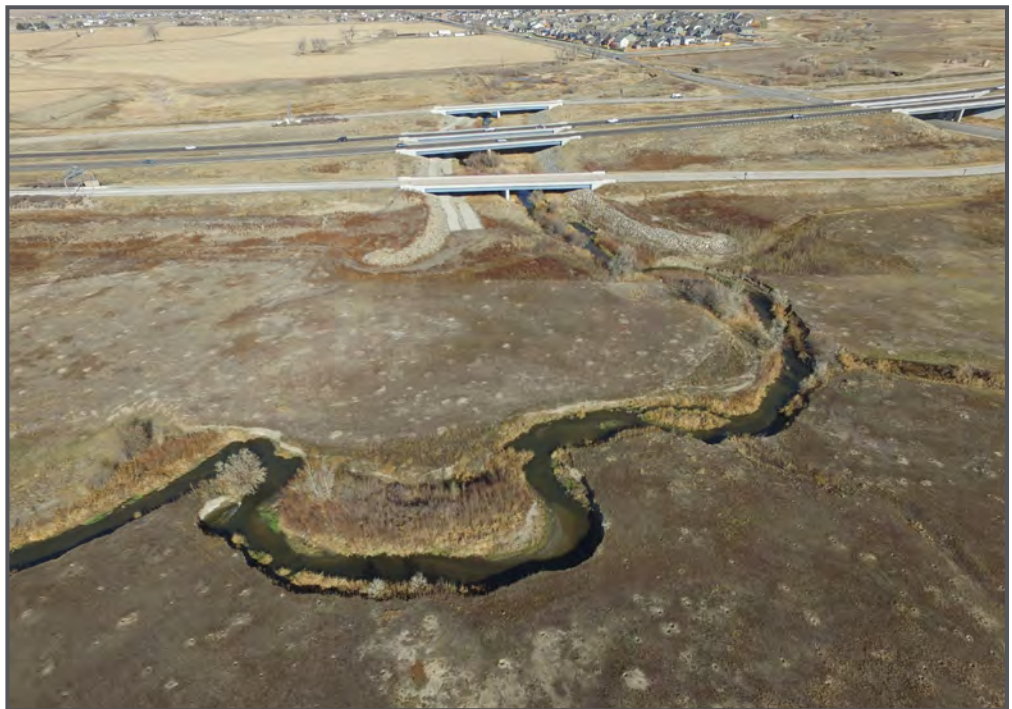
*Aerial view of the pilot project site looking north towards E-470; Big Dry Creek is migrating laterally and causing heavy bank erosion due to the straightening of the channel on both the north and south sides of the site*

Parcel V is an area of Big Dry Creek, between 152nd Avenue and E-470, that has been hydrologically impacted in negative ways and is a prime candidate for a number of improvements. Hydraulically, the straightening of the channel under both 152nd Avenue and E-470 has caused the creek to search for additional space to meander. The creek has sharp bends, steep cut banks and lateral migration almost off of the property. Channel Area 1 in the Pilot Project Conceptual Plan on the facing page contains a large oxbow that is creating very deep vertical cut banks and extensive erosion. The channel has migrated almost onto the Adams County parcel to the west. Channel Area

2 also displays strong lateral migration, with Big Dry Creek doing a U-turn that directs the channel back towards 152nd Avenue. The channel then runs parallel to 152nd Avenue before turning north into Channel Area 1. For both of these areas, multiple options should be explored, but they both offer the opportunity to re-align the channel and cut off the sharp oxbows. If this is done, overflow wetlands can be created between the new channel and the previous channel area. As this would increase the slope of the creek significantly, appropriate grade control measures would need to be installed.

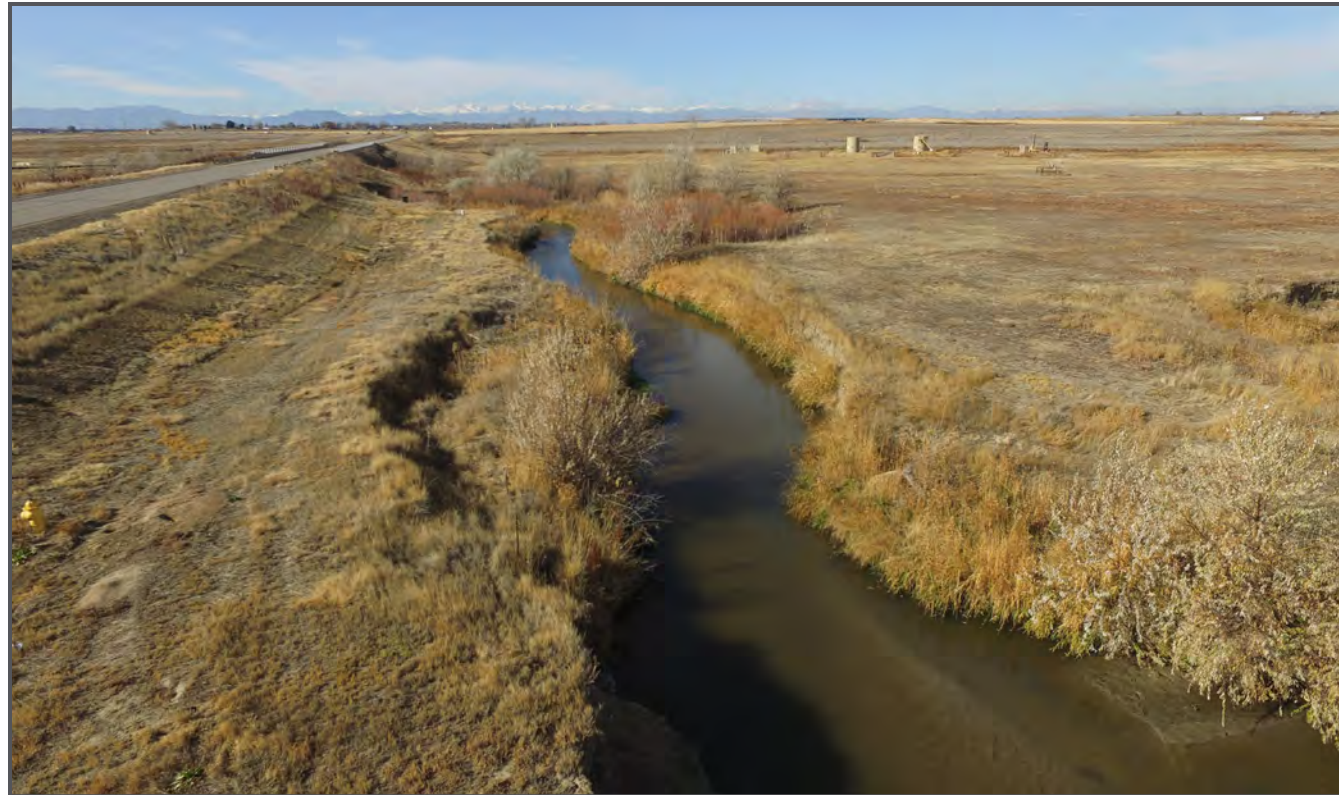
Big Dry Creek running parallel to 152nd Avenue

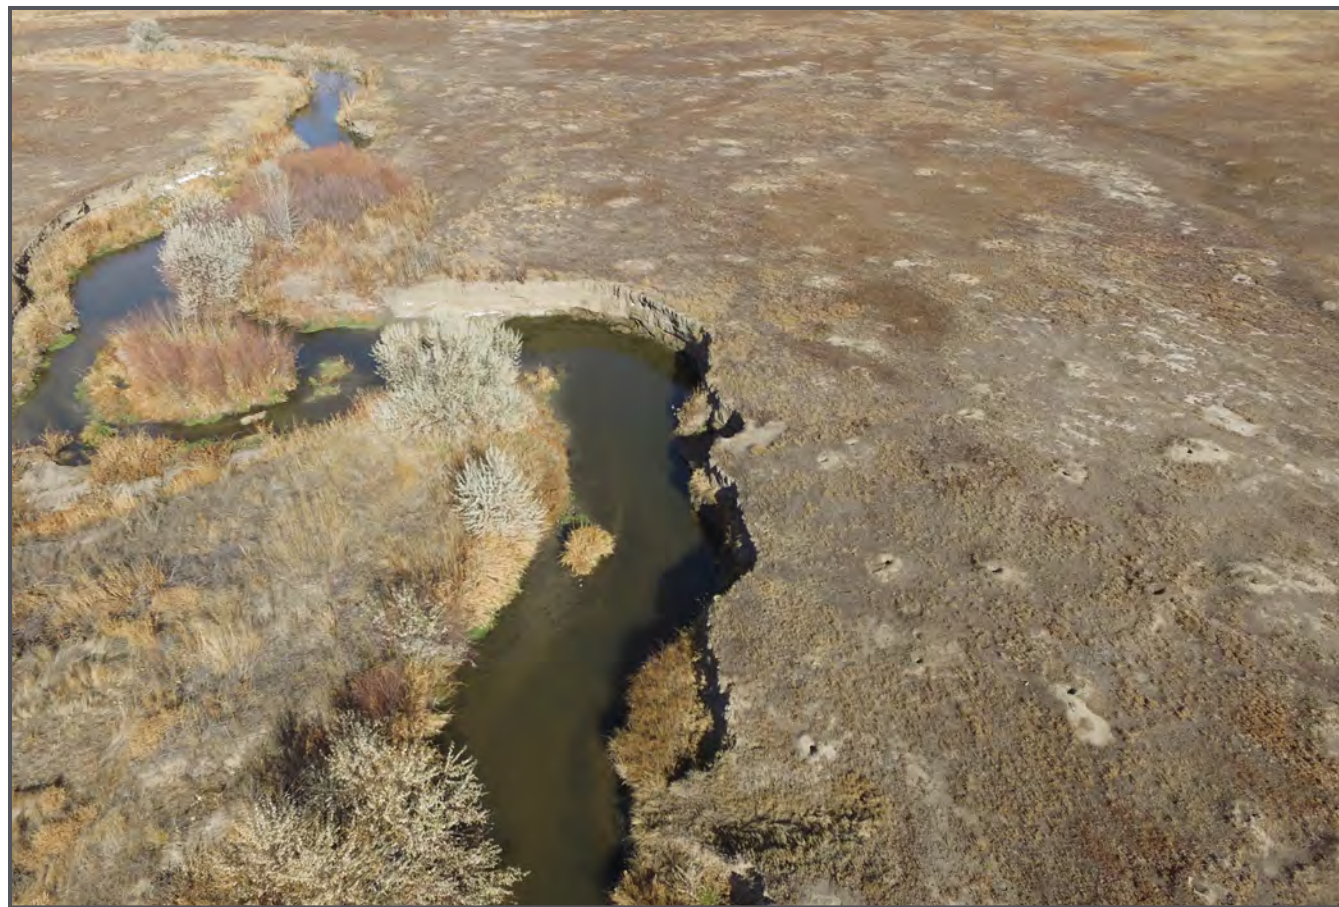
Dramatic sharp turns and vertical cut banks on Big Dry Creek on the pilot project site

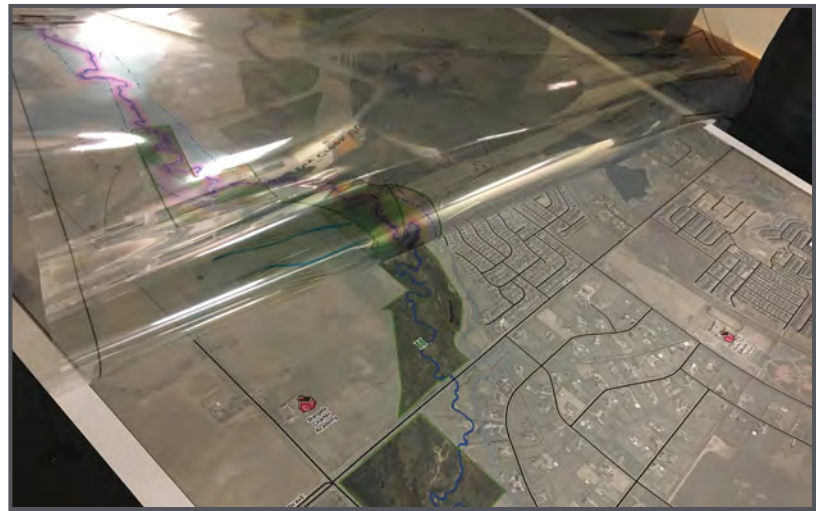
*Overlays allowed the team to add and remove different layers of information*

of the Big Dry Creek Master Plan was laid out and developed. During the charrettes, the team was able to add and remove layers in order to understand how they interacted/conflicted and where there were opportunities to combine projects. For example, the original routing for a trail was often changed once the environmental layer was overlaid, showing the trail going through healthy riparian or wetland habitat. Instead, the trail was rerouted through an area that was less sensitive. Another example is creek crossings being re-located to align with areas that require major channel work. This way, a channel improvement project could be designed to also fulfill recreational needs.

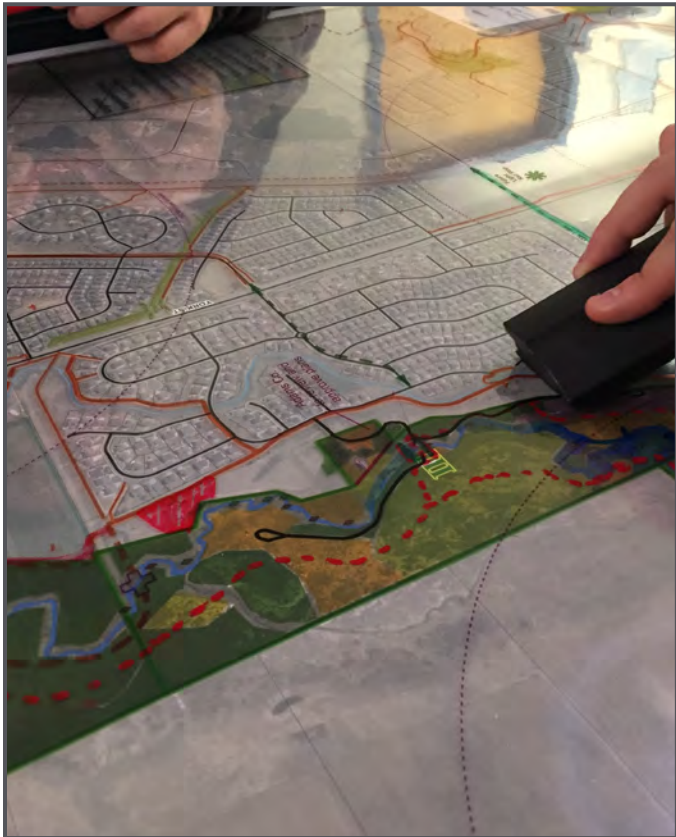
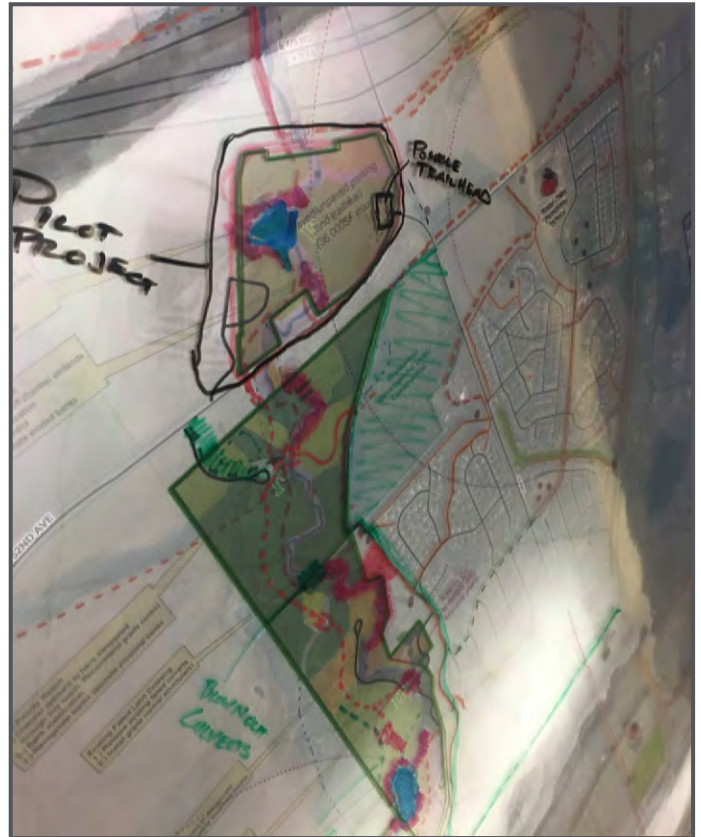
*Possible trail alignments and improvements drawn on top of the overlay maps created a clear depiction of the layers of information needed to be analyzed throughout the design process.*
